## Photo report

# Creation of a hydraulically bound base layer, rehabilitation of an unpaved road in the region of Gunung Mas/Kalimantan by using the NovoCrete® technology

- Location: Gunung Mas/Indonesia
- Period of execution: November 2012
- Time needed: not yet finished
- Cement: 190 kg/m<sup>3</sup> cement + 2 % NovoCrete
- Milling depth: 35 cm

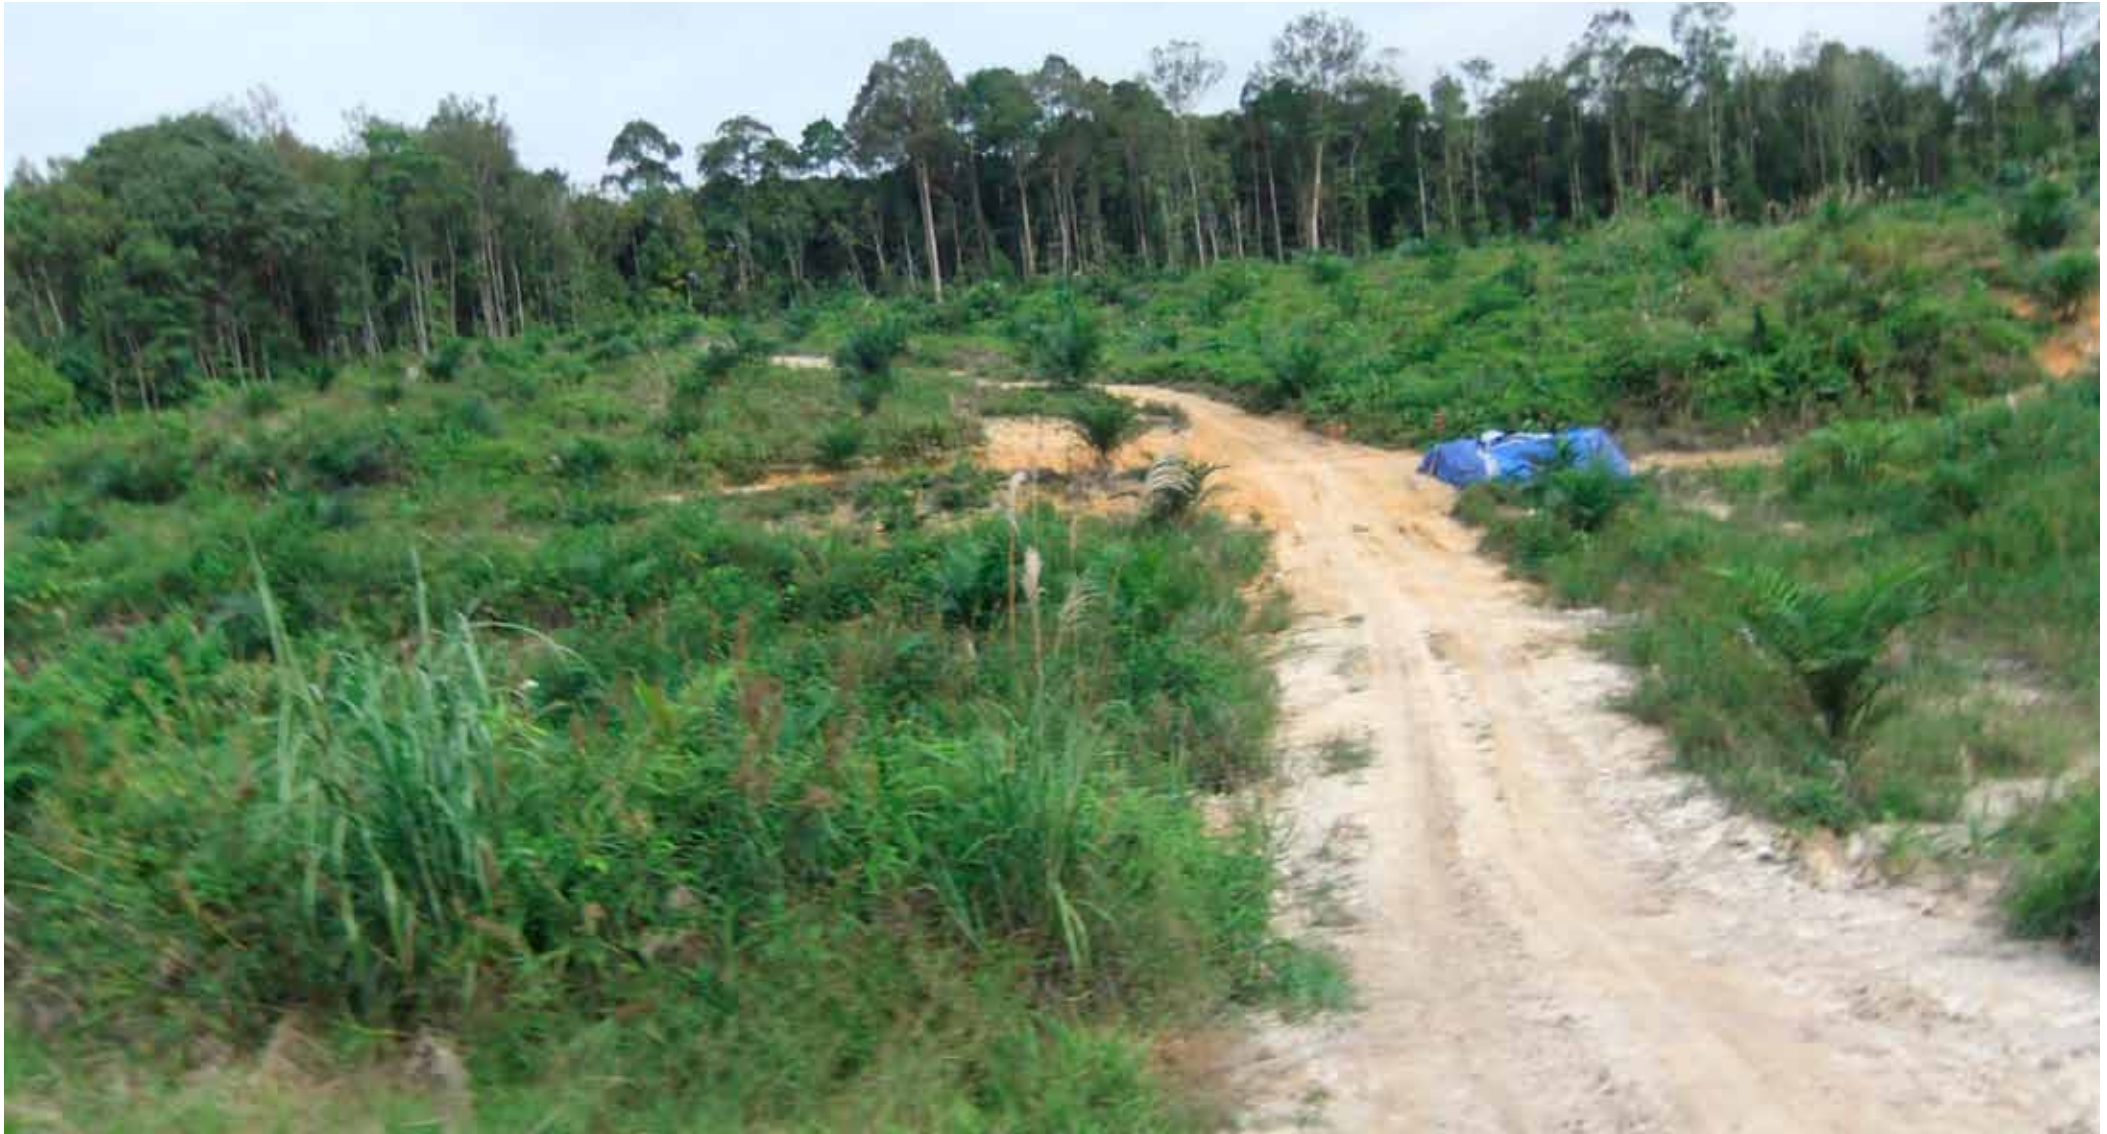
Ausgangssituation

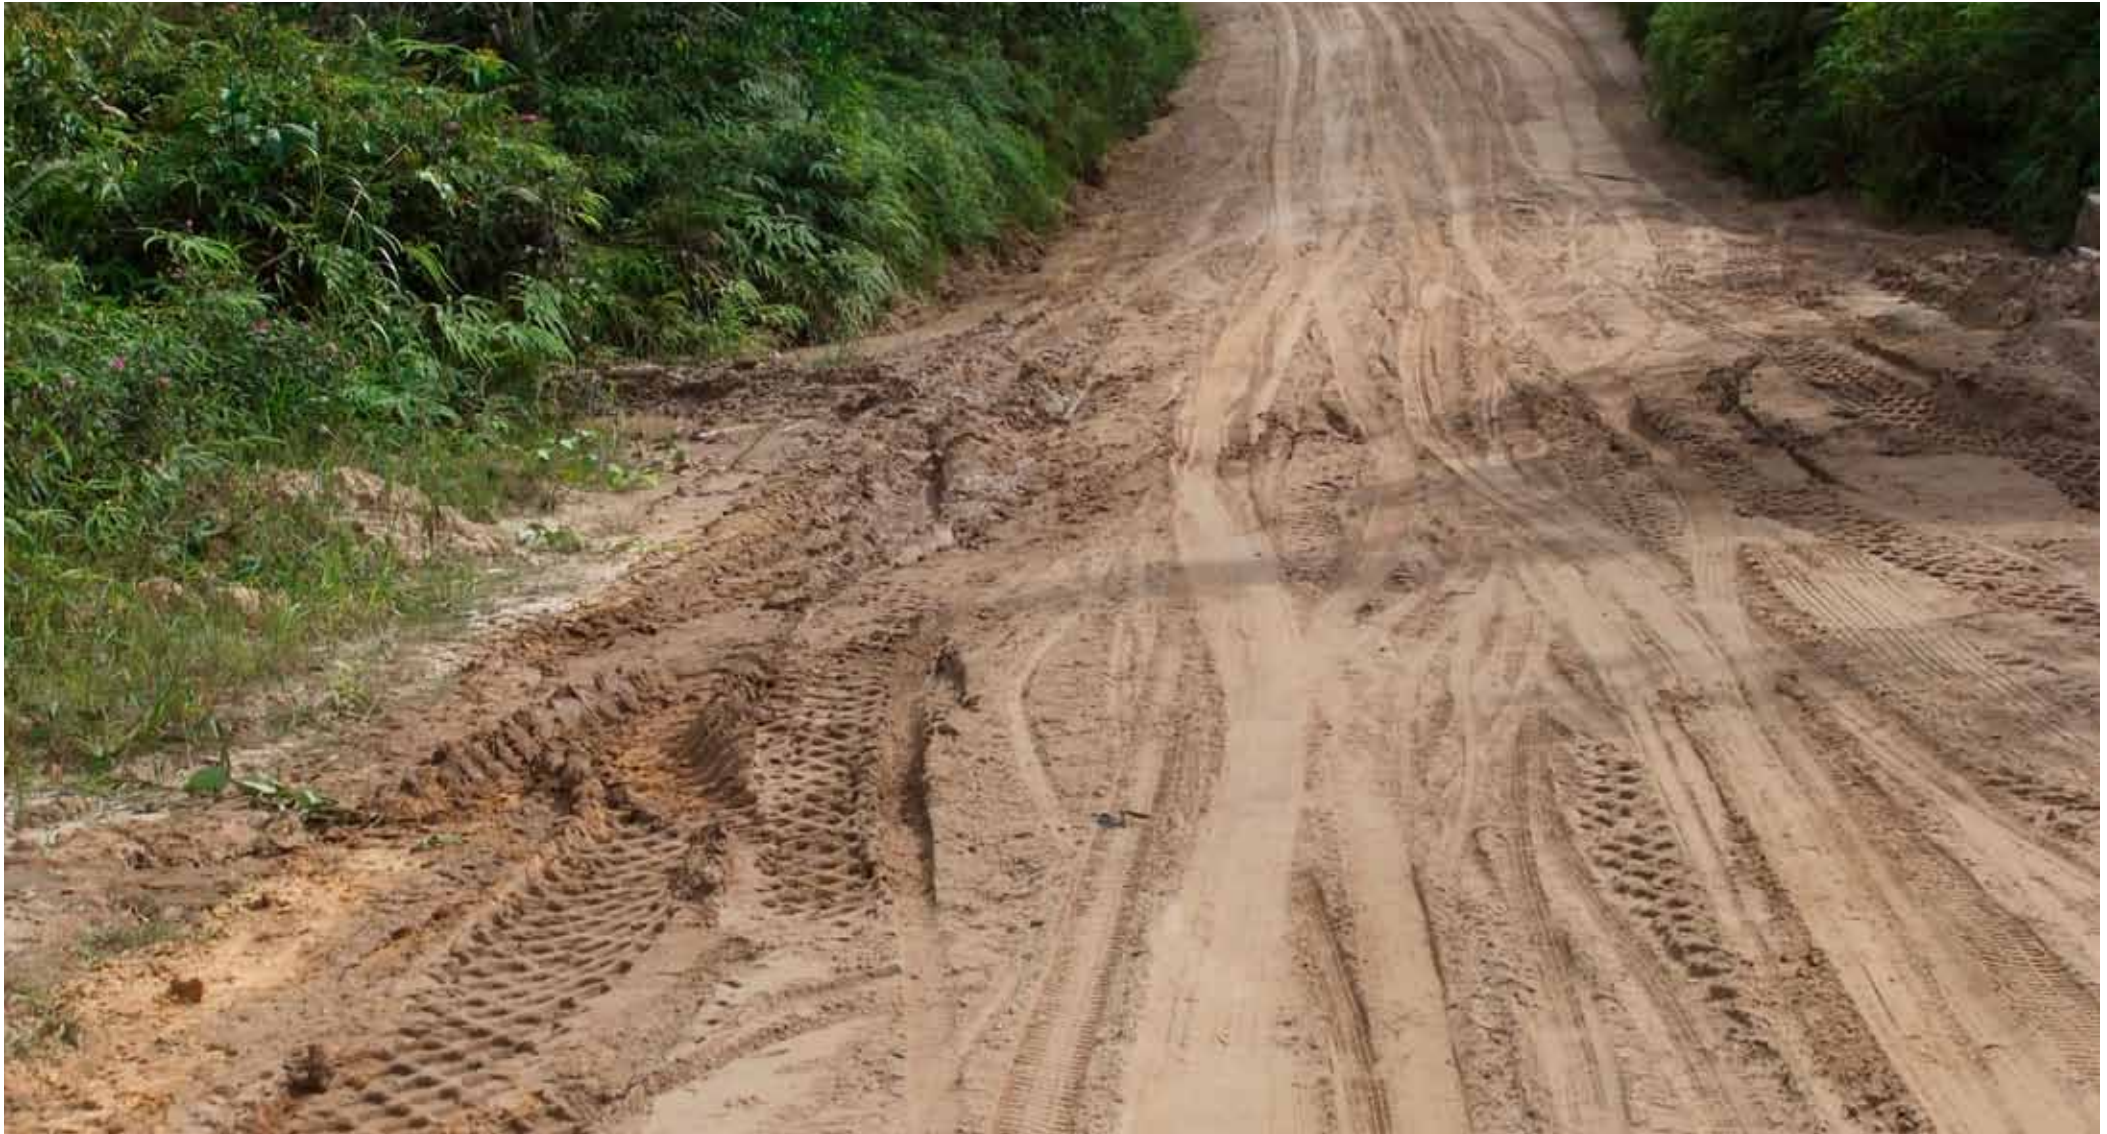
Initial situation

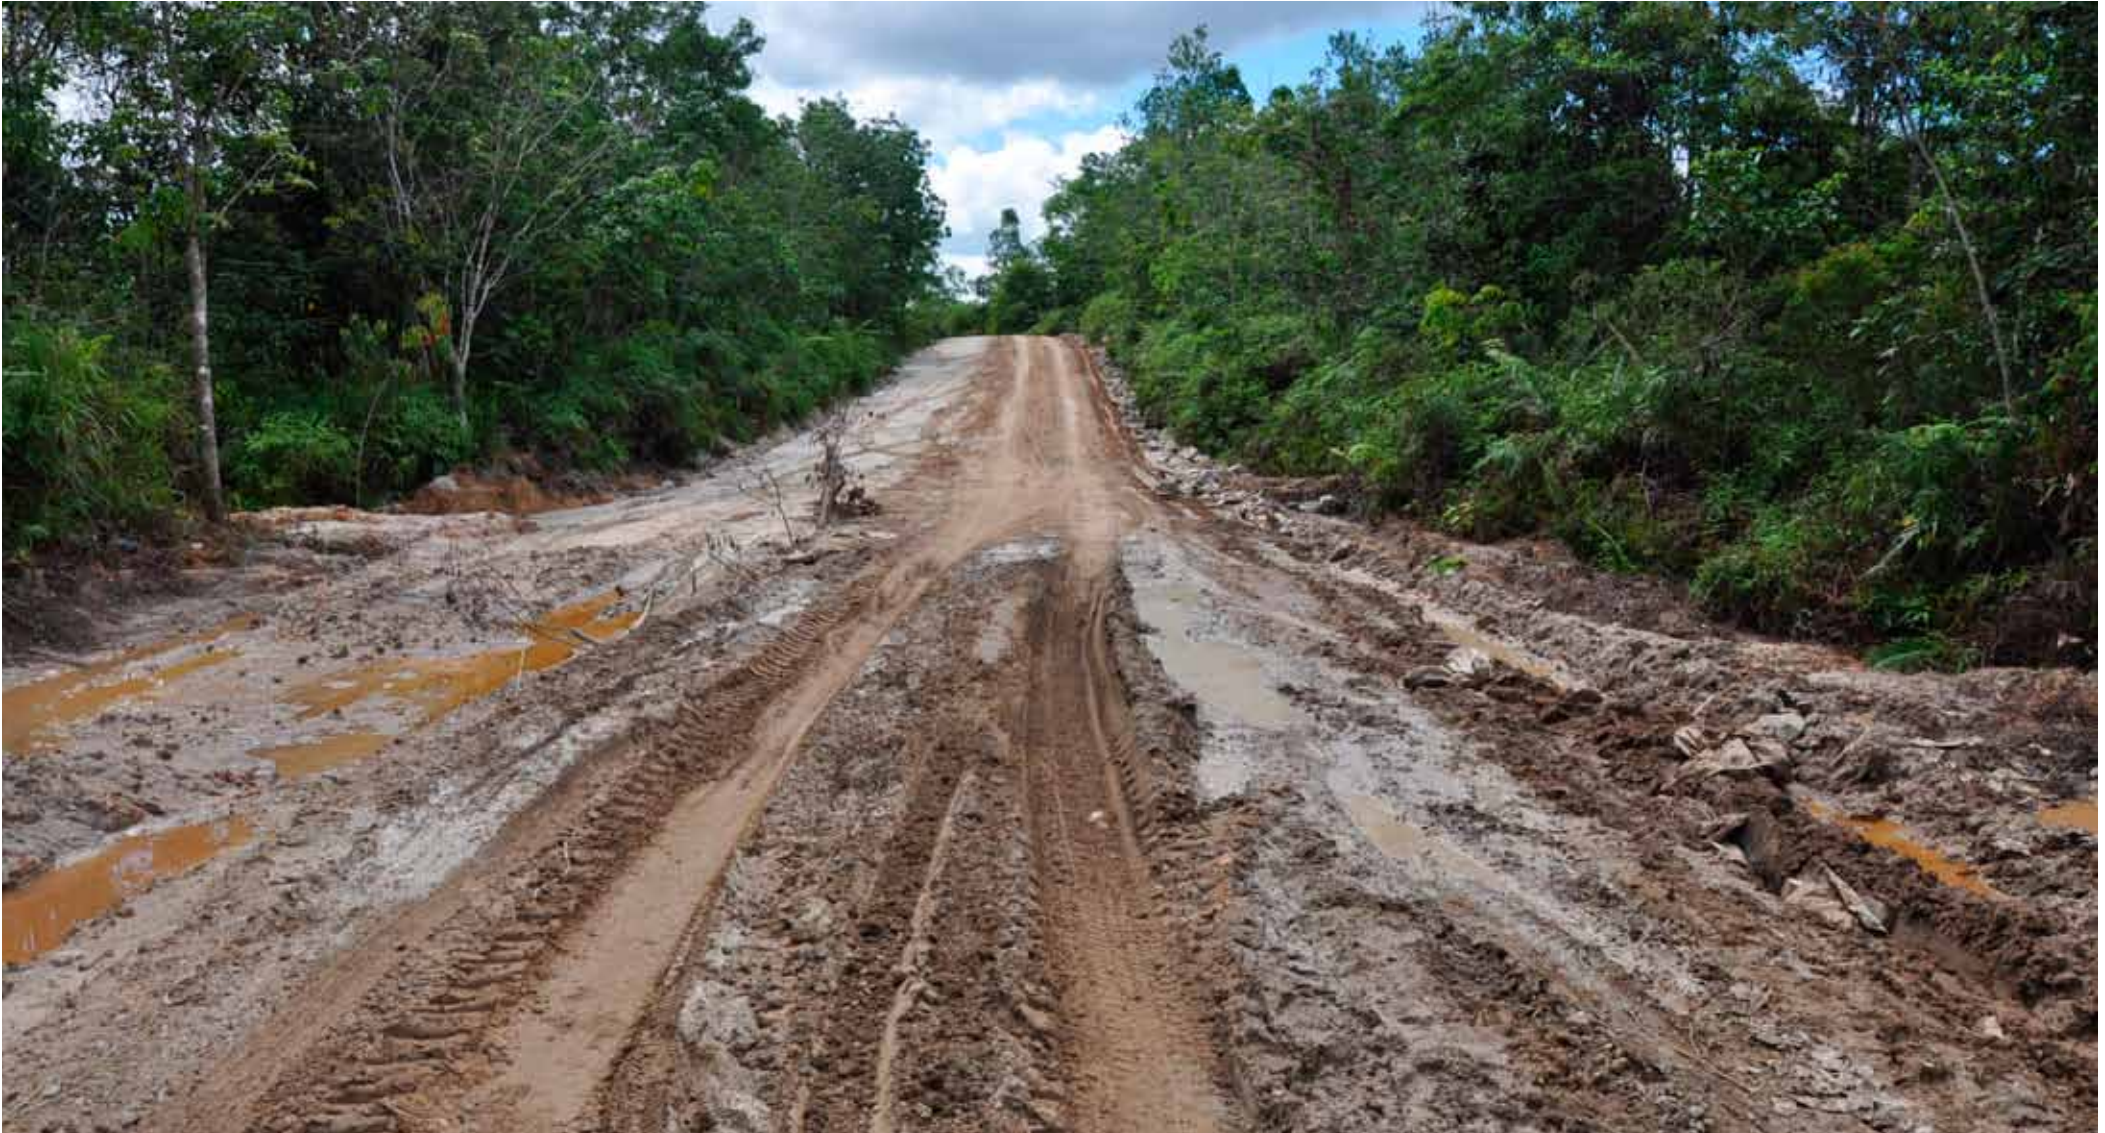
Initial situation

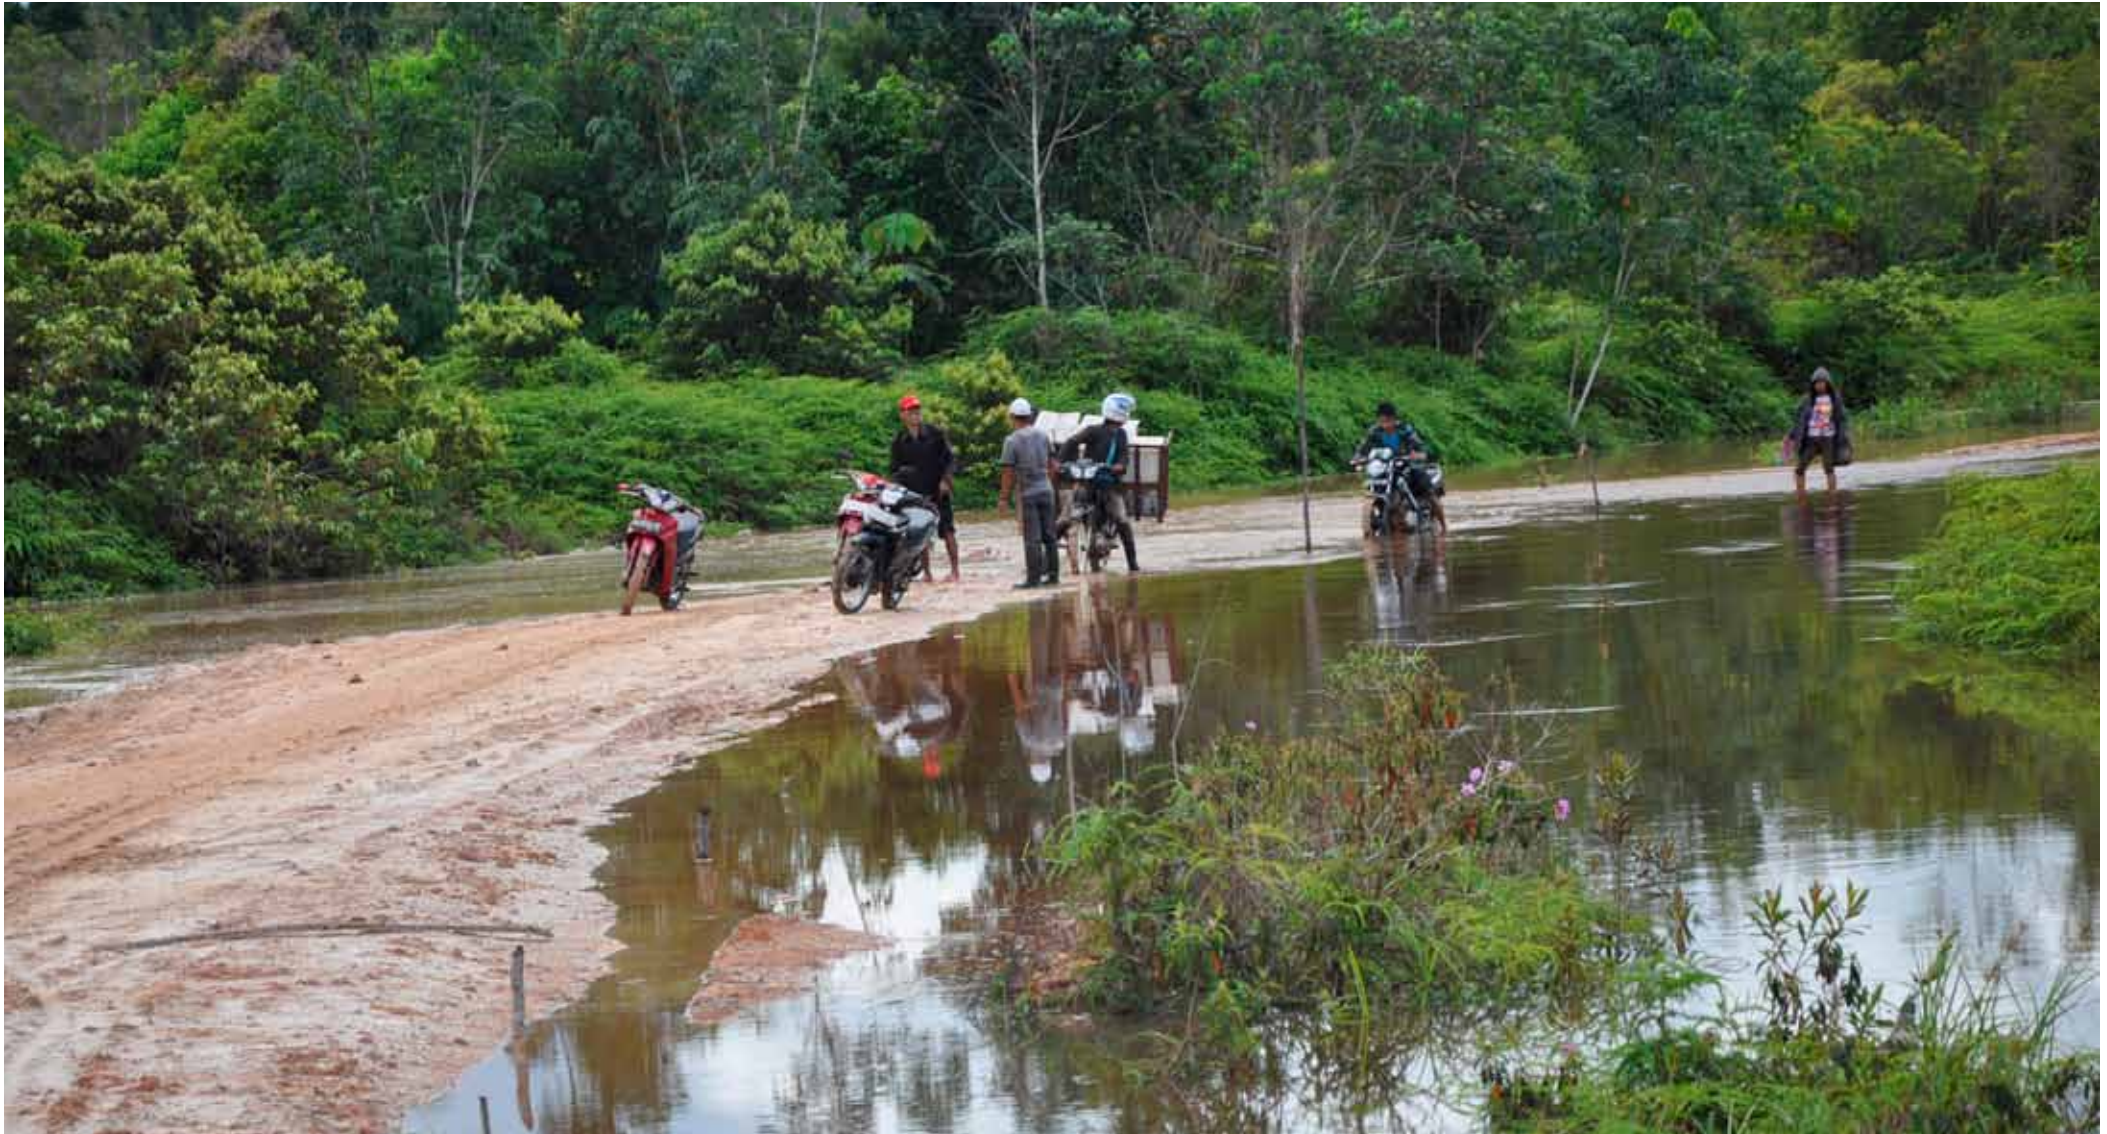
*Initial situation after heavy rainfall*

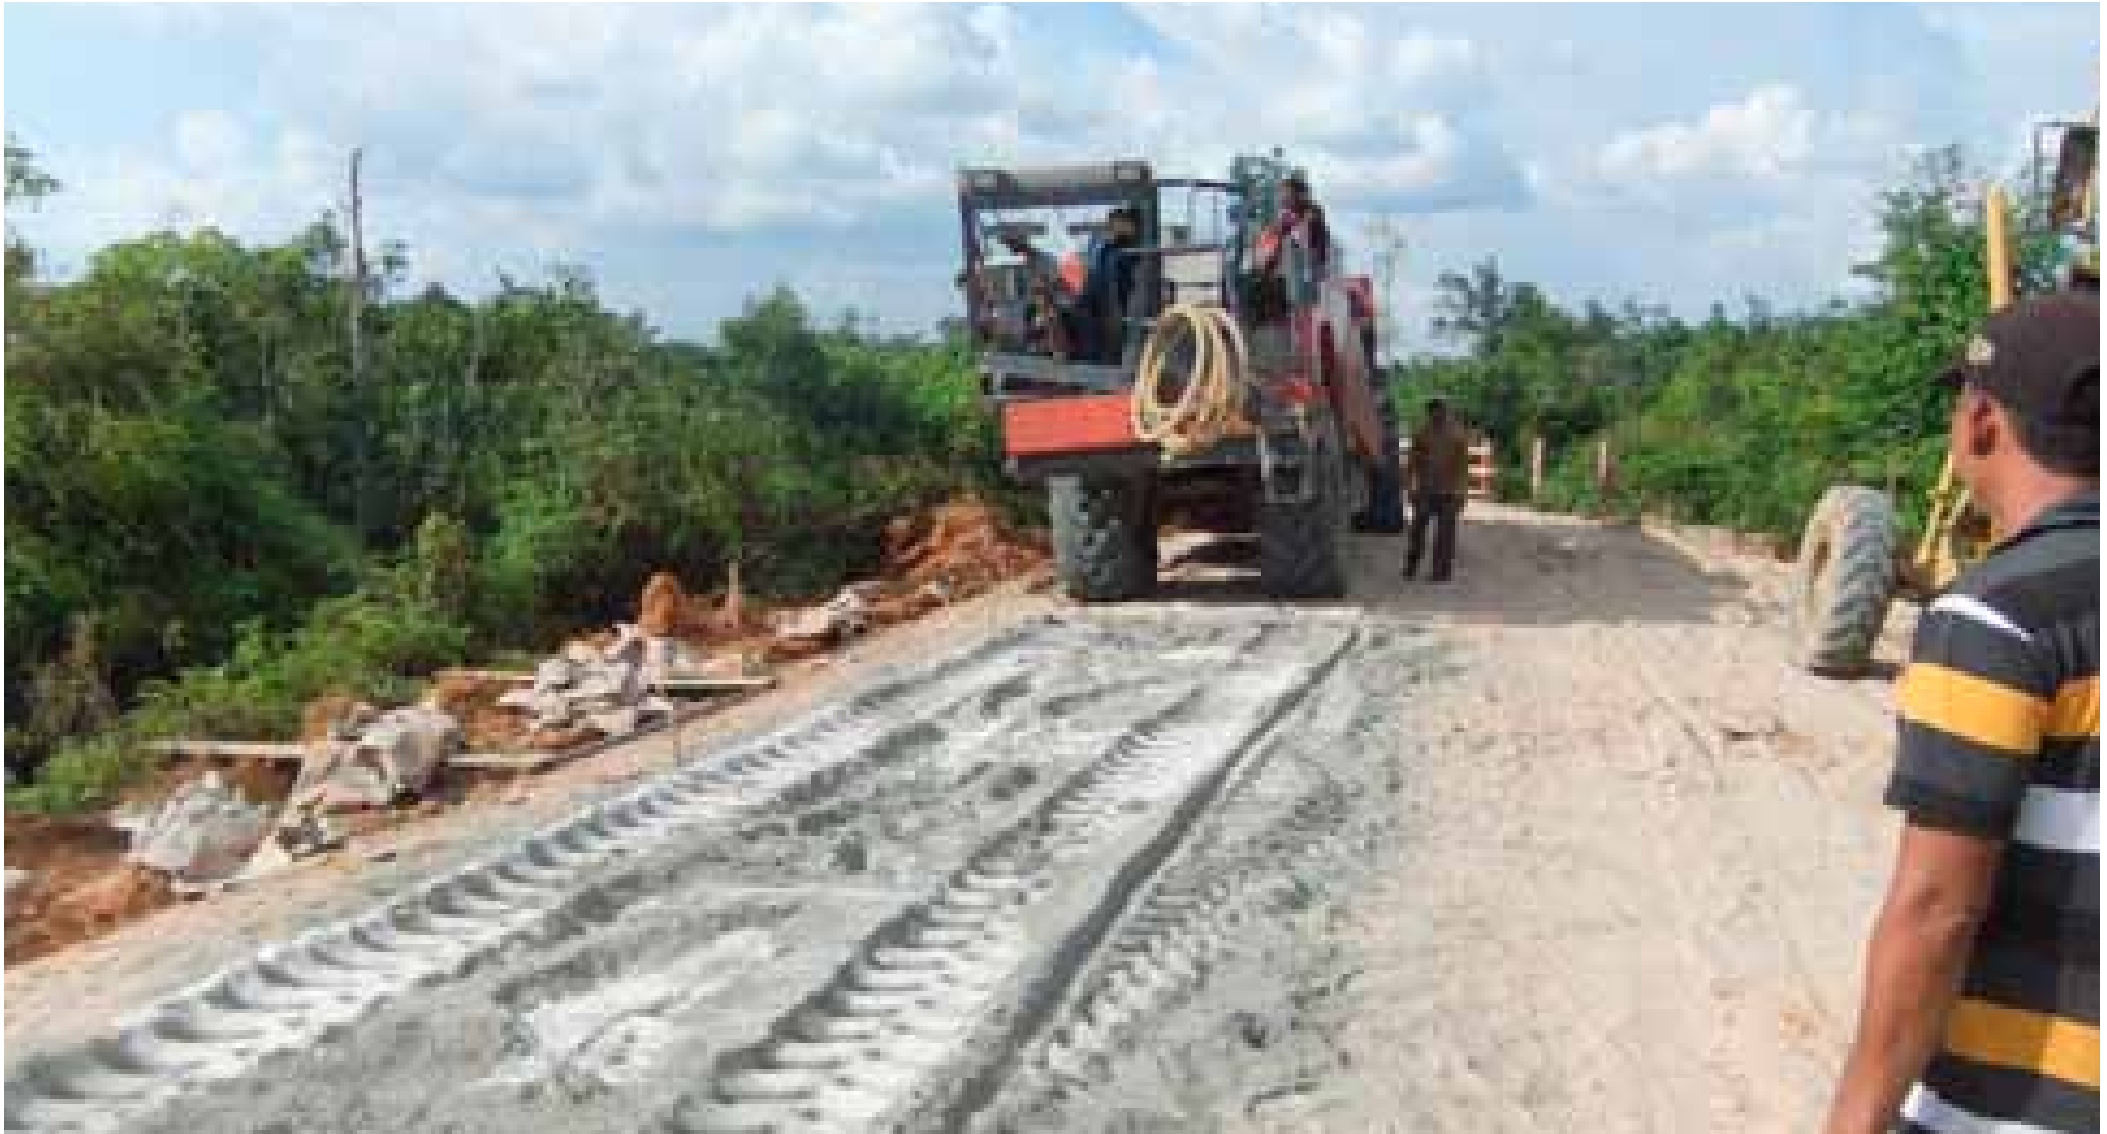
Milling of the cement-Novocrete® mixture up to a depth of 35 cm

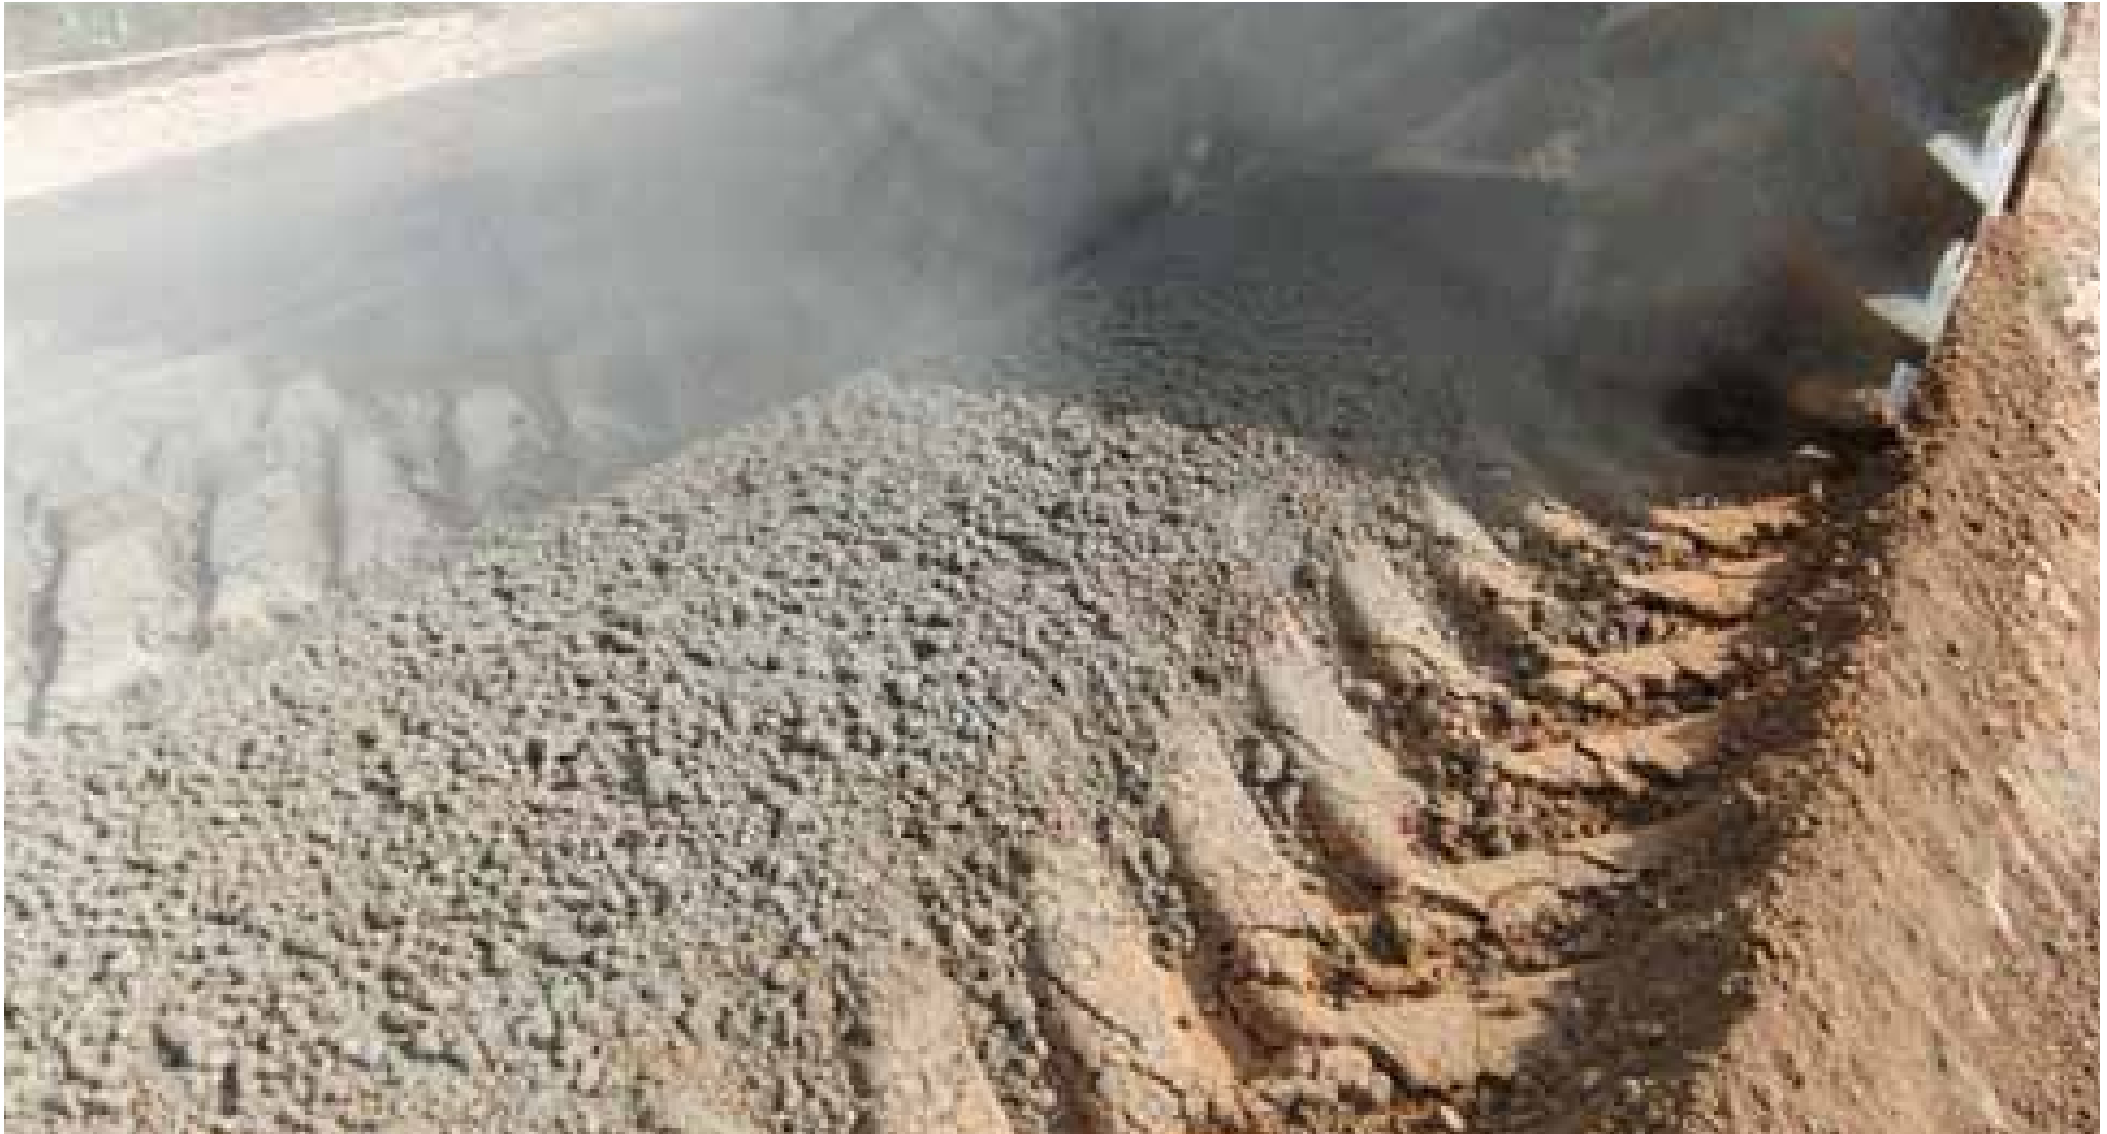
Mixture of soil and binding agent after the first milling procedure

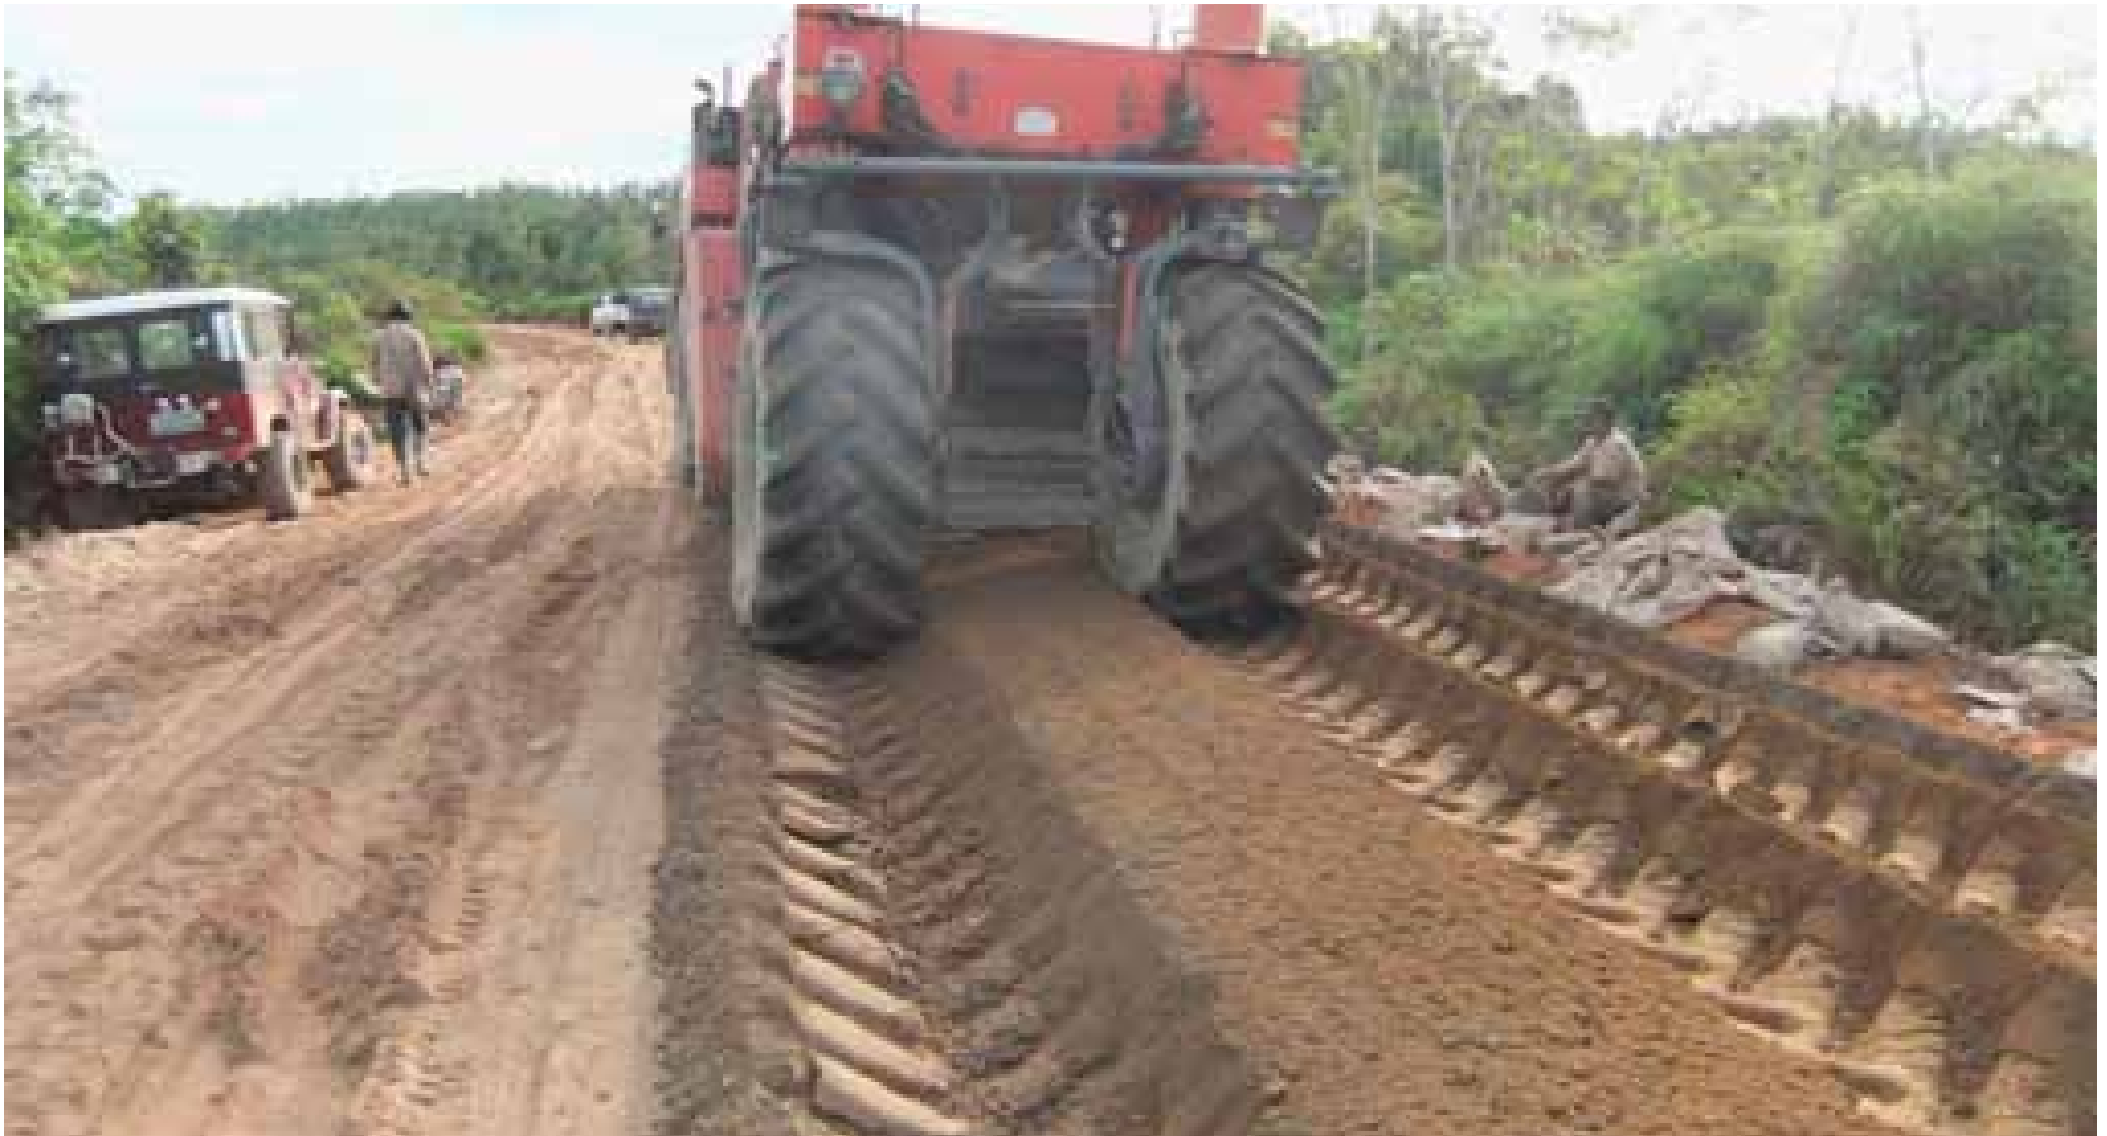
Milling of the cement-Novocrete® mixture up to a depth of 35 cm by adding water

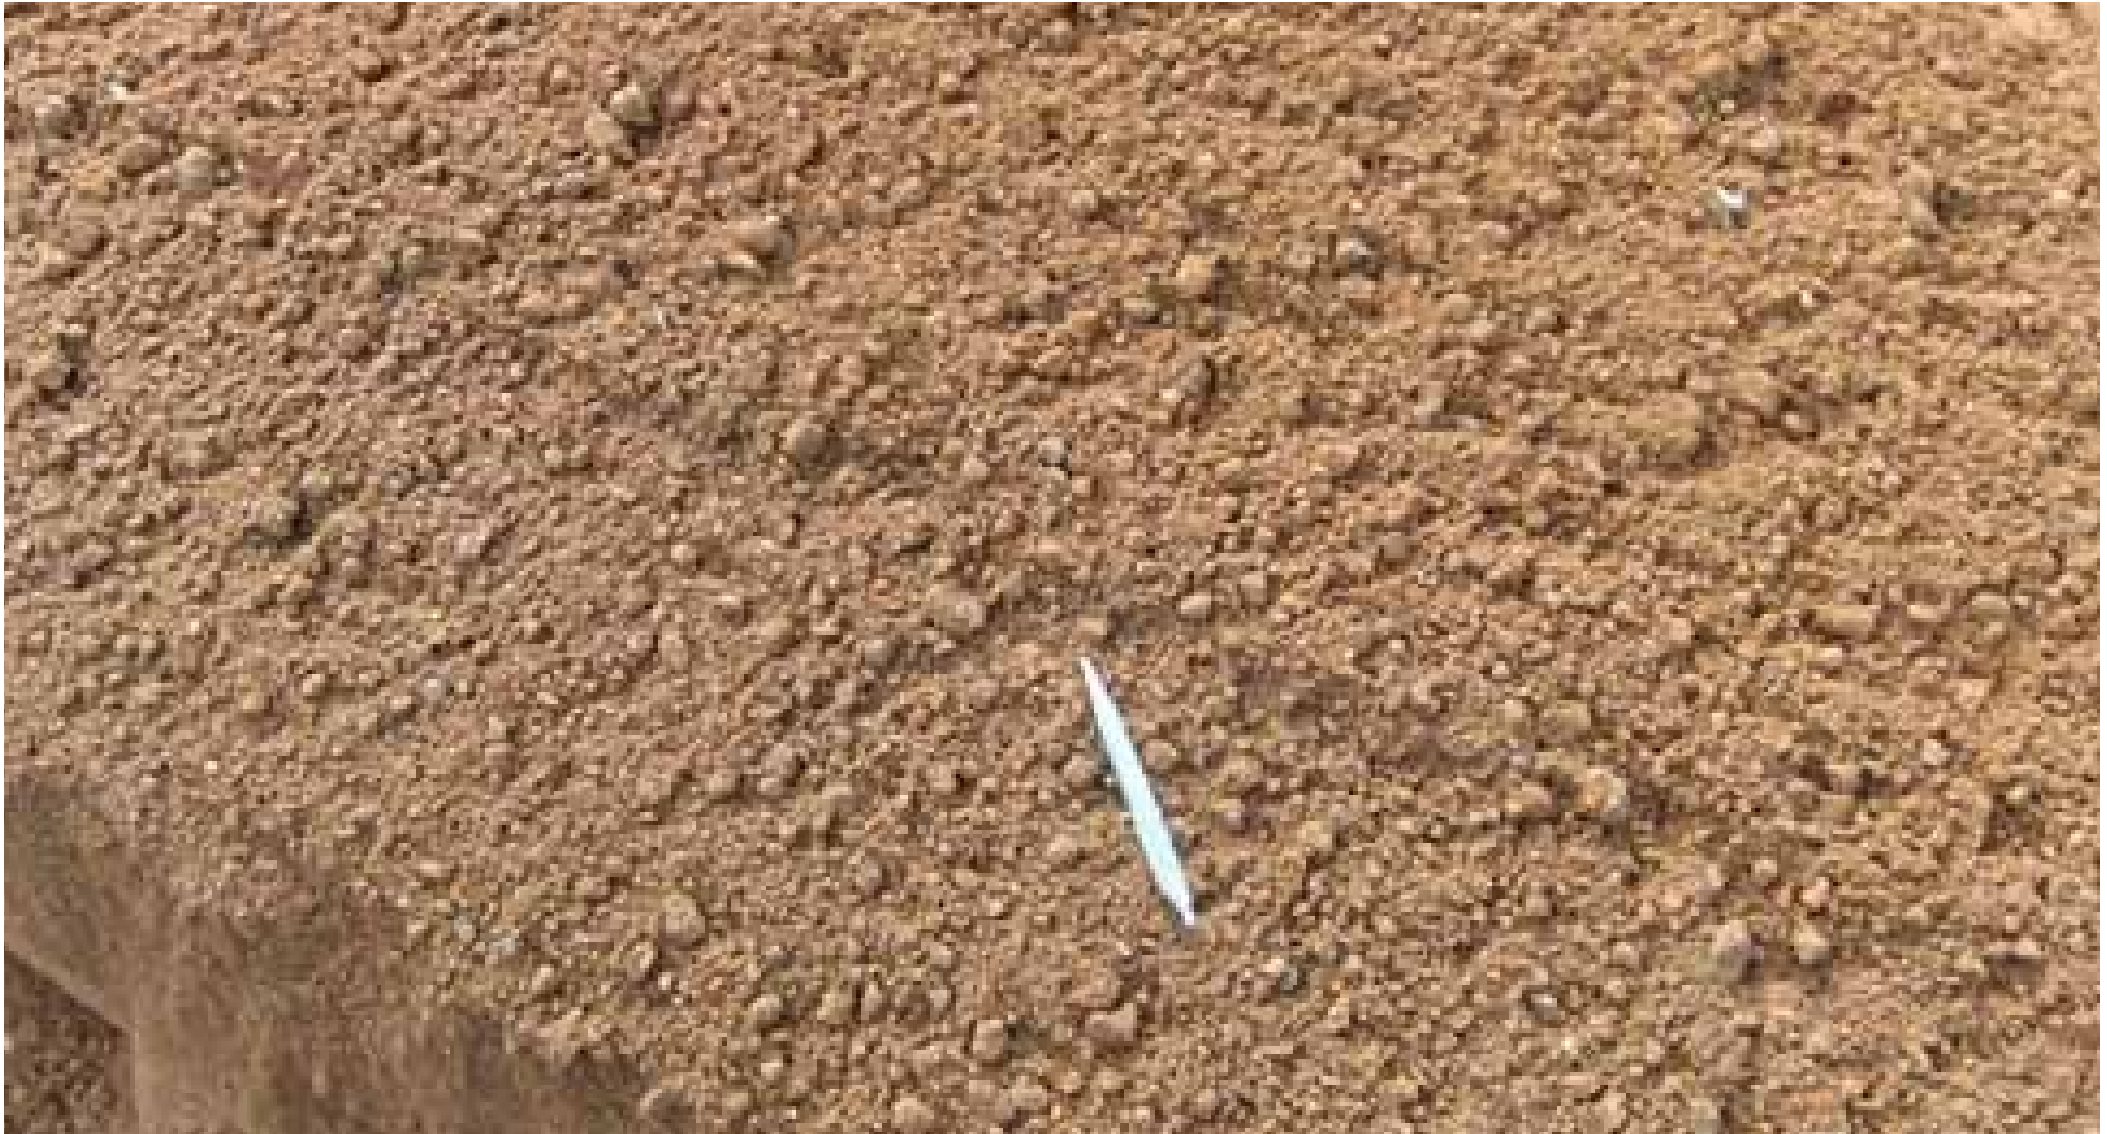
*Homogeneous mixture after second milling procedure*

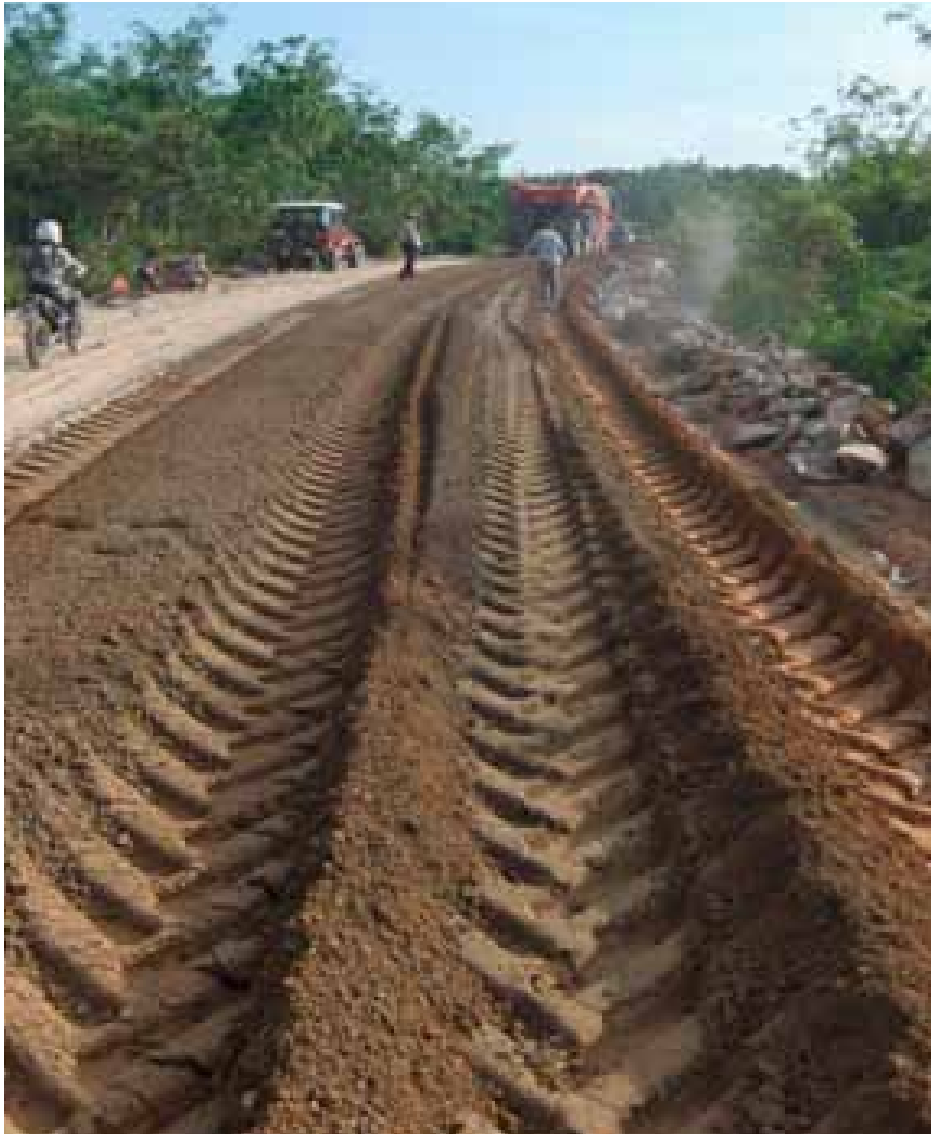
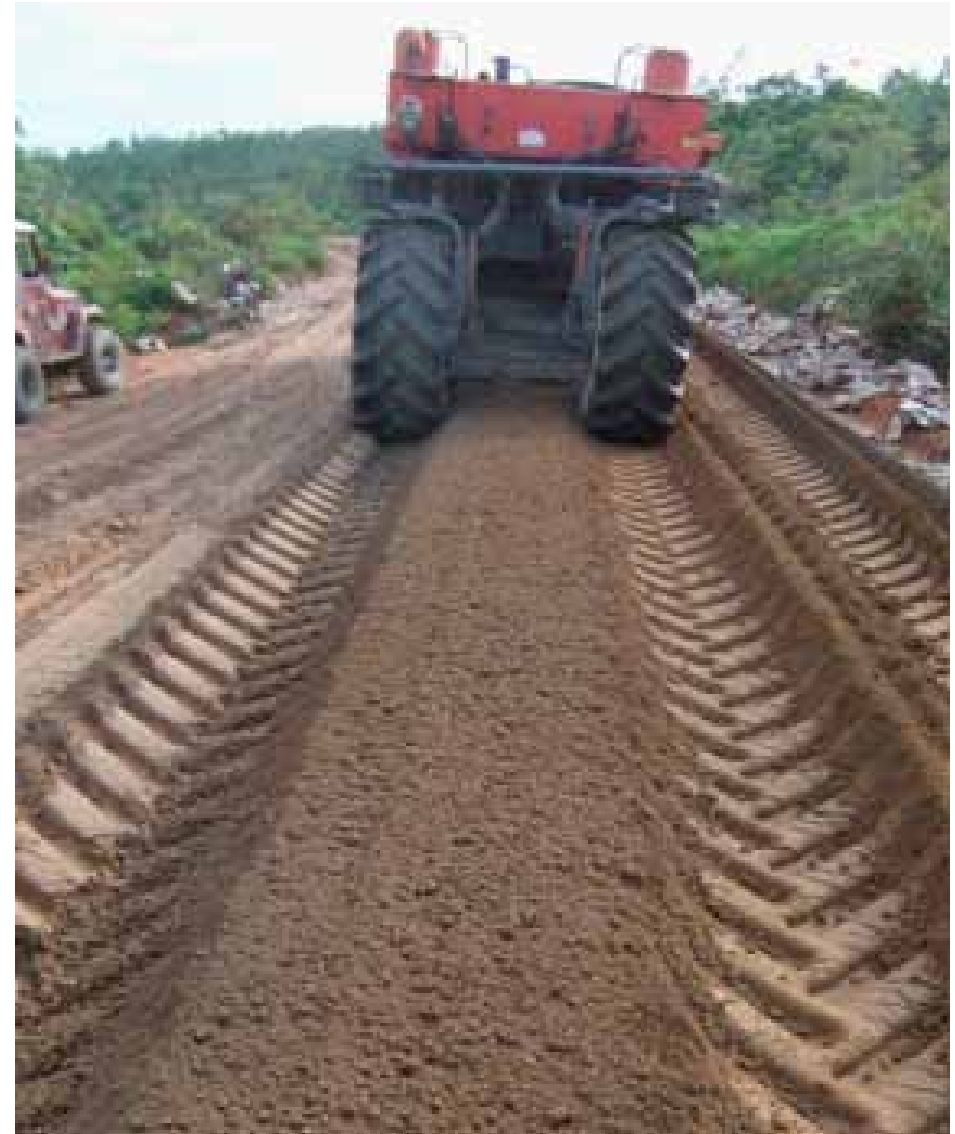
*Homogeneous mixture after second milling procedure*

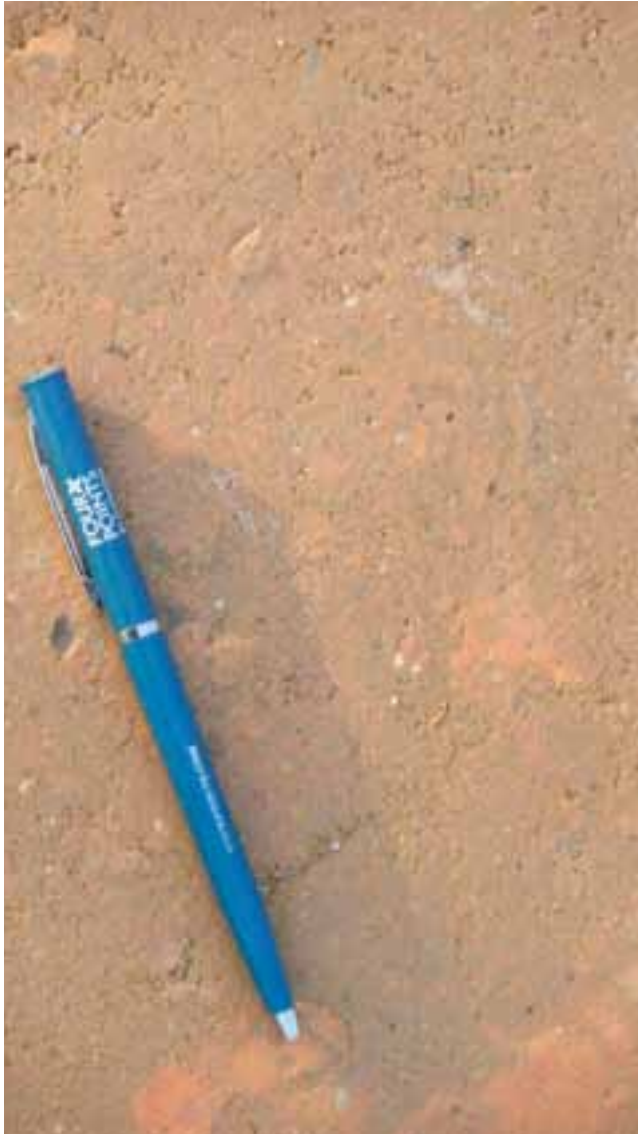
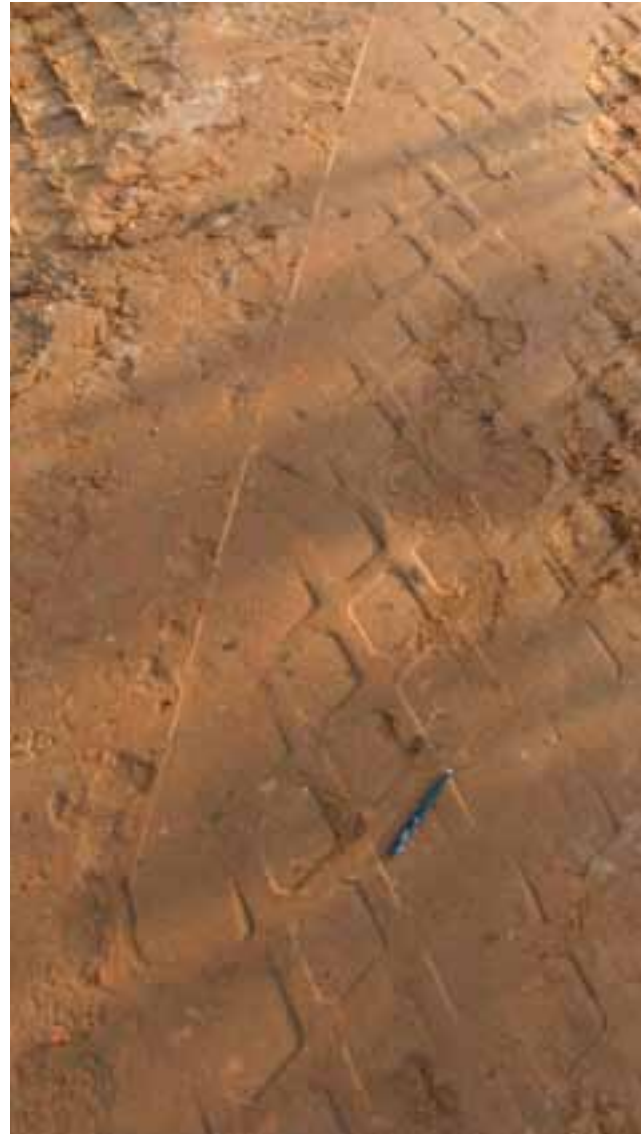
Close-up of the surface after compaction
