## Photo report

# Creation of a hydraulically bound base layer, rehabilitation of an unpaved road in the region of Gunung Mas/Kalimantan by using the NovoCrete® technology

- Location: Gunung Mas/Indonesia
- Period of execution: November 2012
- Time needed: not yet finished
- Cement: 190 kg/m<sup>3</sup> cement + 2 % NovoCrete
- Milling depth: 35 cm

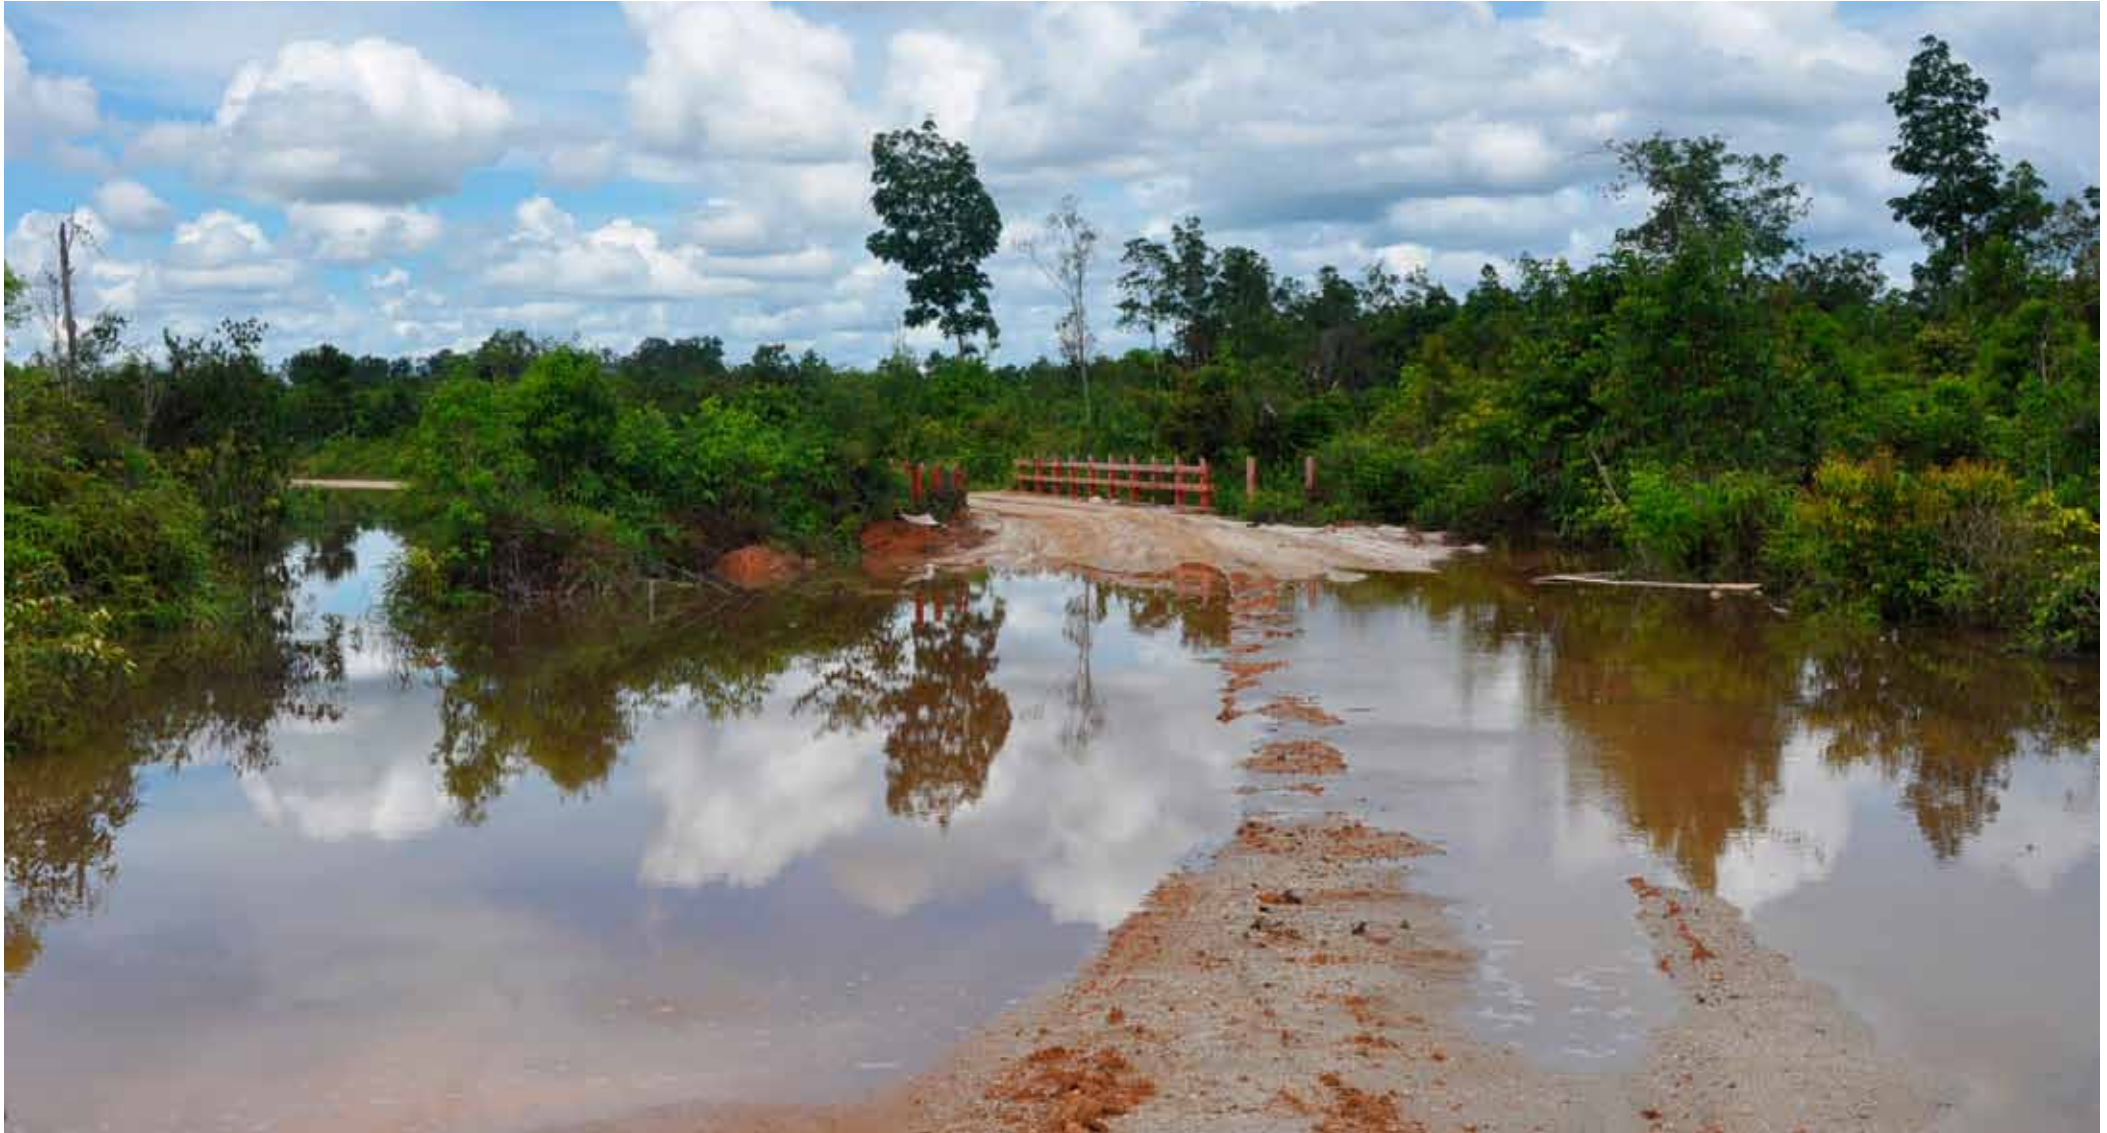
*Situation after heavy rainfall*

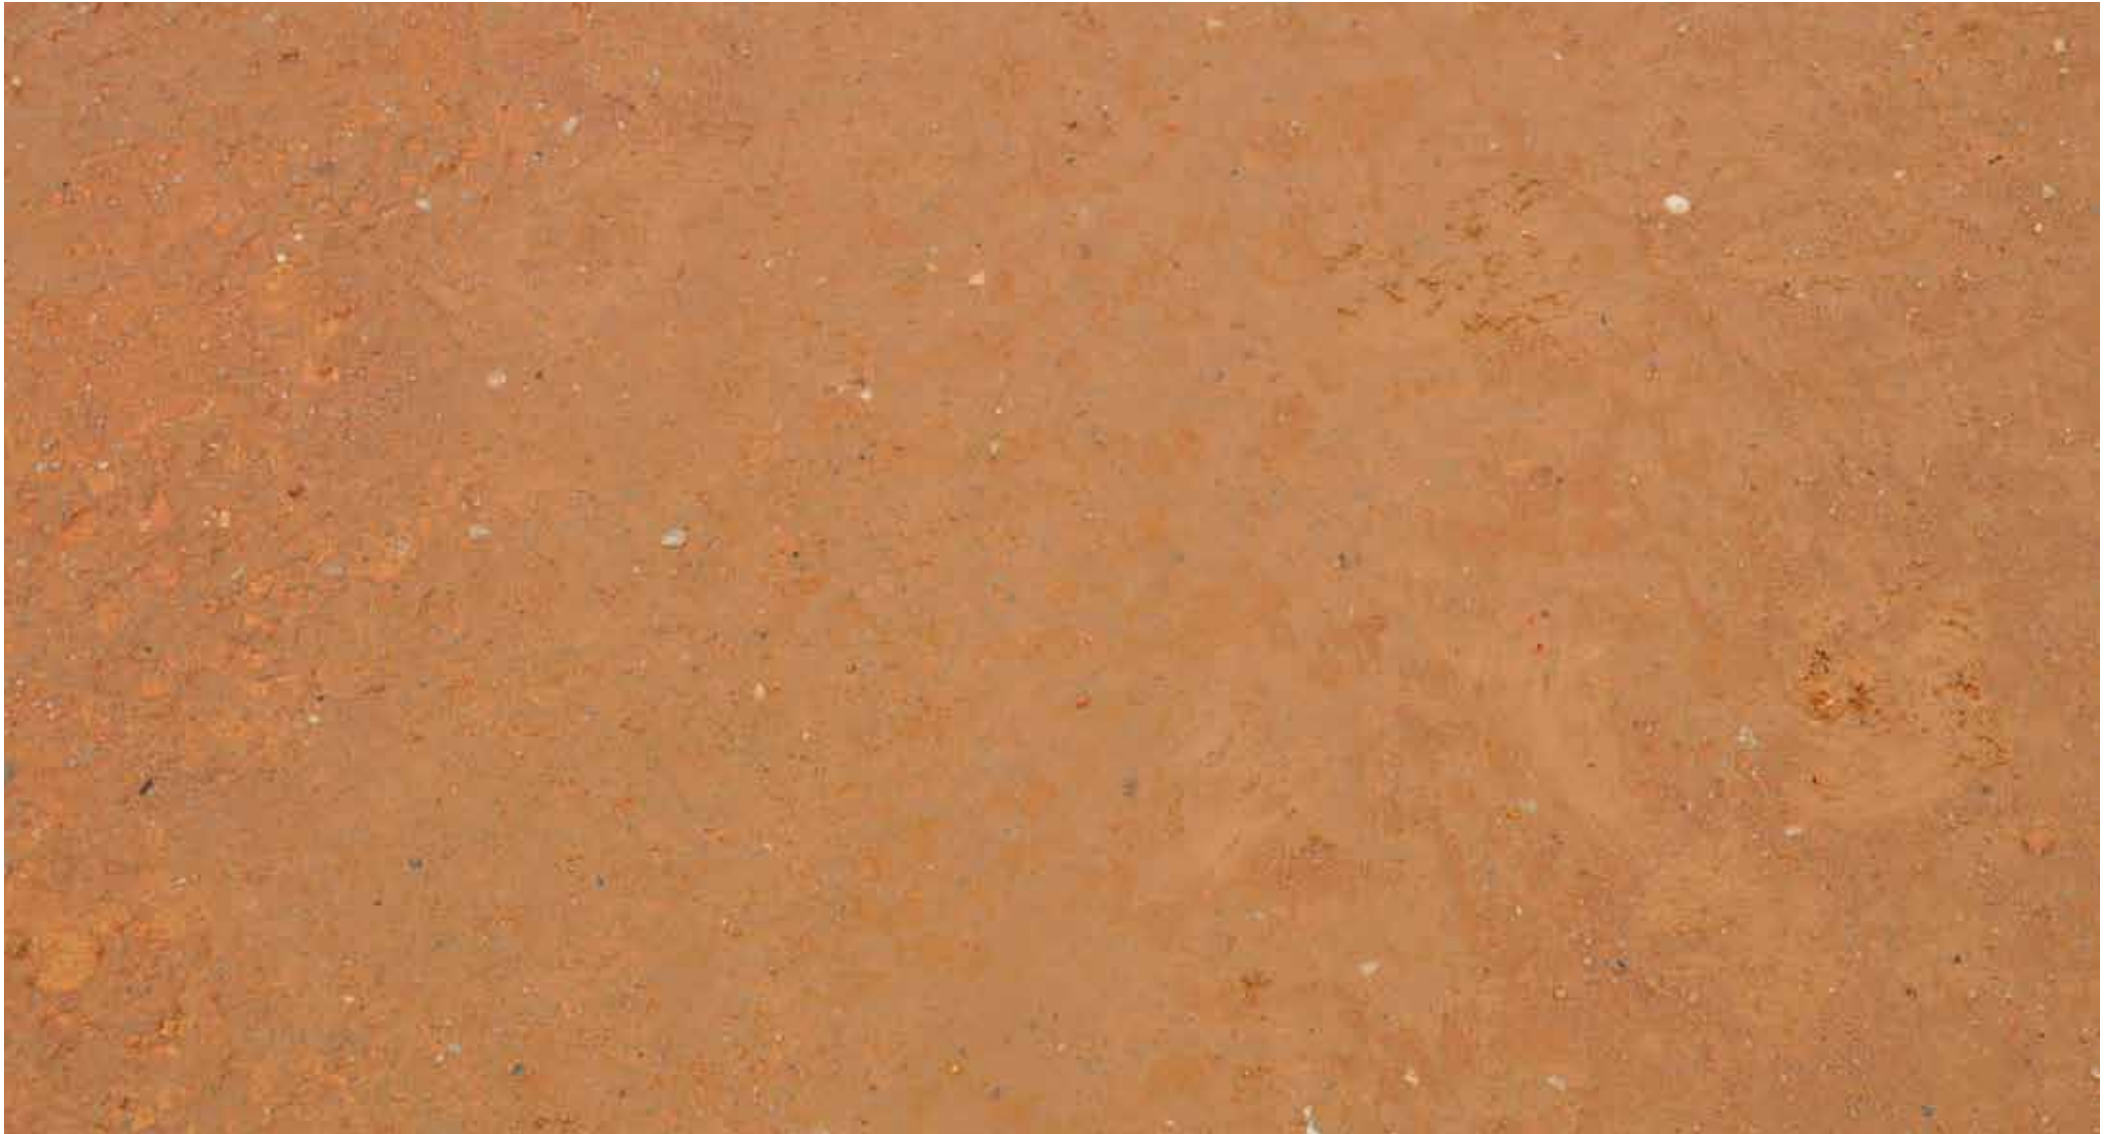
Close-up of surface after being flooded for several days

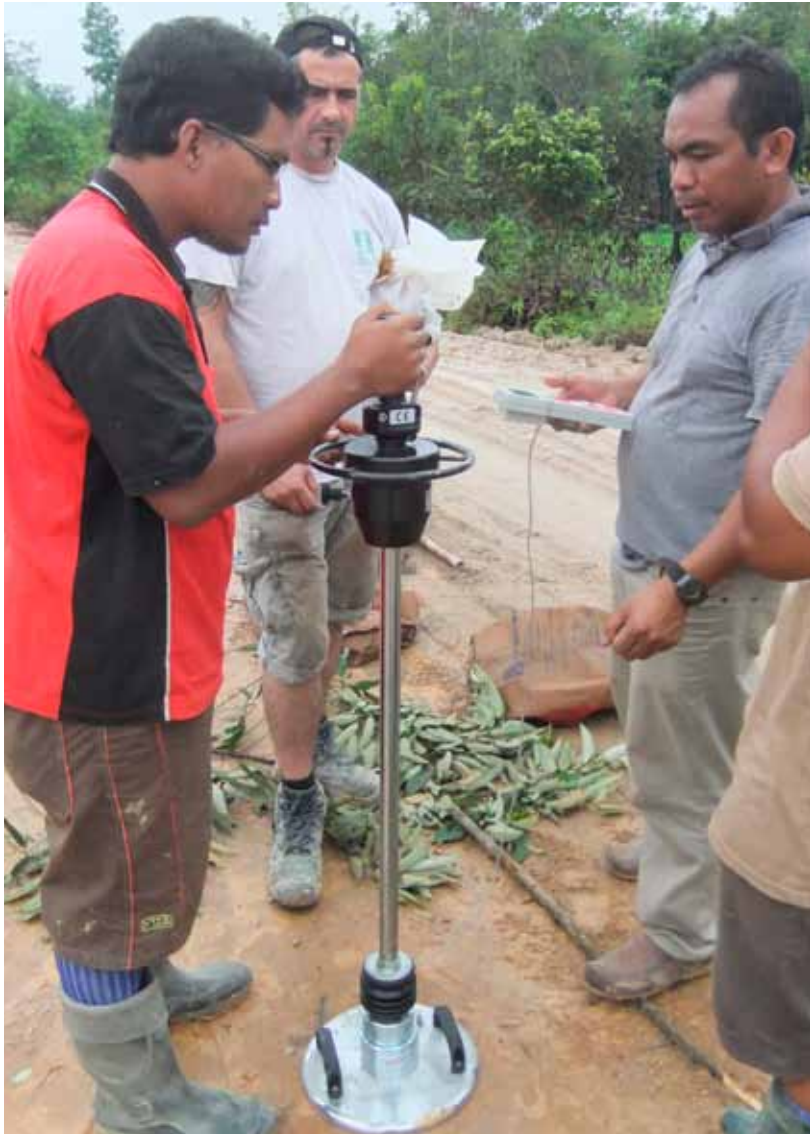
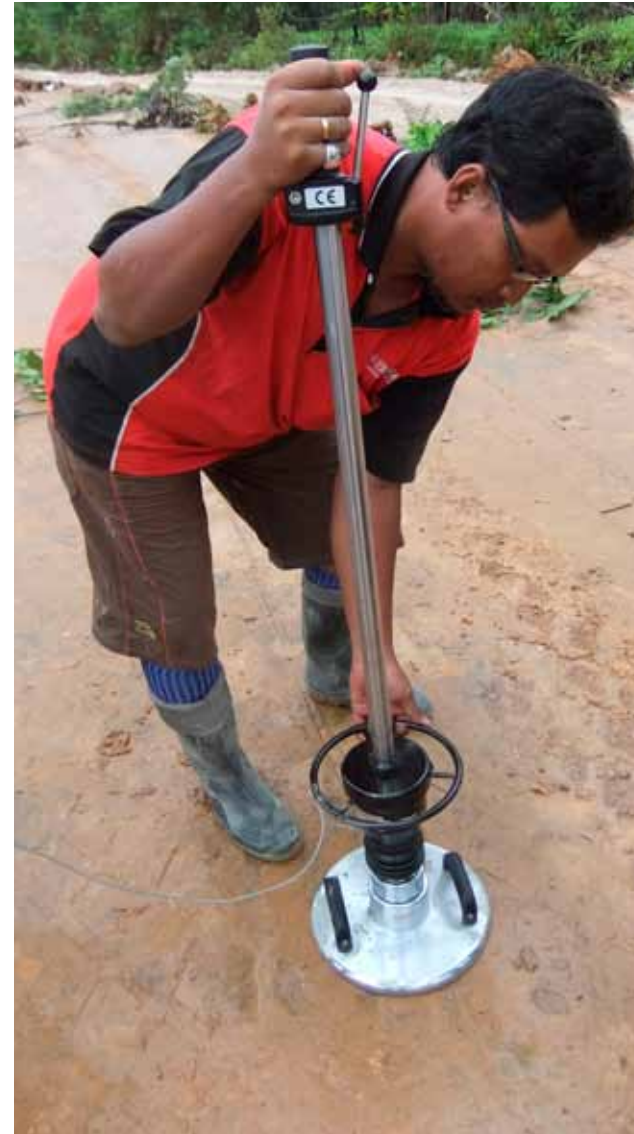
Analyse of the load bearing capacity by using a dynamic falling weight drop tester

No. Titik	Jenis yang diuji / test	Metode Pengujian	Hasil uji / test	Spesifikasi	Ket.
1	2	3	4	5	6
1	CBR Lapangan umur 35 hari	SNI 03-1738-1989	120.75 %	120 – 200 %	Oke
2	CBR Lapangan umur 11 hari	SNI 03-1738-1989	115.72 %	120 – 200 %	-
3	CBR Lapangan umur 31 hari	SNI 03-1738-1989	116.22 %	120 – 200 %	-
4	CBR Lapangan umur 30 hari	SNI 03-1738-1989	121.75 %	120 – 200 %	Oke
5	CBR Lapangan umur 30 hari	SNI 03-1738-1989	123.26 %	120 – 200 %	Oke

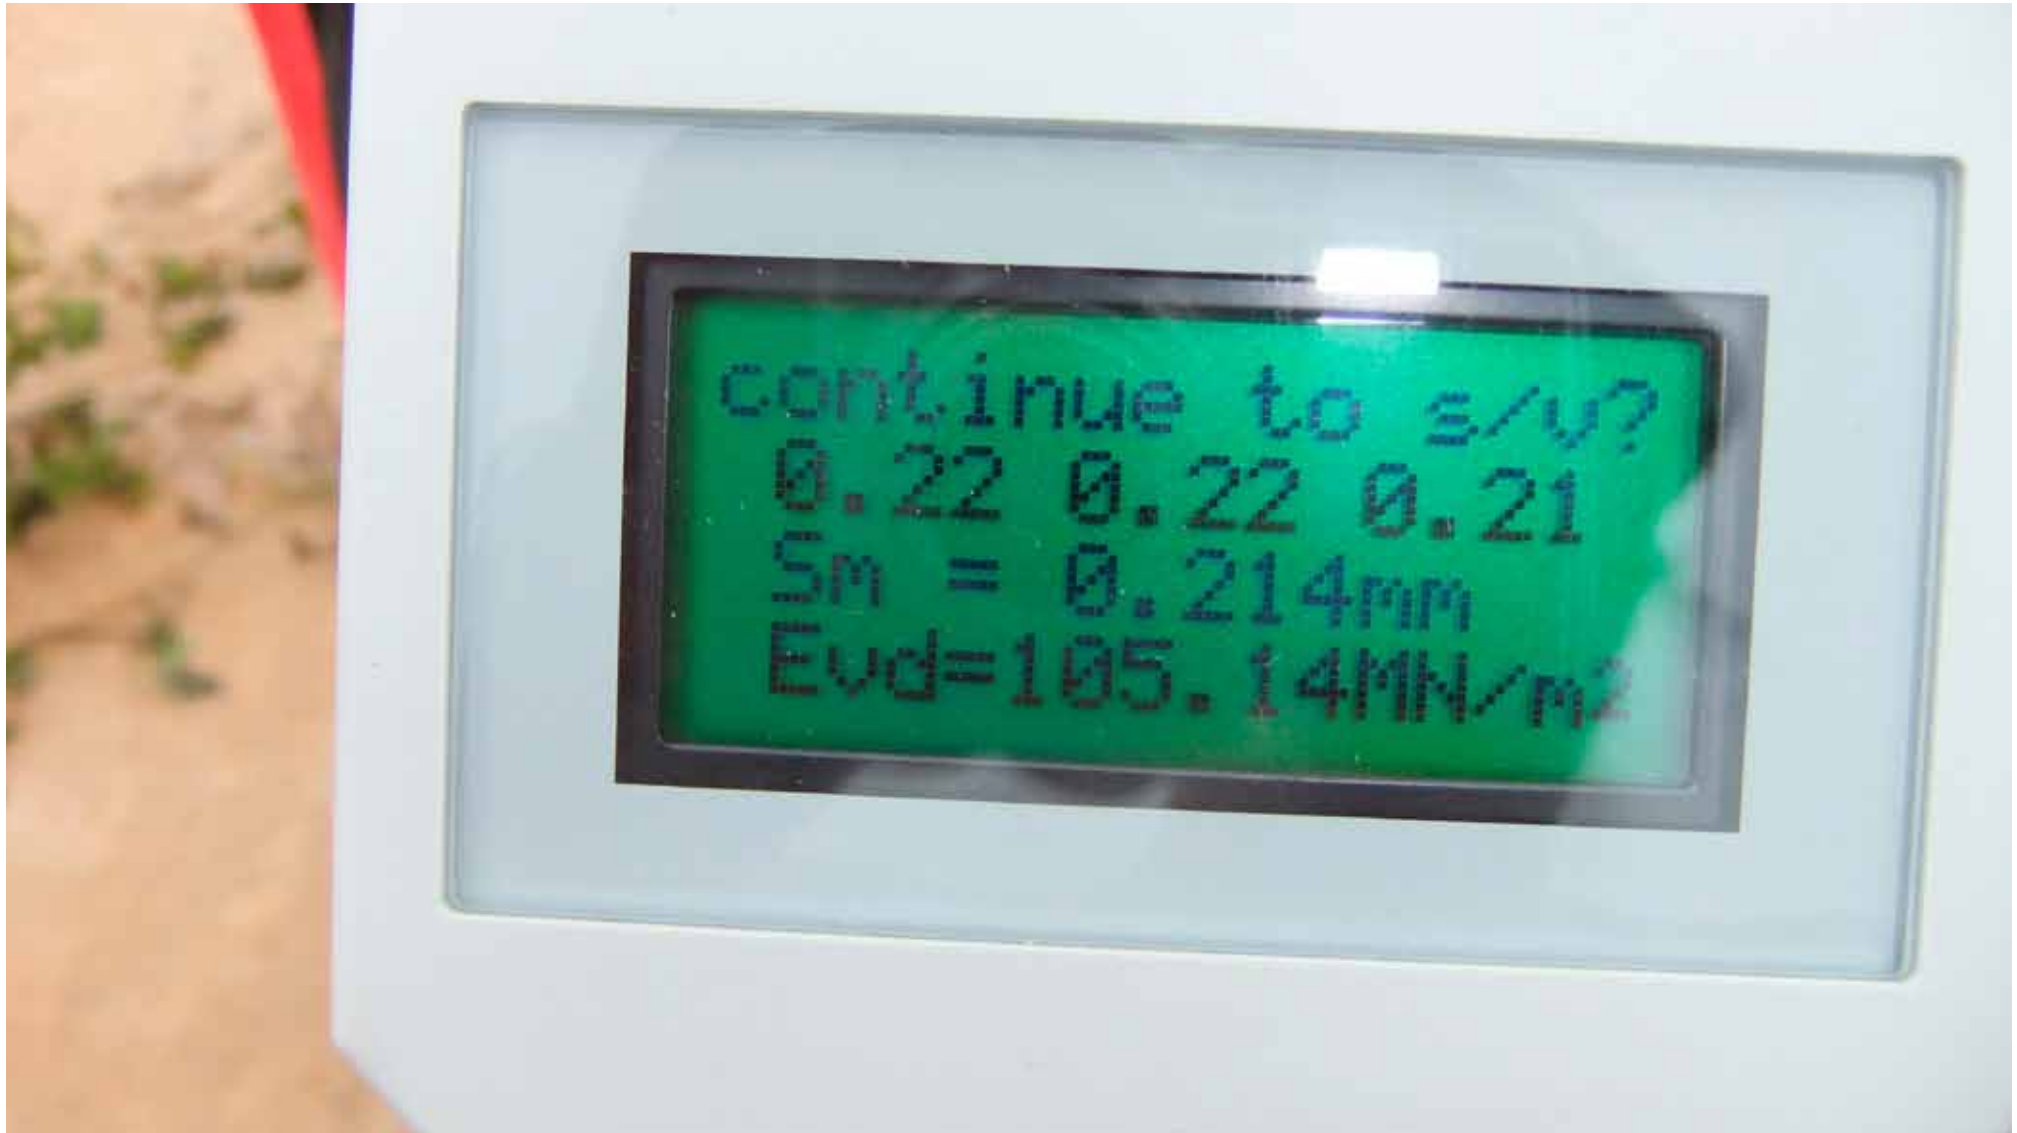
Analyse of the load bearing capacity by using a dynamic falling weight drop tester

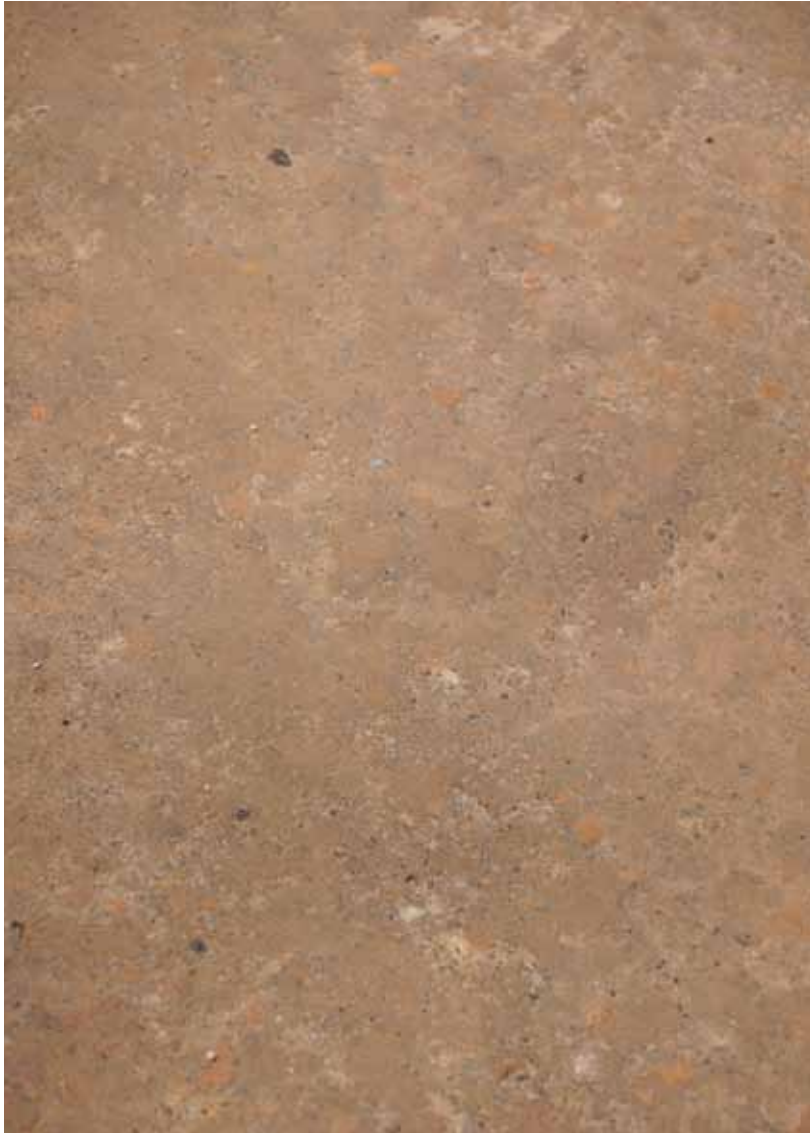
Close-up of finished surface

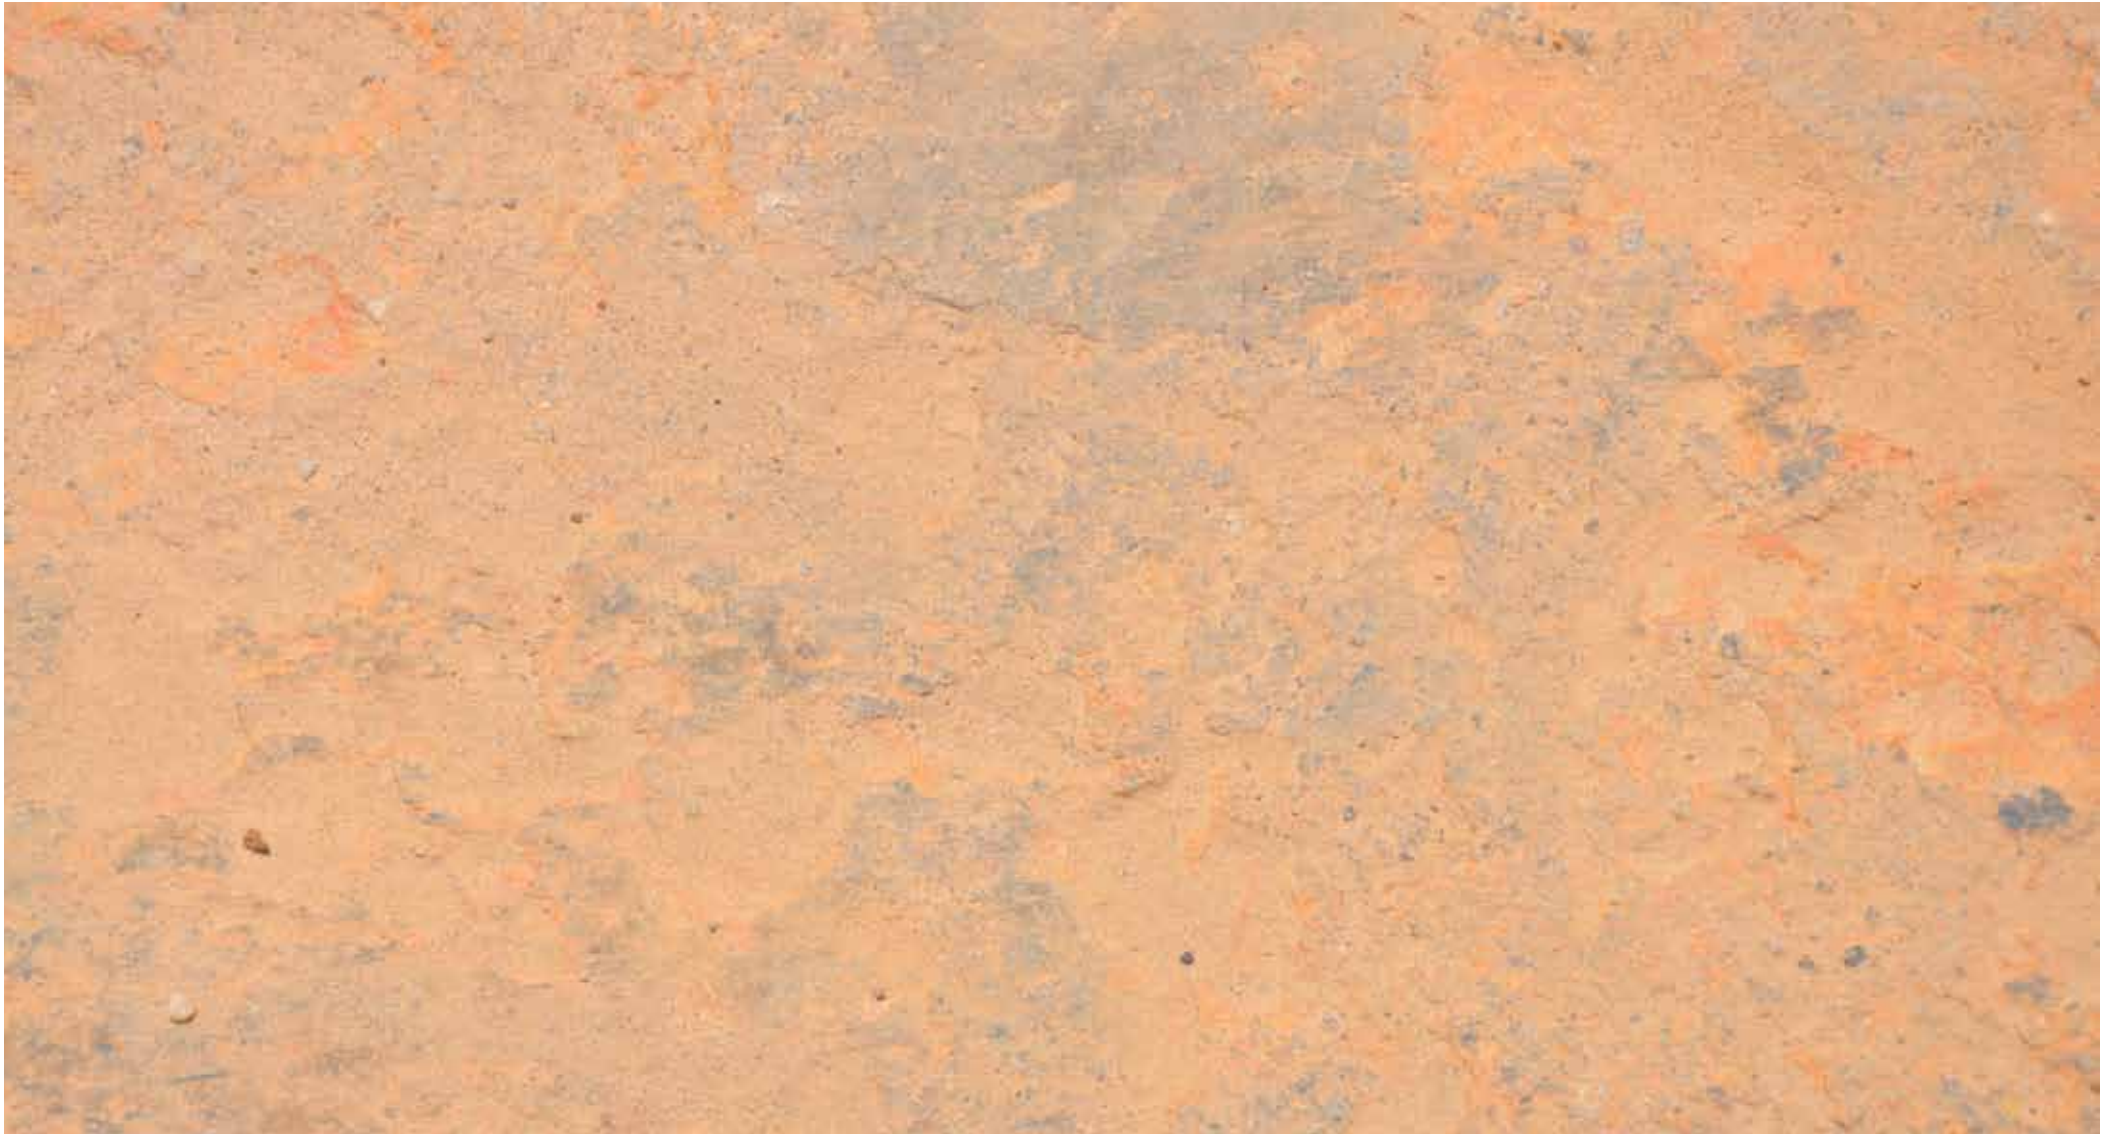
Close-up of finished surface
