Photo report

Partly-rehabilitation of a container trans-shipment center in the exterior area of the harbour in Karlsruhe by using the NovoCrete® technology

- Location: Karlsruhe/Germany
- Period of execution: February 2014
- Time needed: 2 days
- Cement: 160 kg/m³ with 2 % NovoCrete
- Milling depth: 45 cm

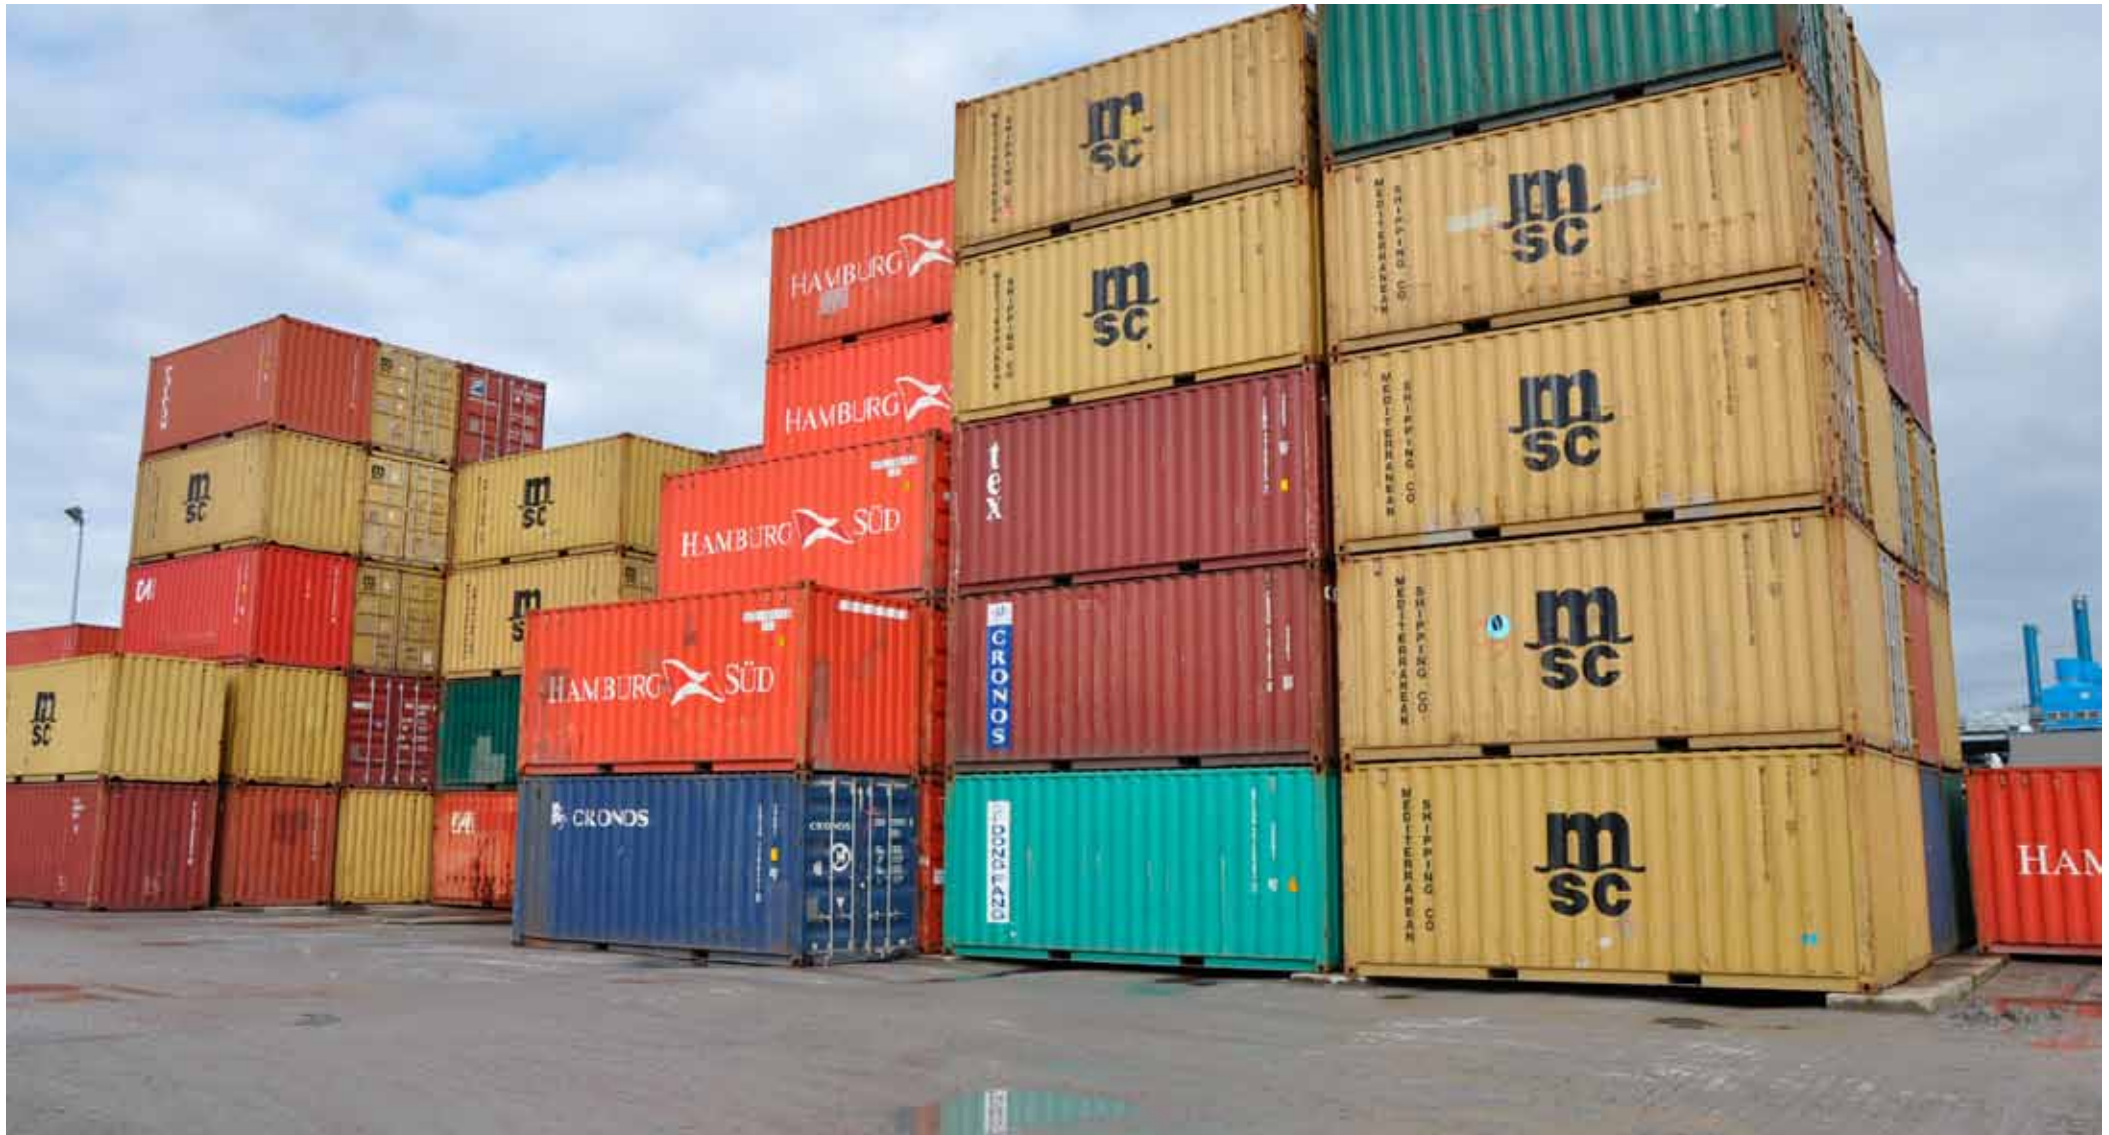
Initial situation

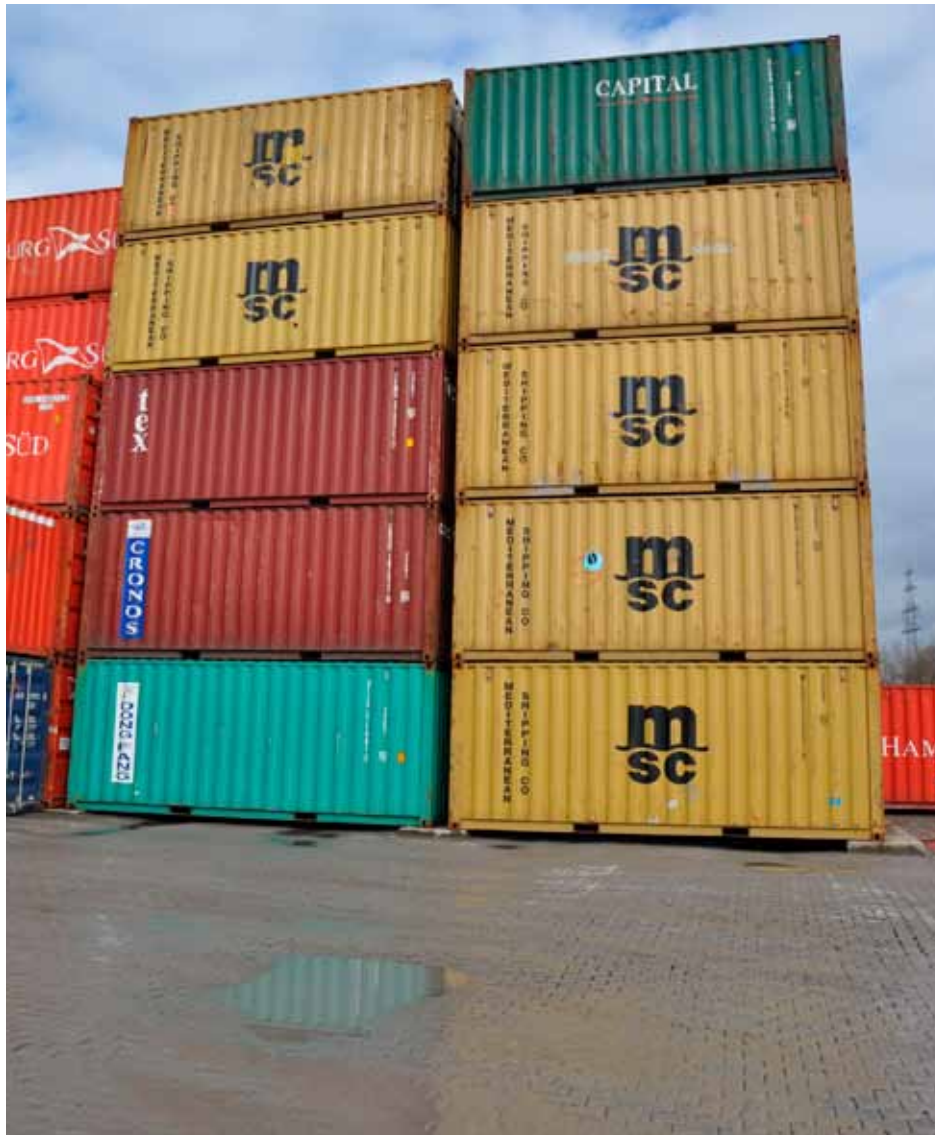
Initial situation

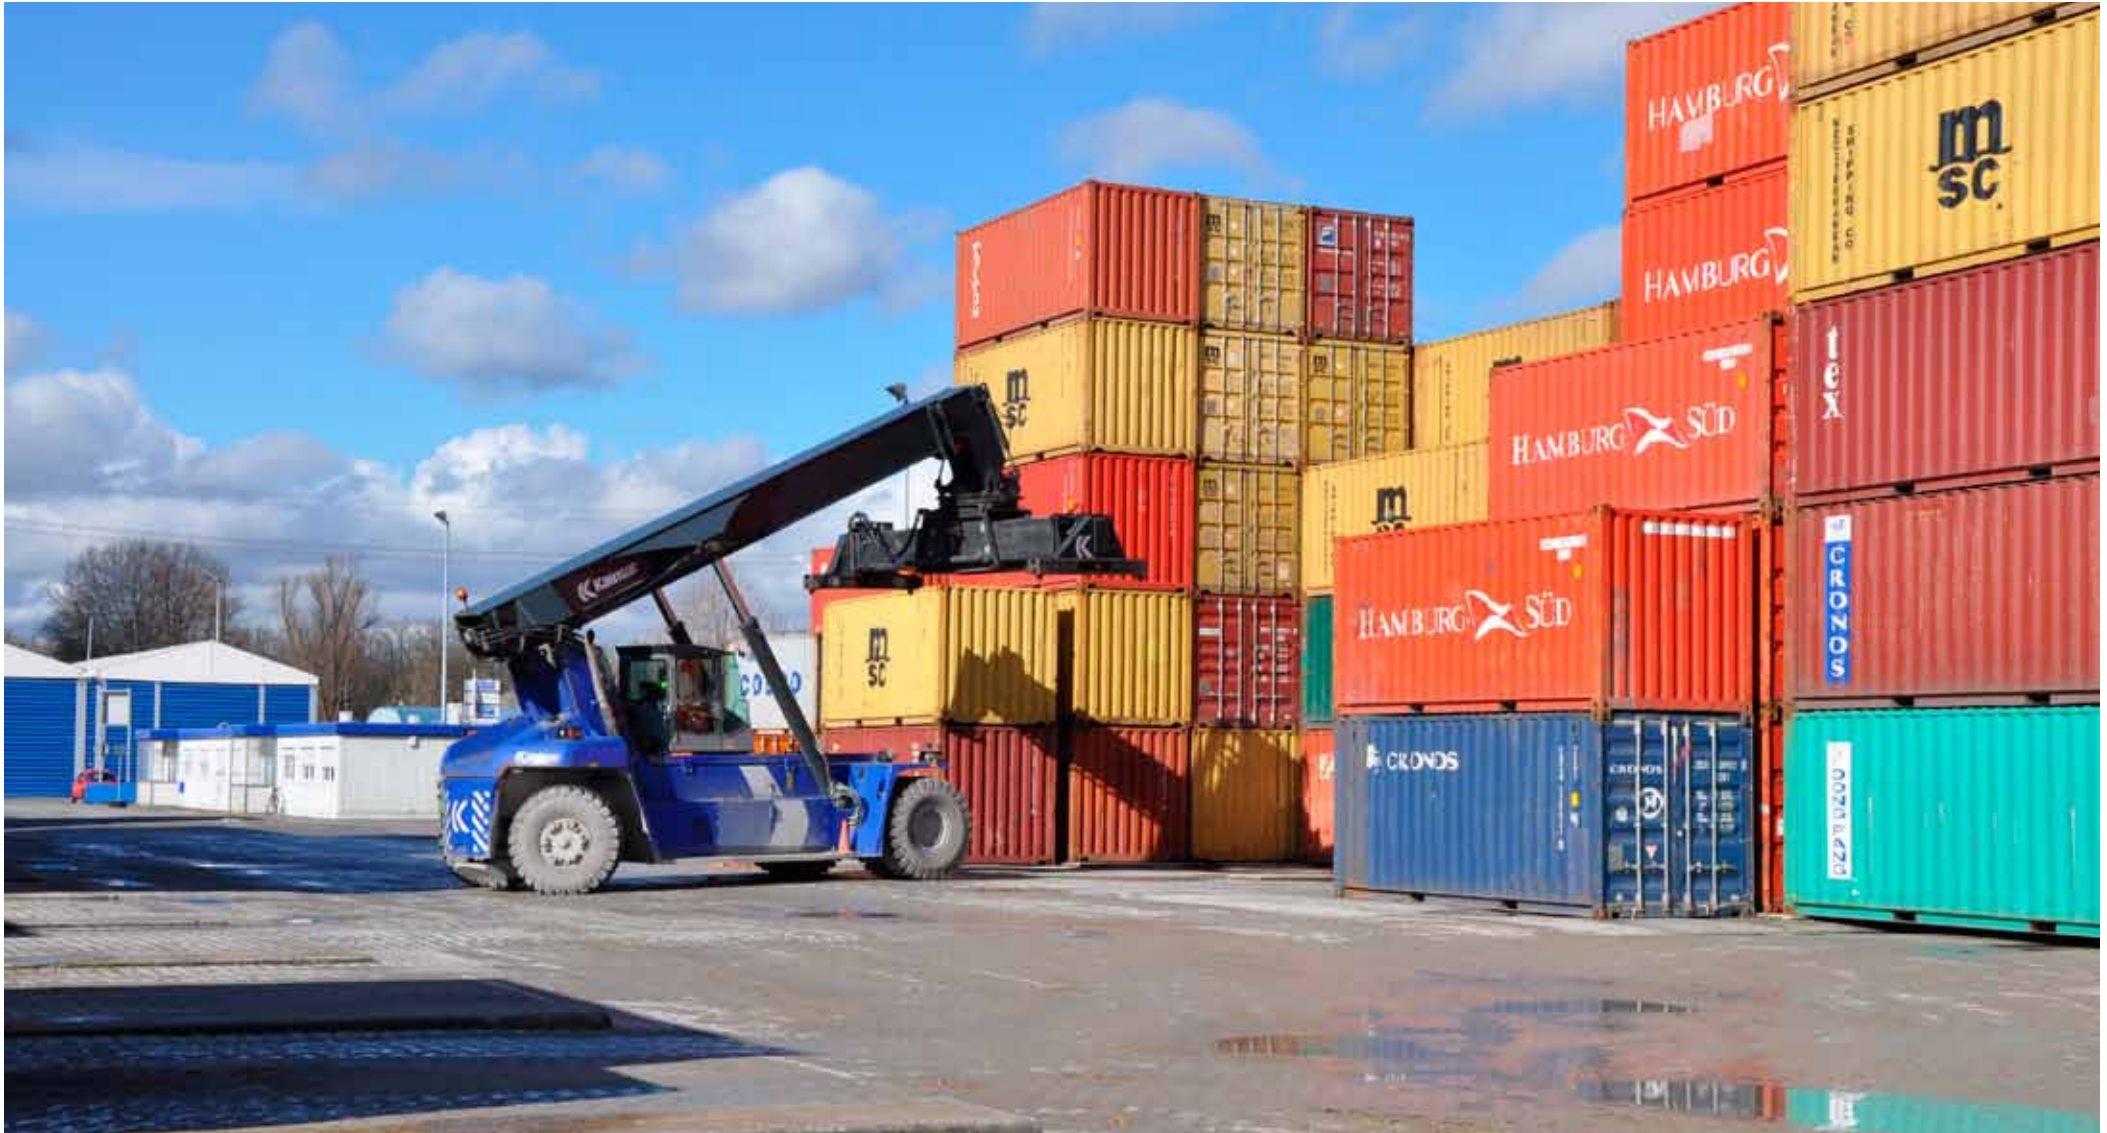
Initial situation

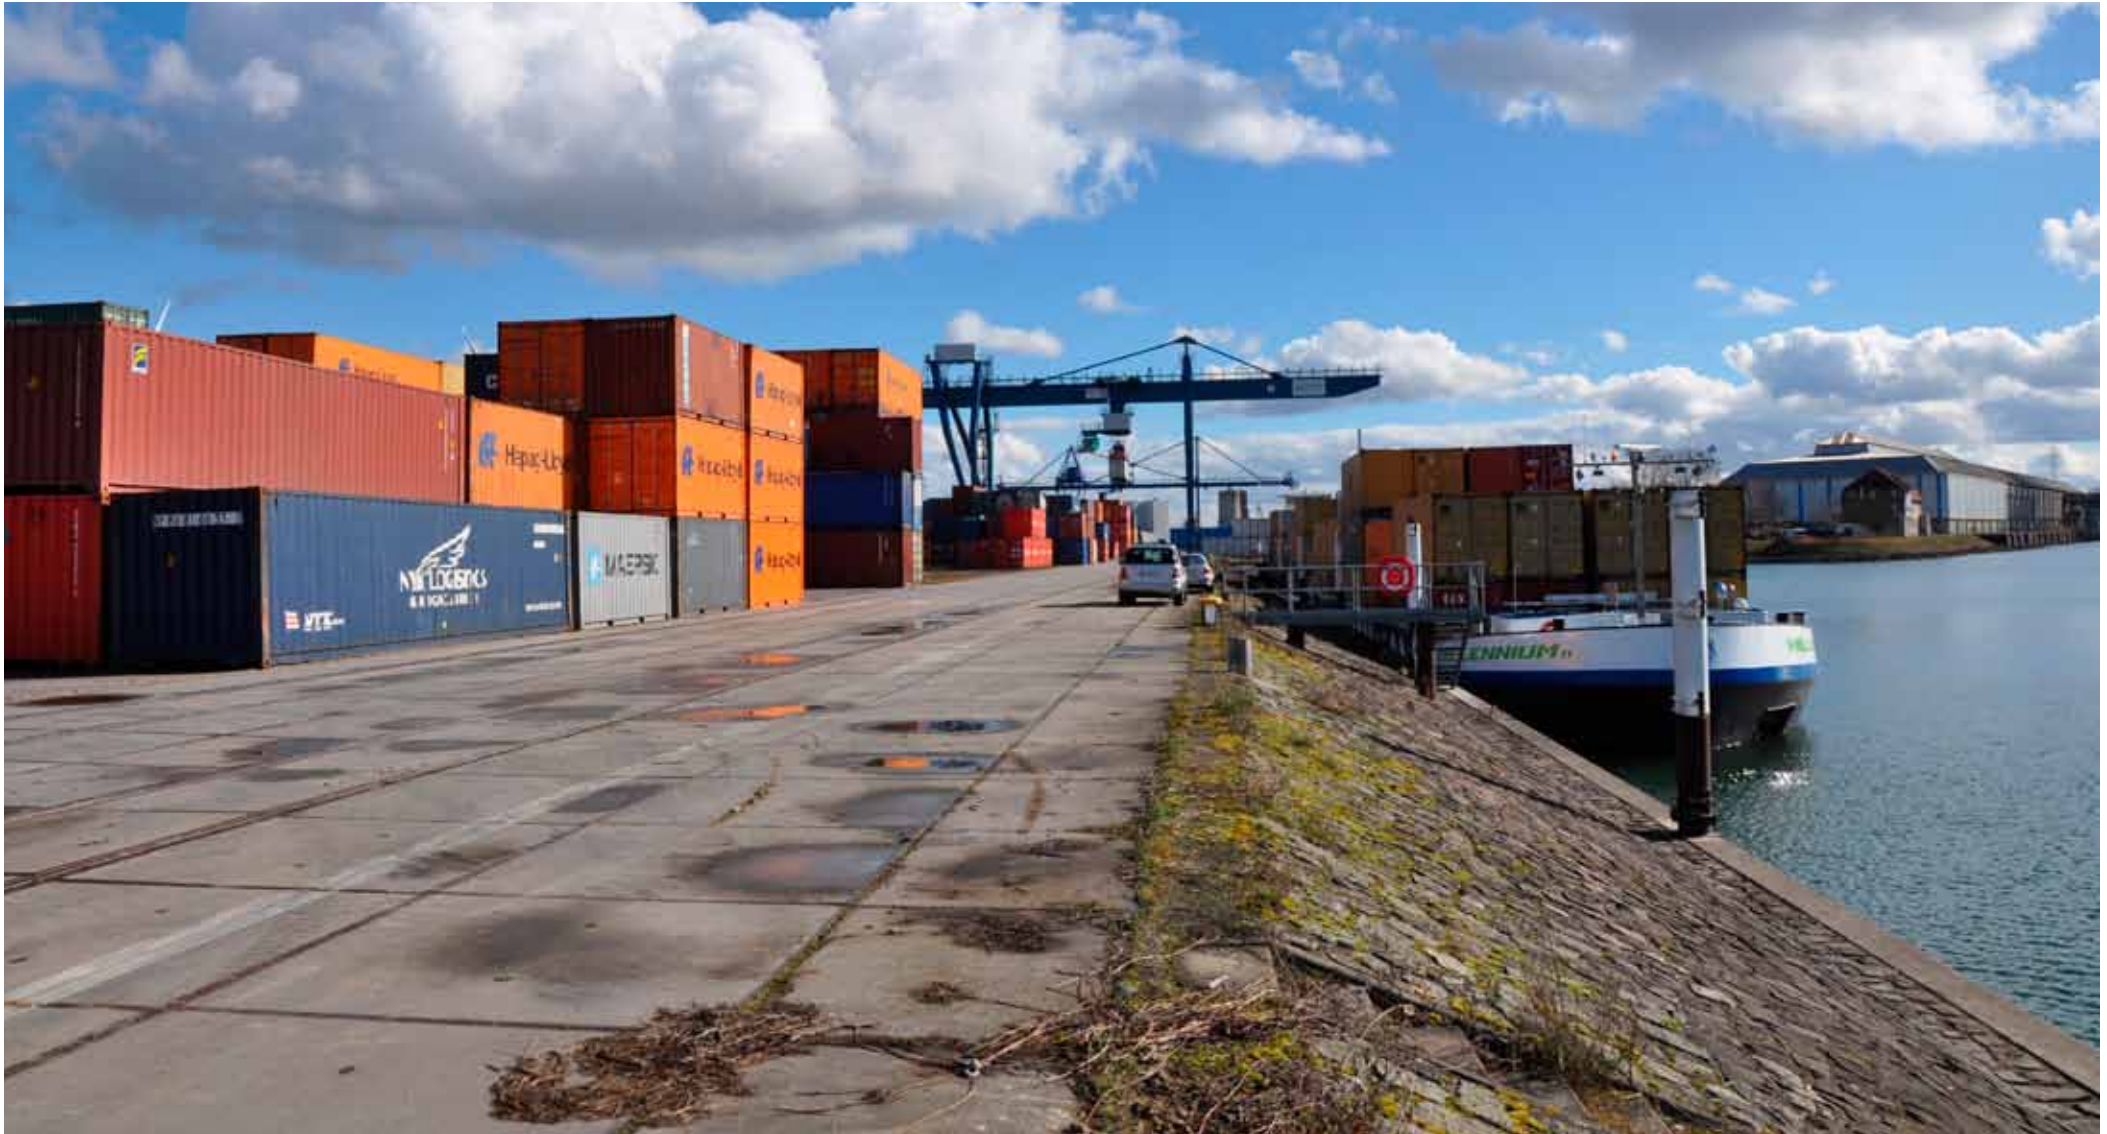
Initial situation

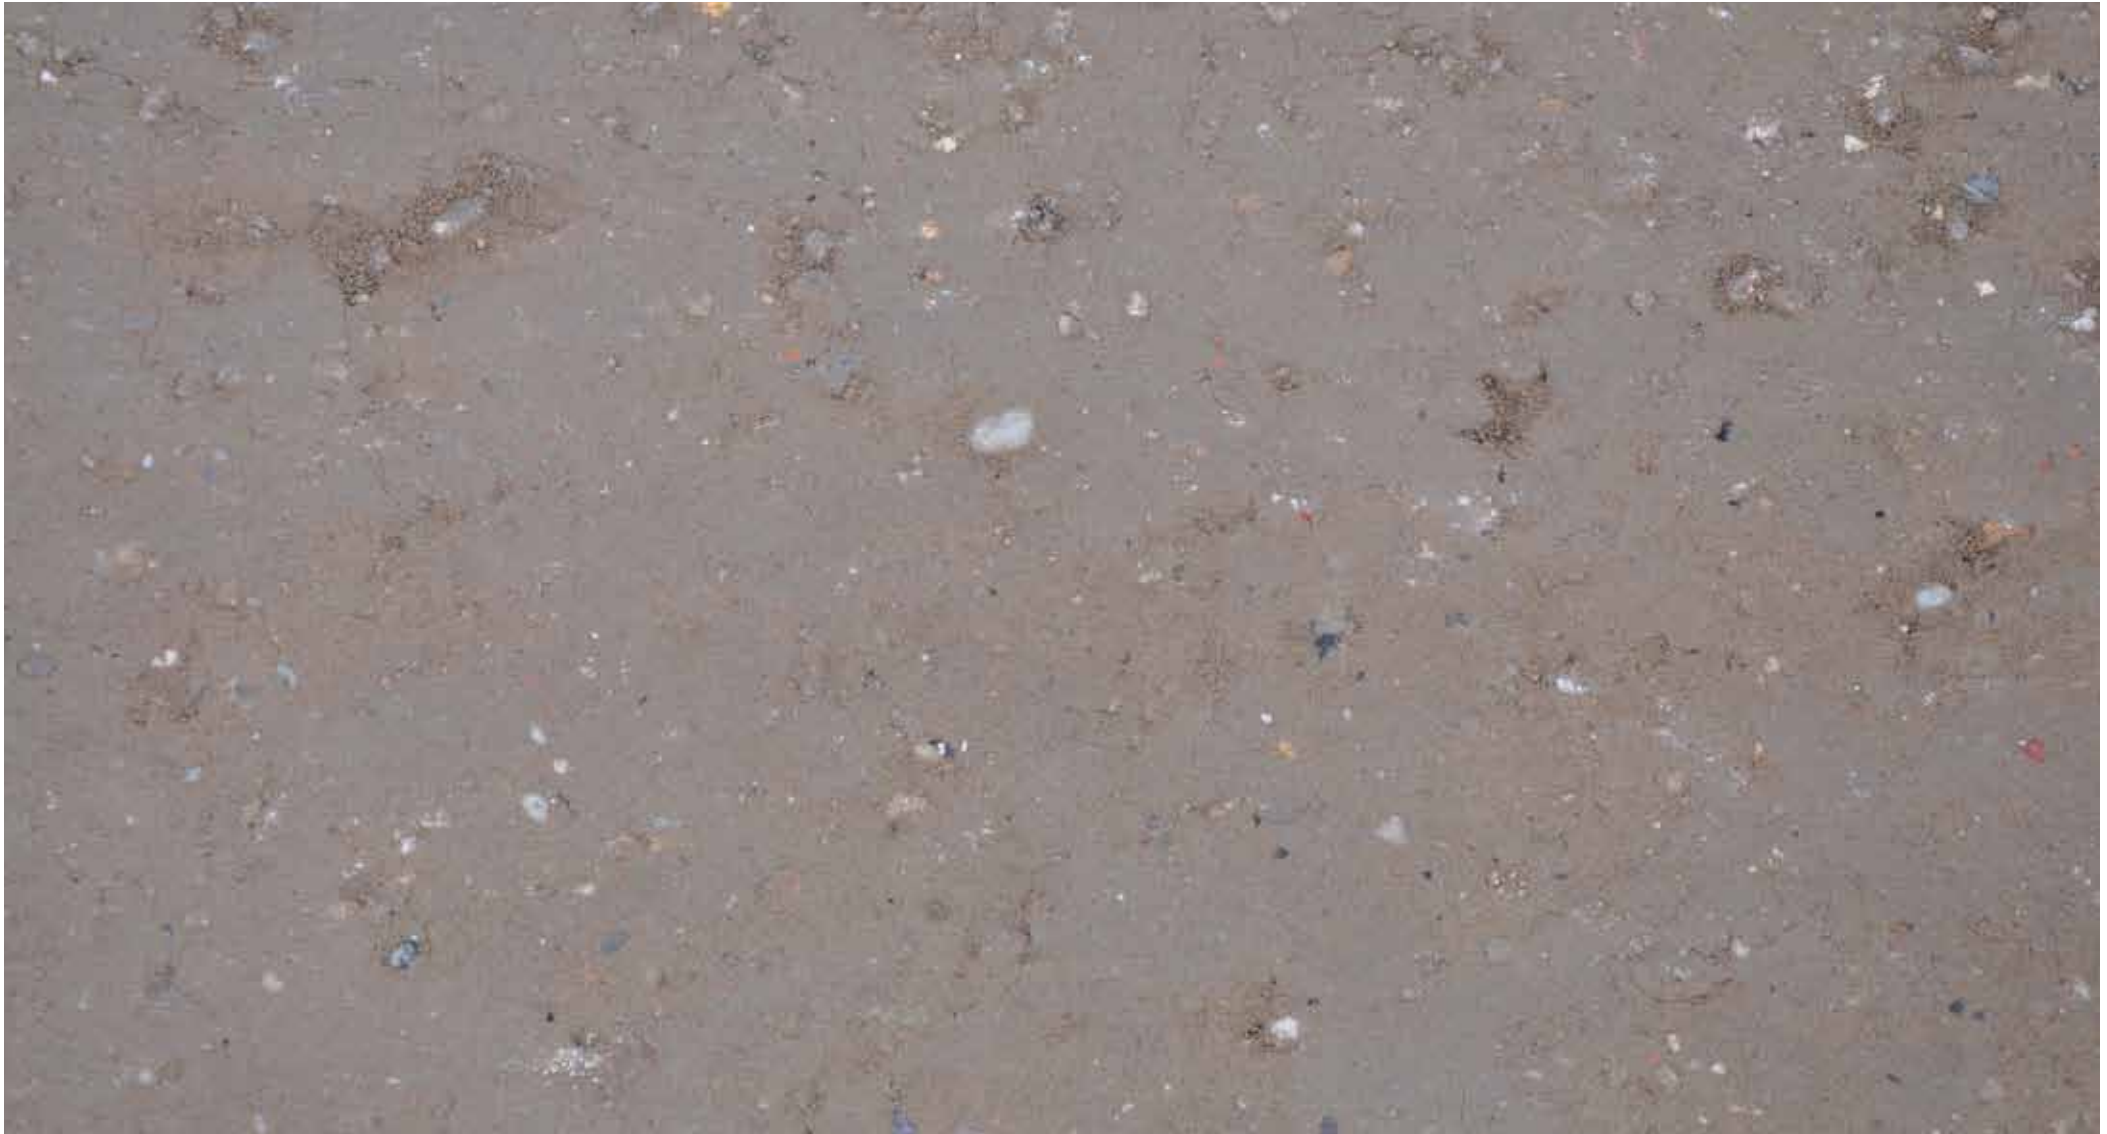
Close-up of the surface after compaction

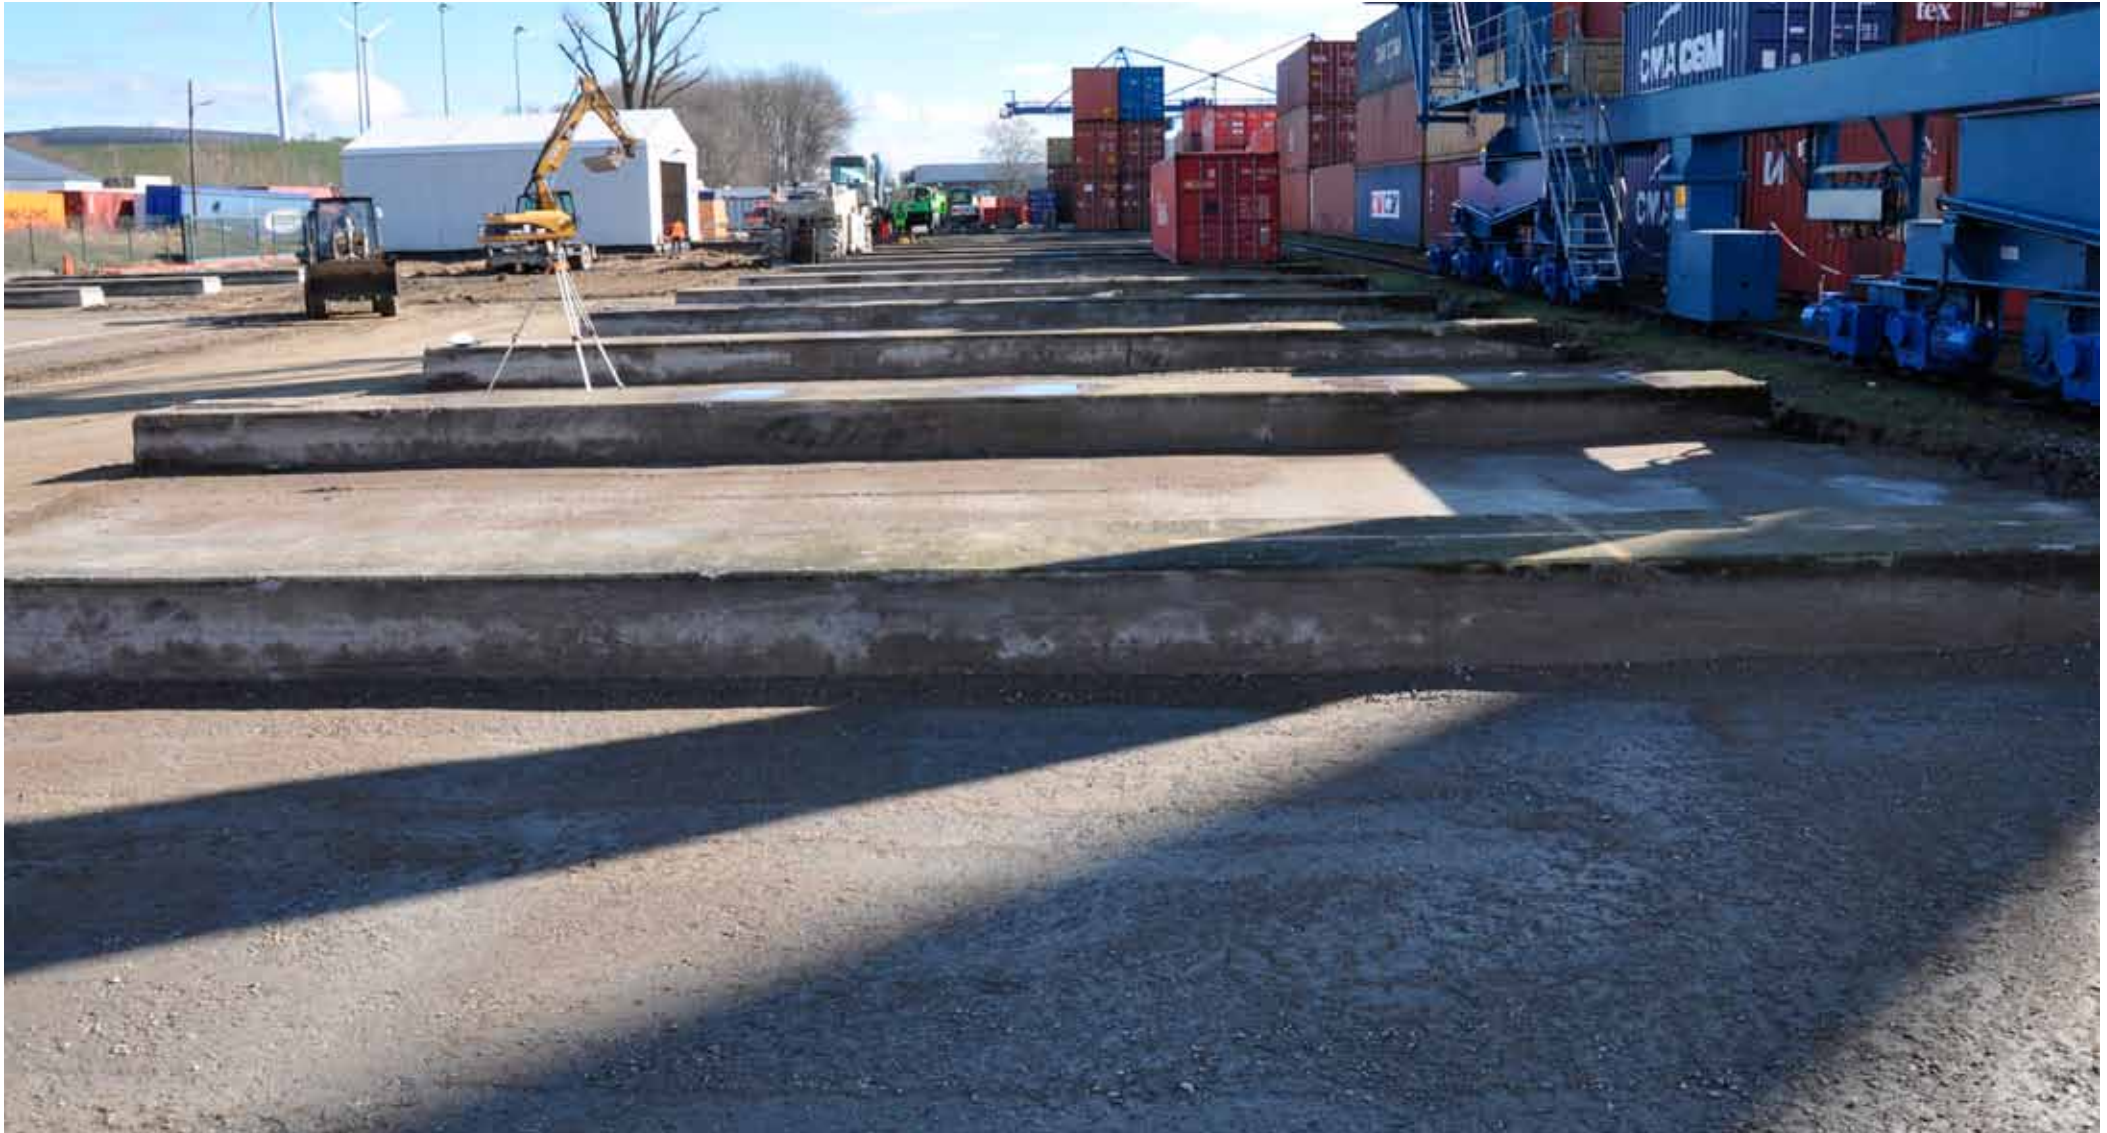
Stabilized area after one day - values in load bearing capacity $> 300 \text{ MN/m}^2$

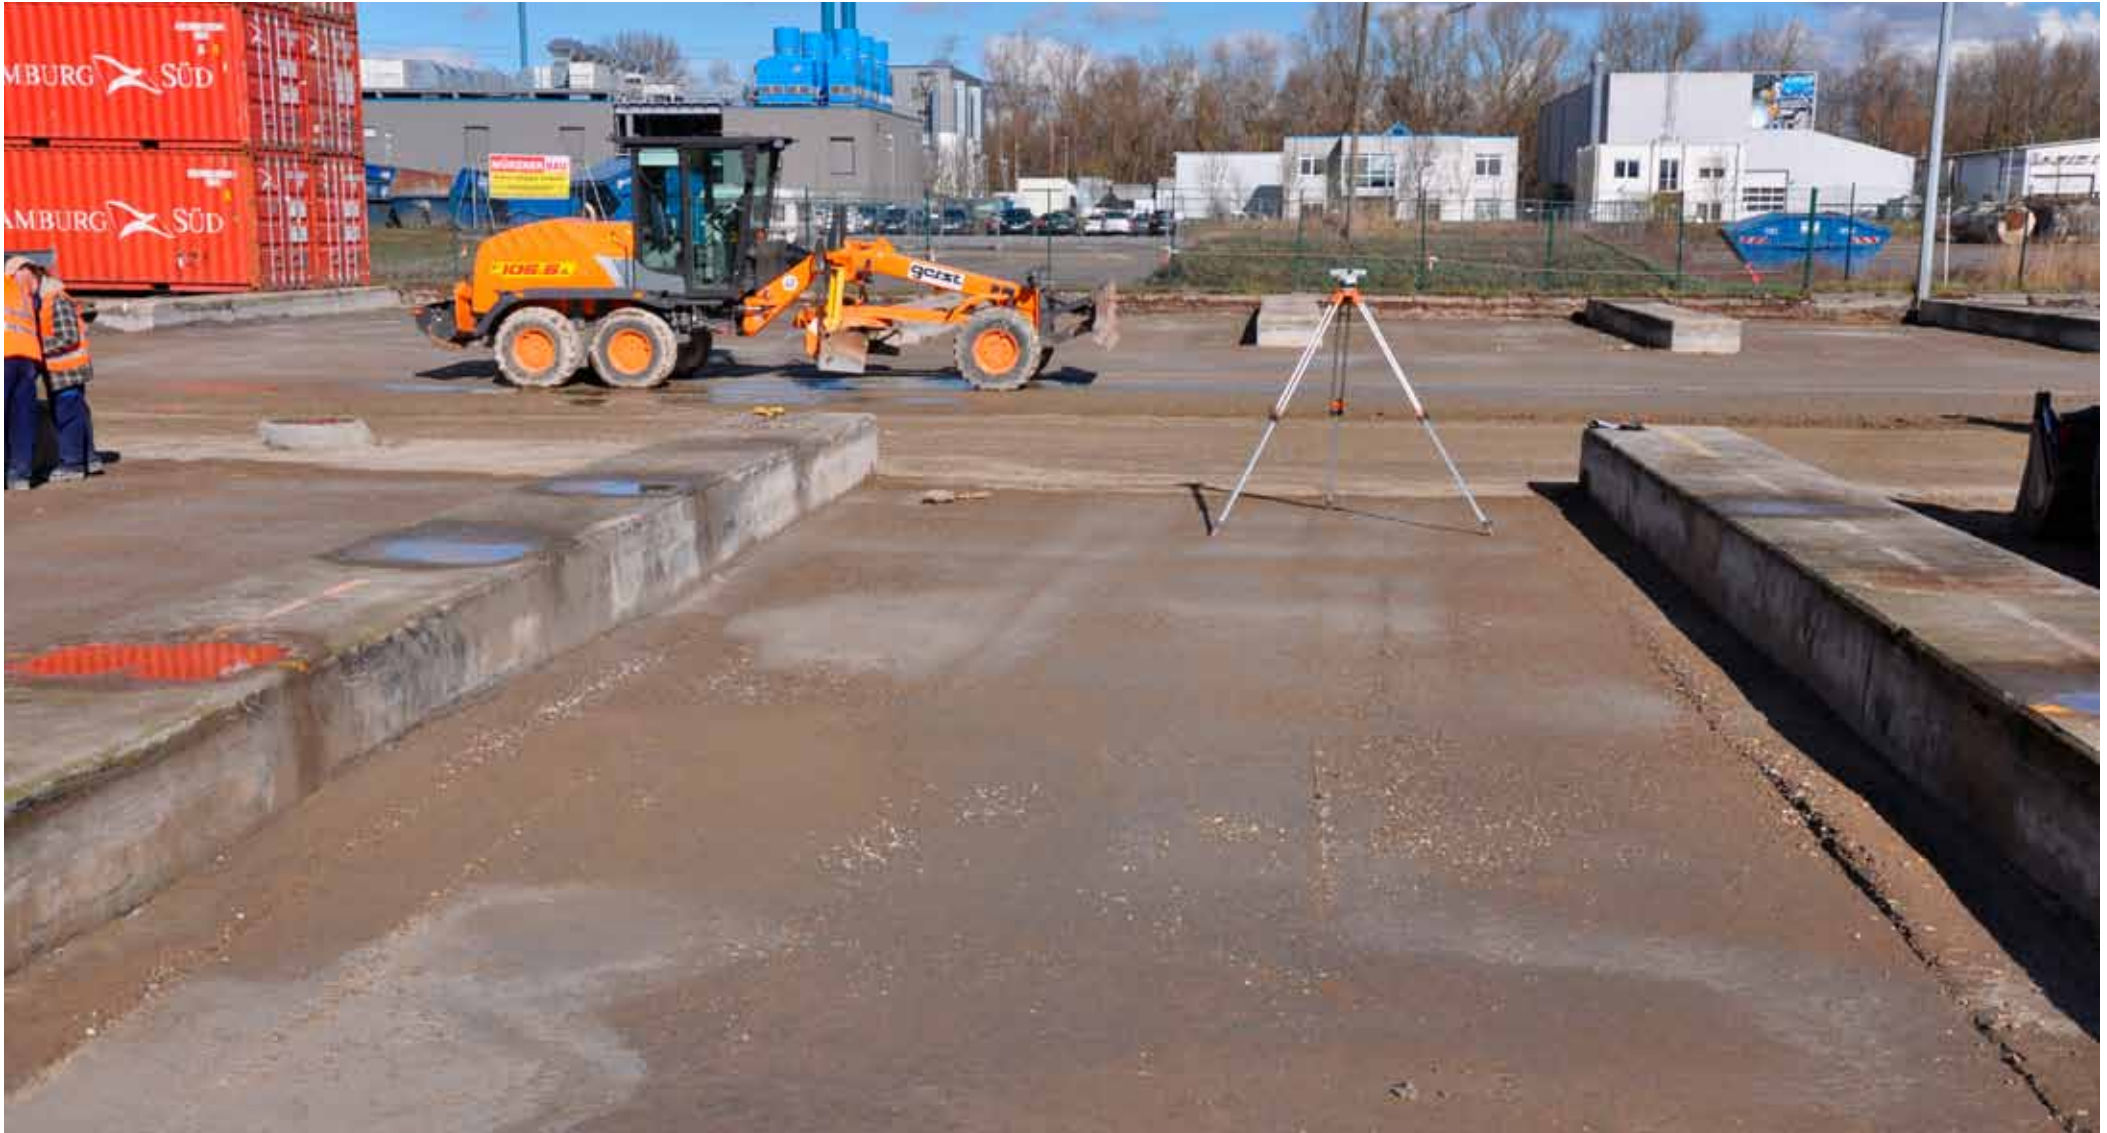
Stabilized area after one day - values in load bearing capacity $> 300 \text{ MN/m}^2$

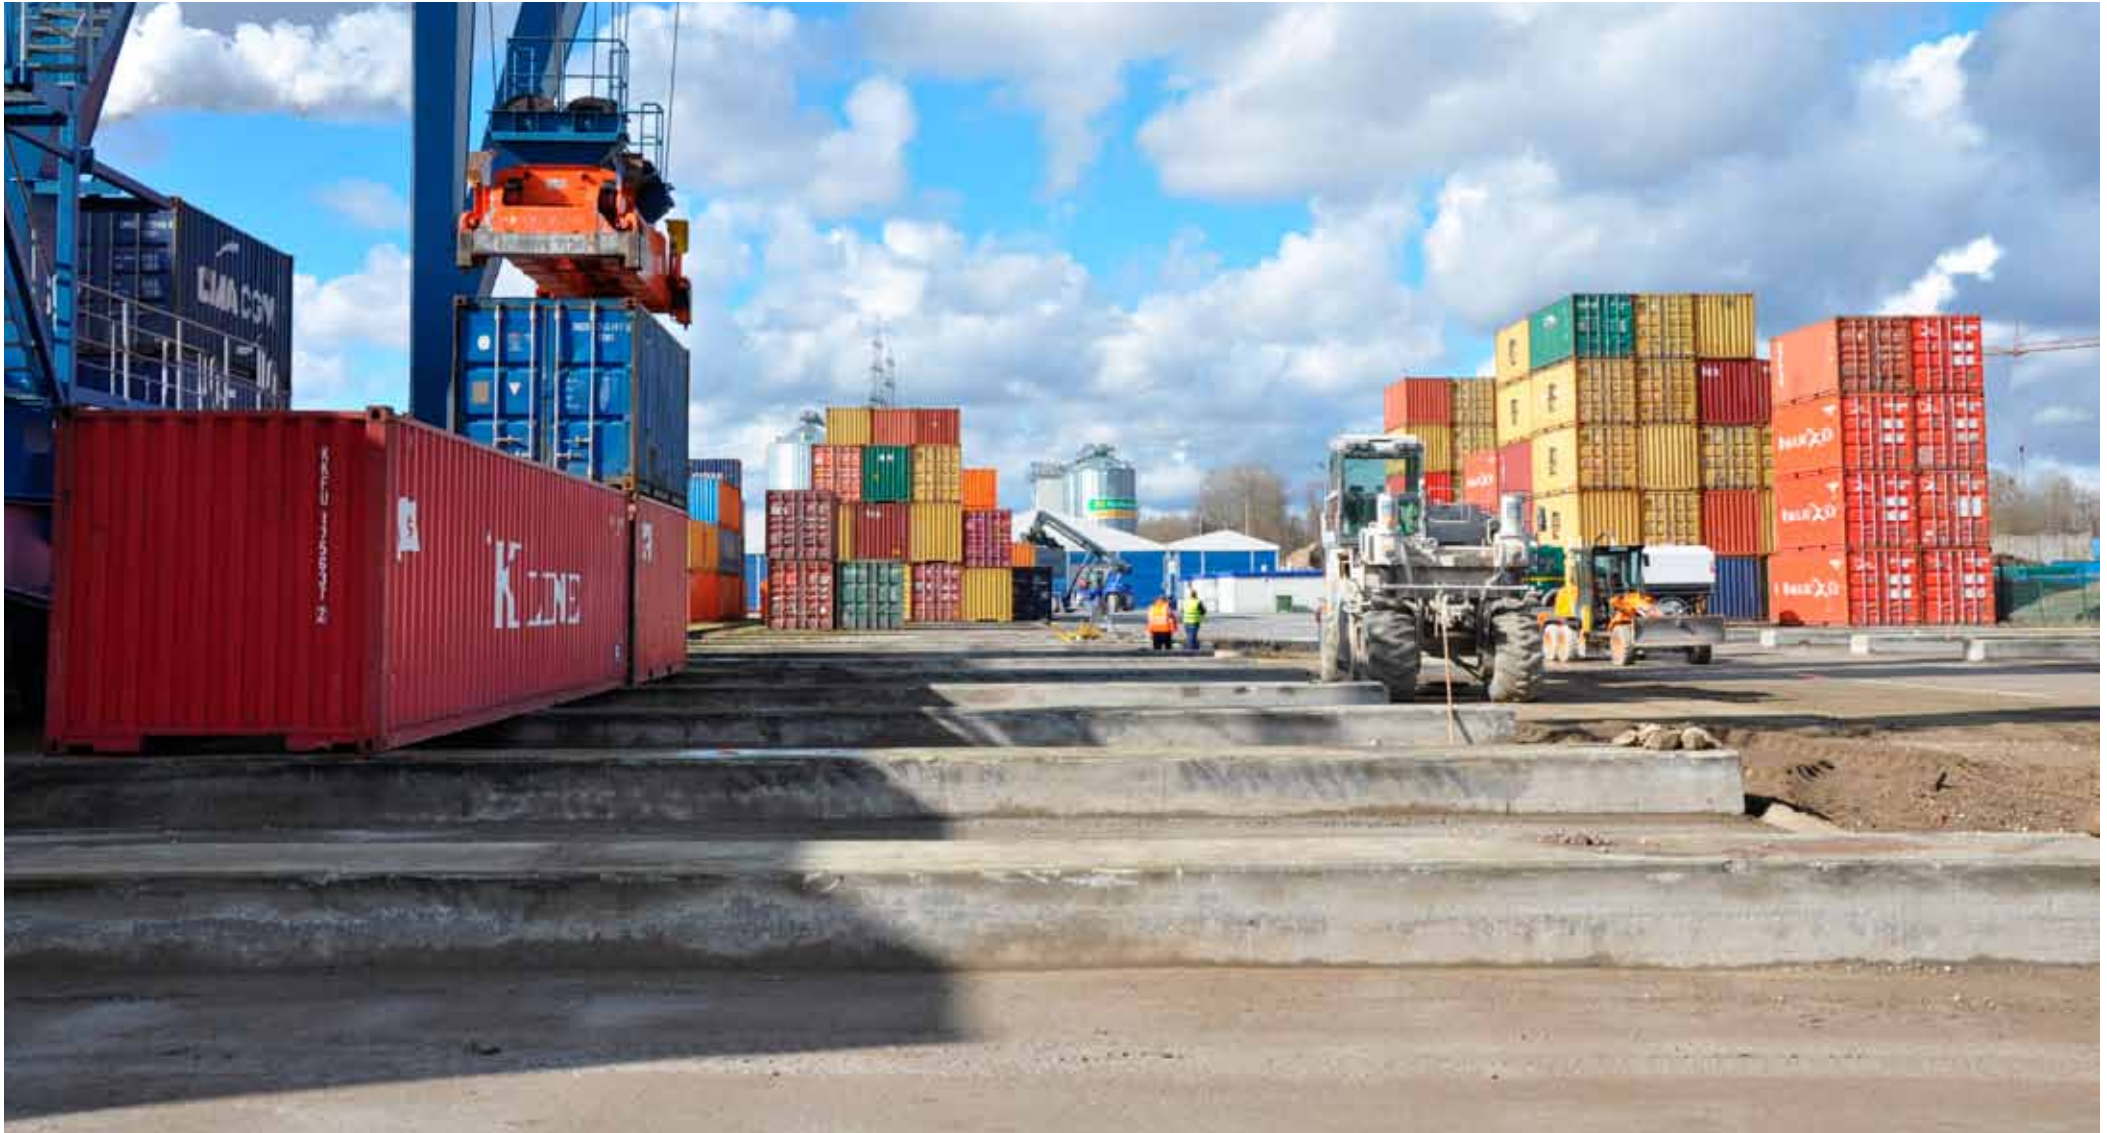
Stabilized area after one day - values in load bearing capacity $> 300 \text{ MN/m}^2$

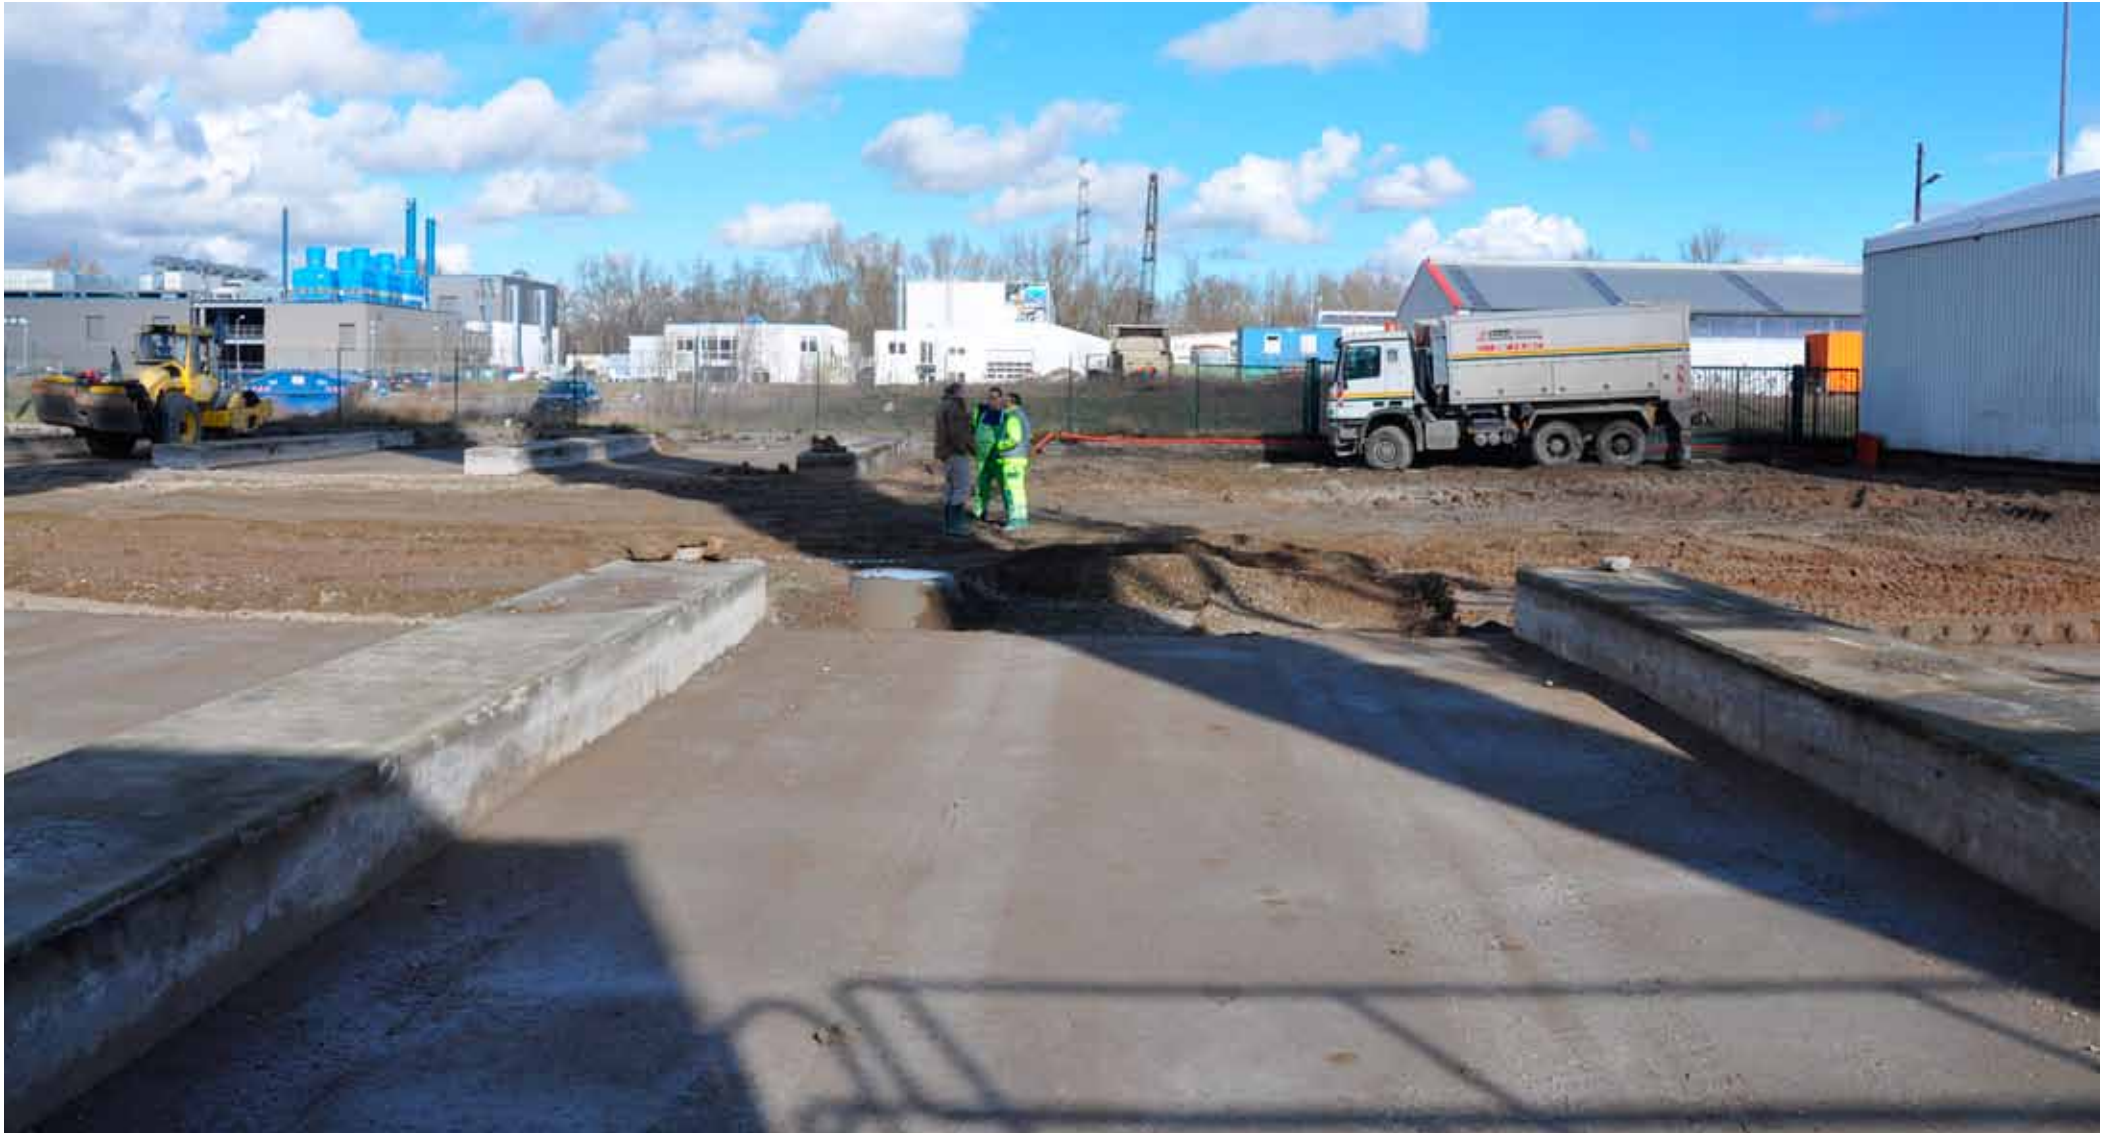
Stabilized area after one day - values in load bearing capacity $> 300 \text{ MN/m}^2$

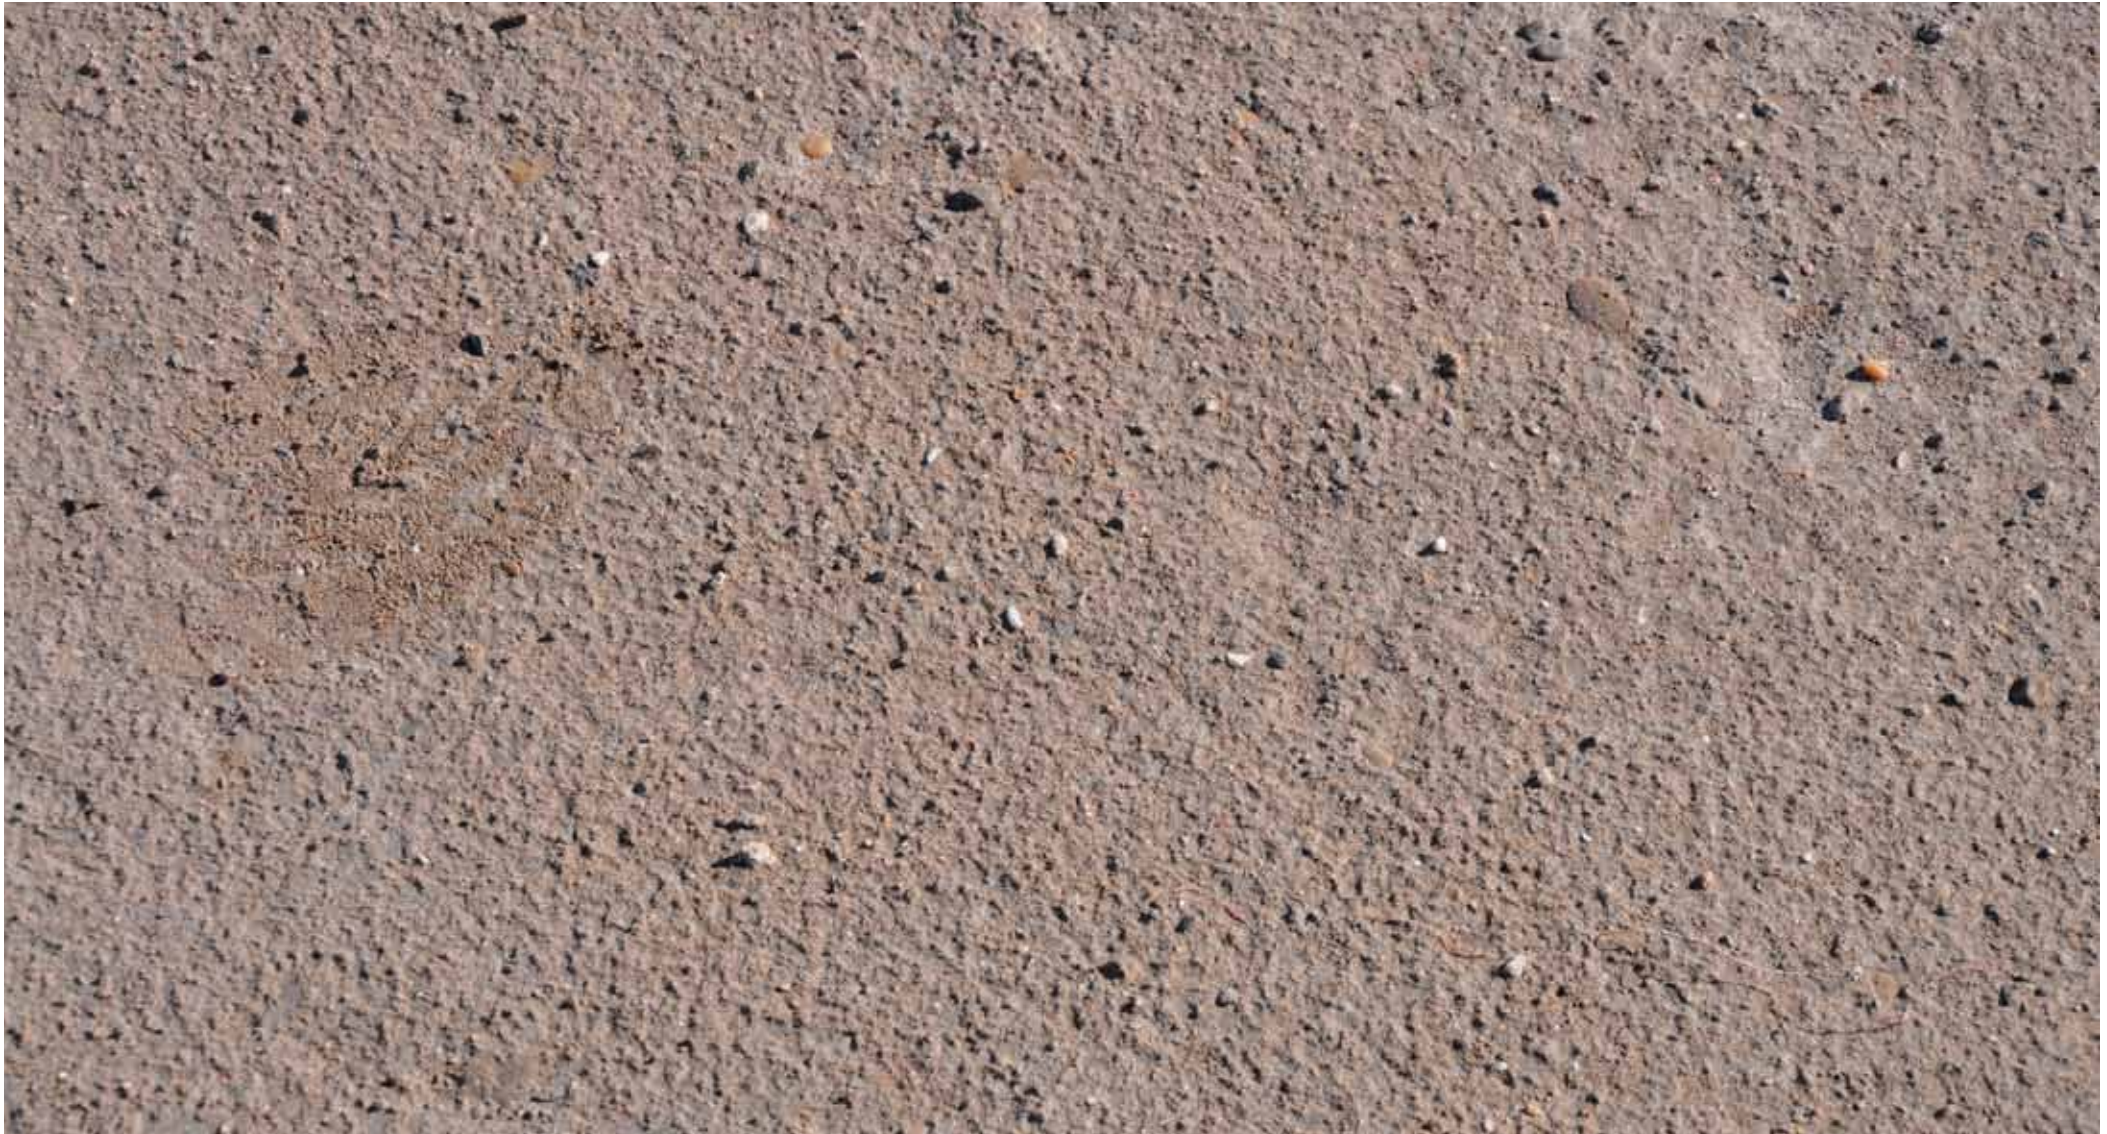
Stabilized area after one day - values in load bearing capacity $> 300 \text{ MN/m}^2$
