Jobsite report

Rehabilitation of the magistral (M5) between Boljevac and Straza in Serbia with the Mix-Paver technology and the cement additive NovoCrete®

- Location: Boljevac/Serbia
- Period of execution: May/June 2012
- Time needed: 15 days
- Cement: 110 kg/m³ Zement 32,5 with 2% NovoCrete
- Strength of layer: 18 cm

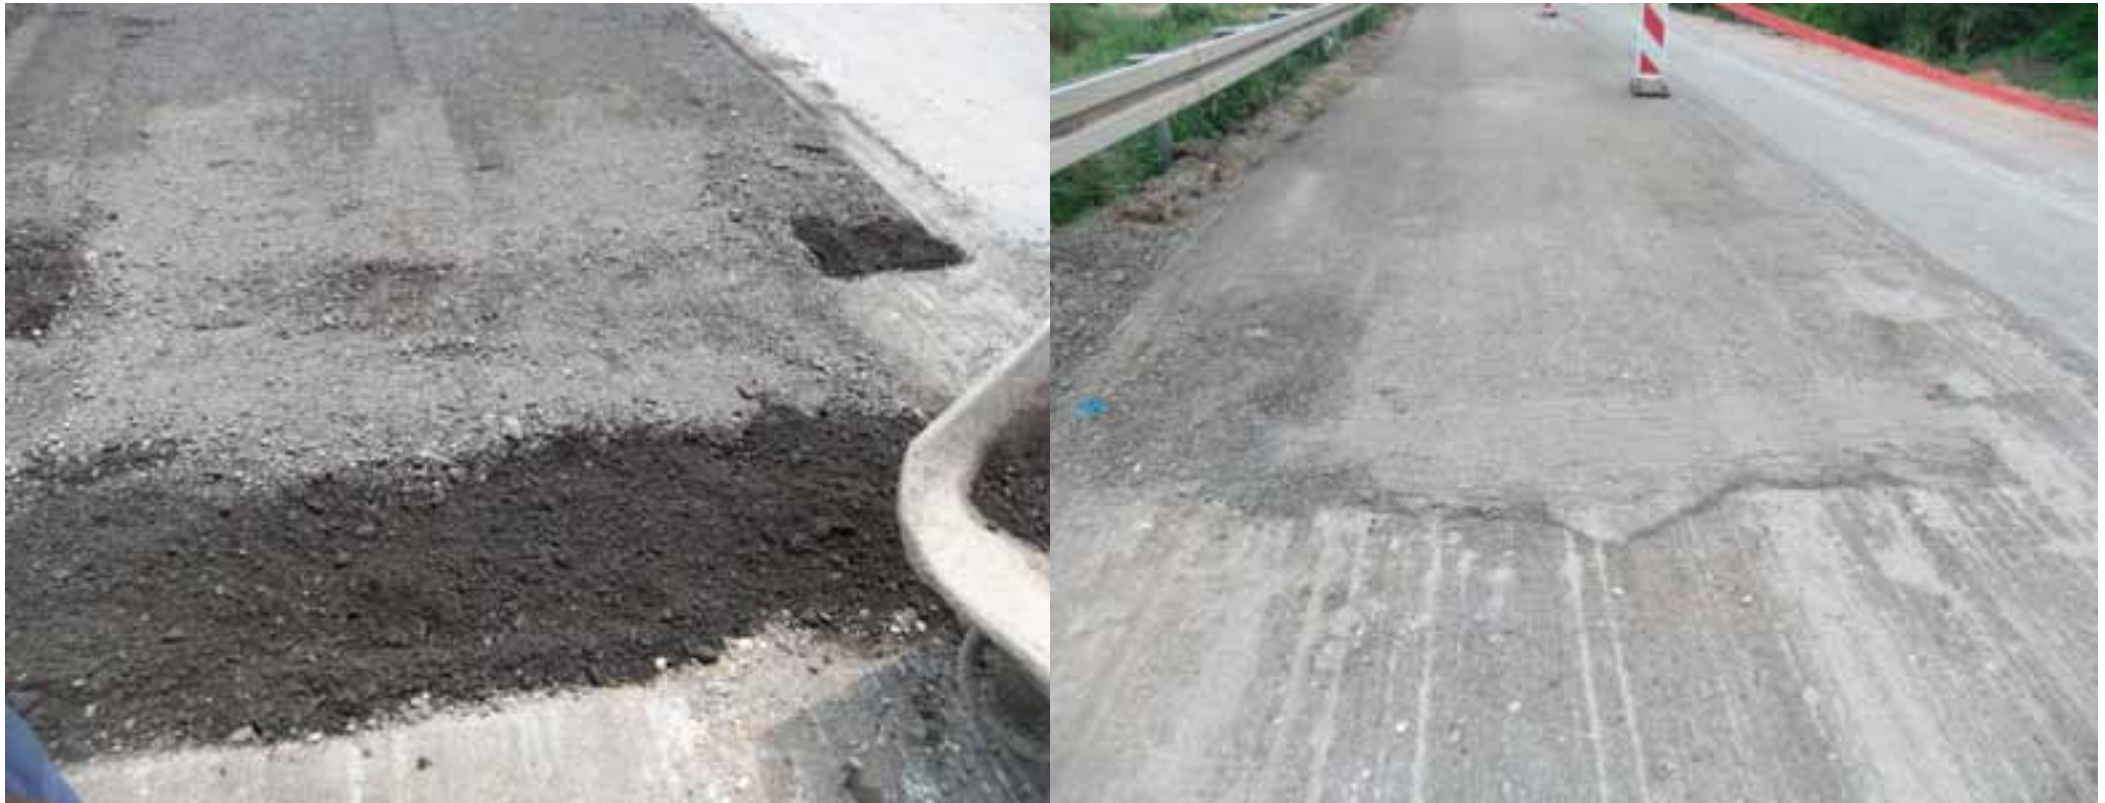
Initial situation after milling of the old asphalt layer

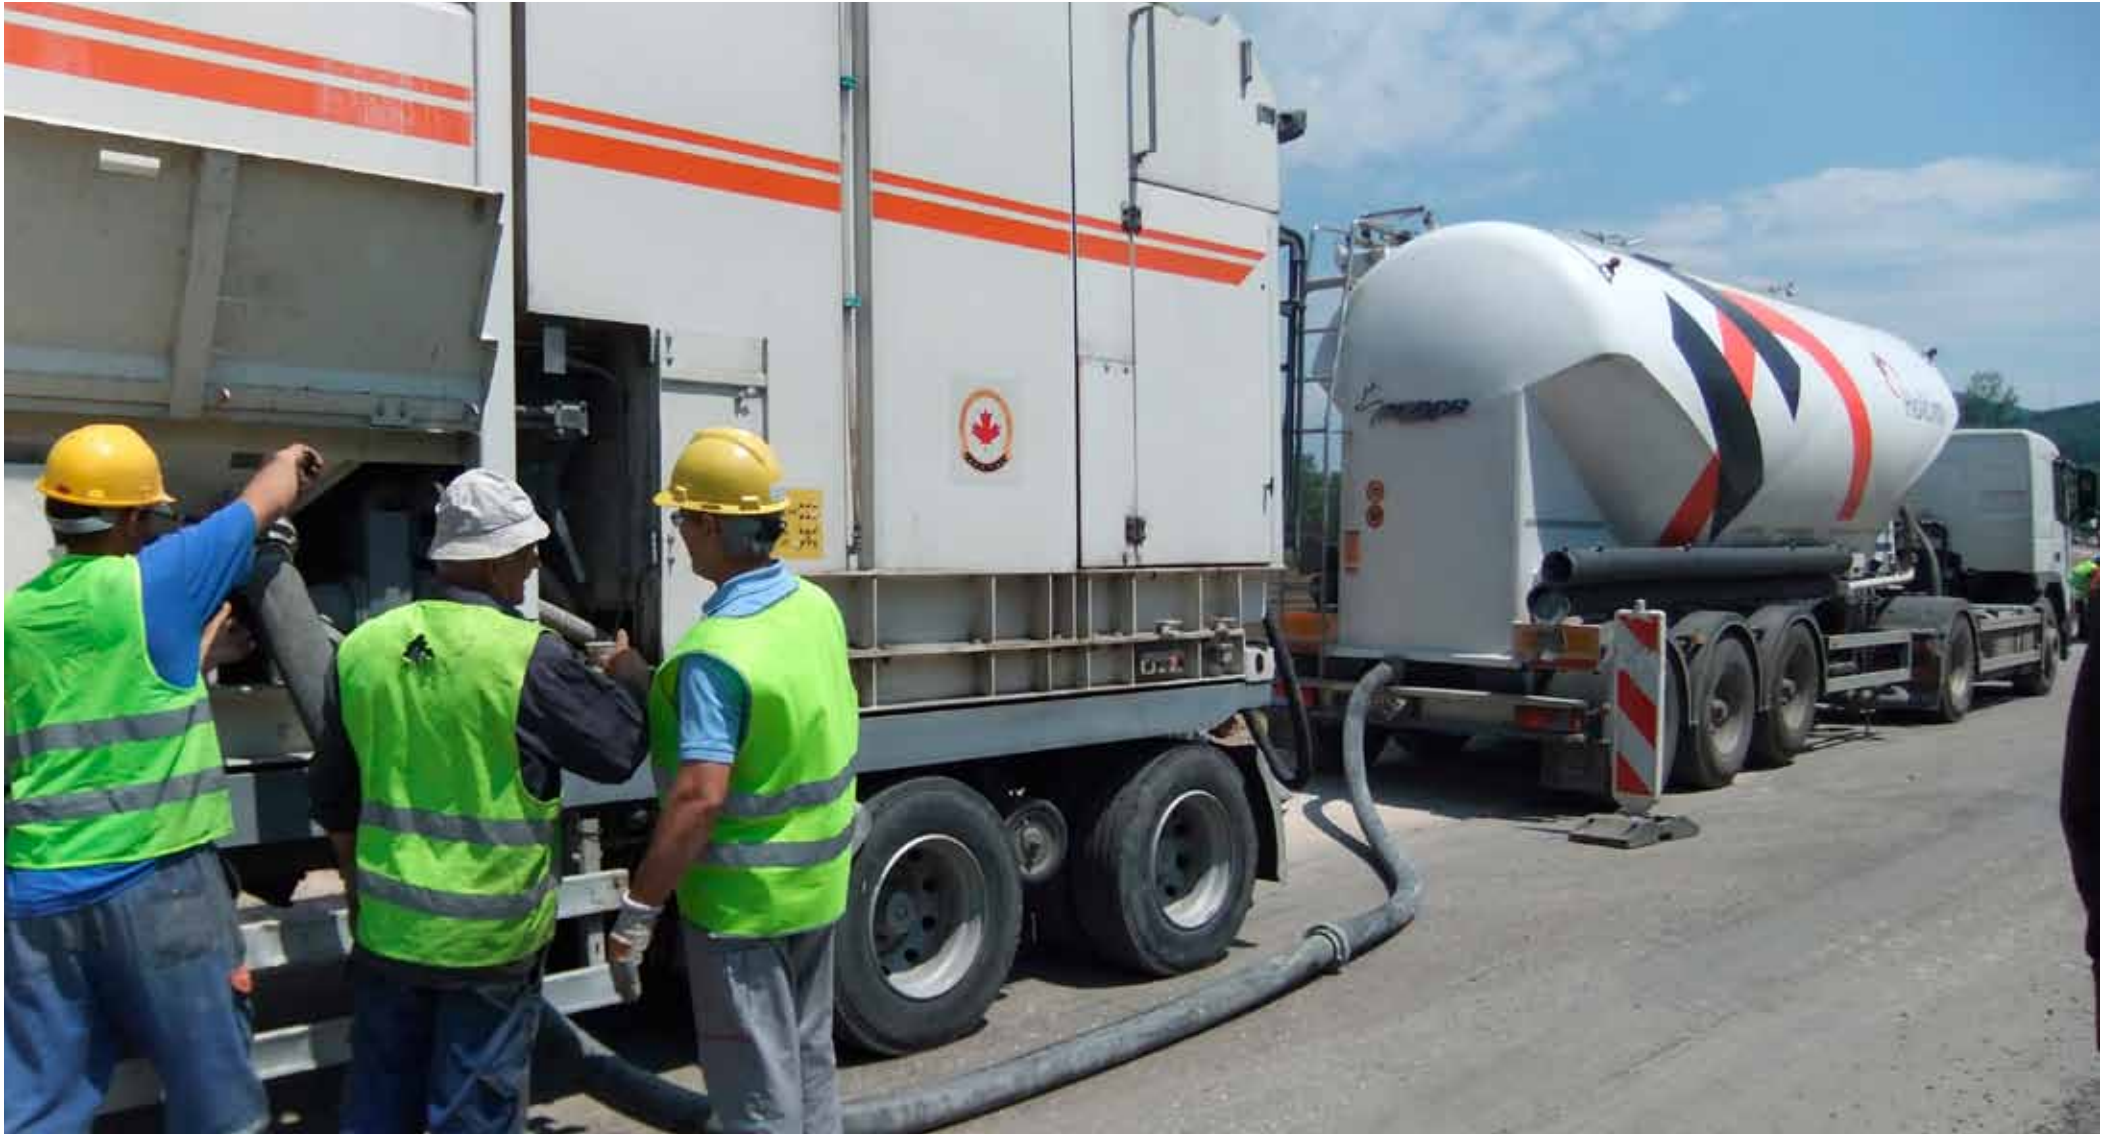
Delivery of cement for the slurry machine

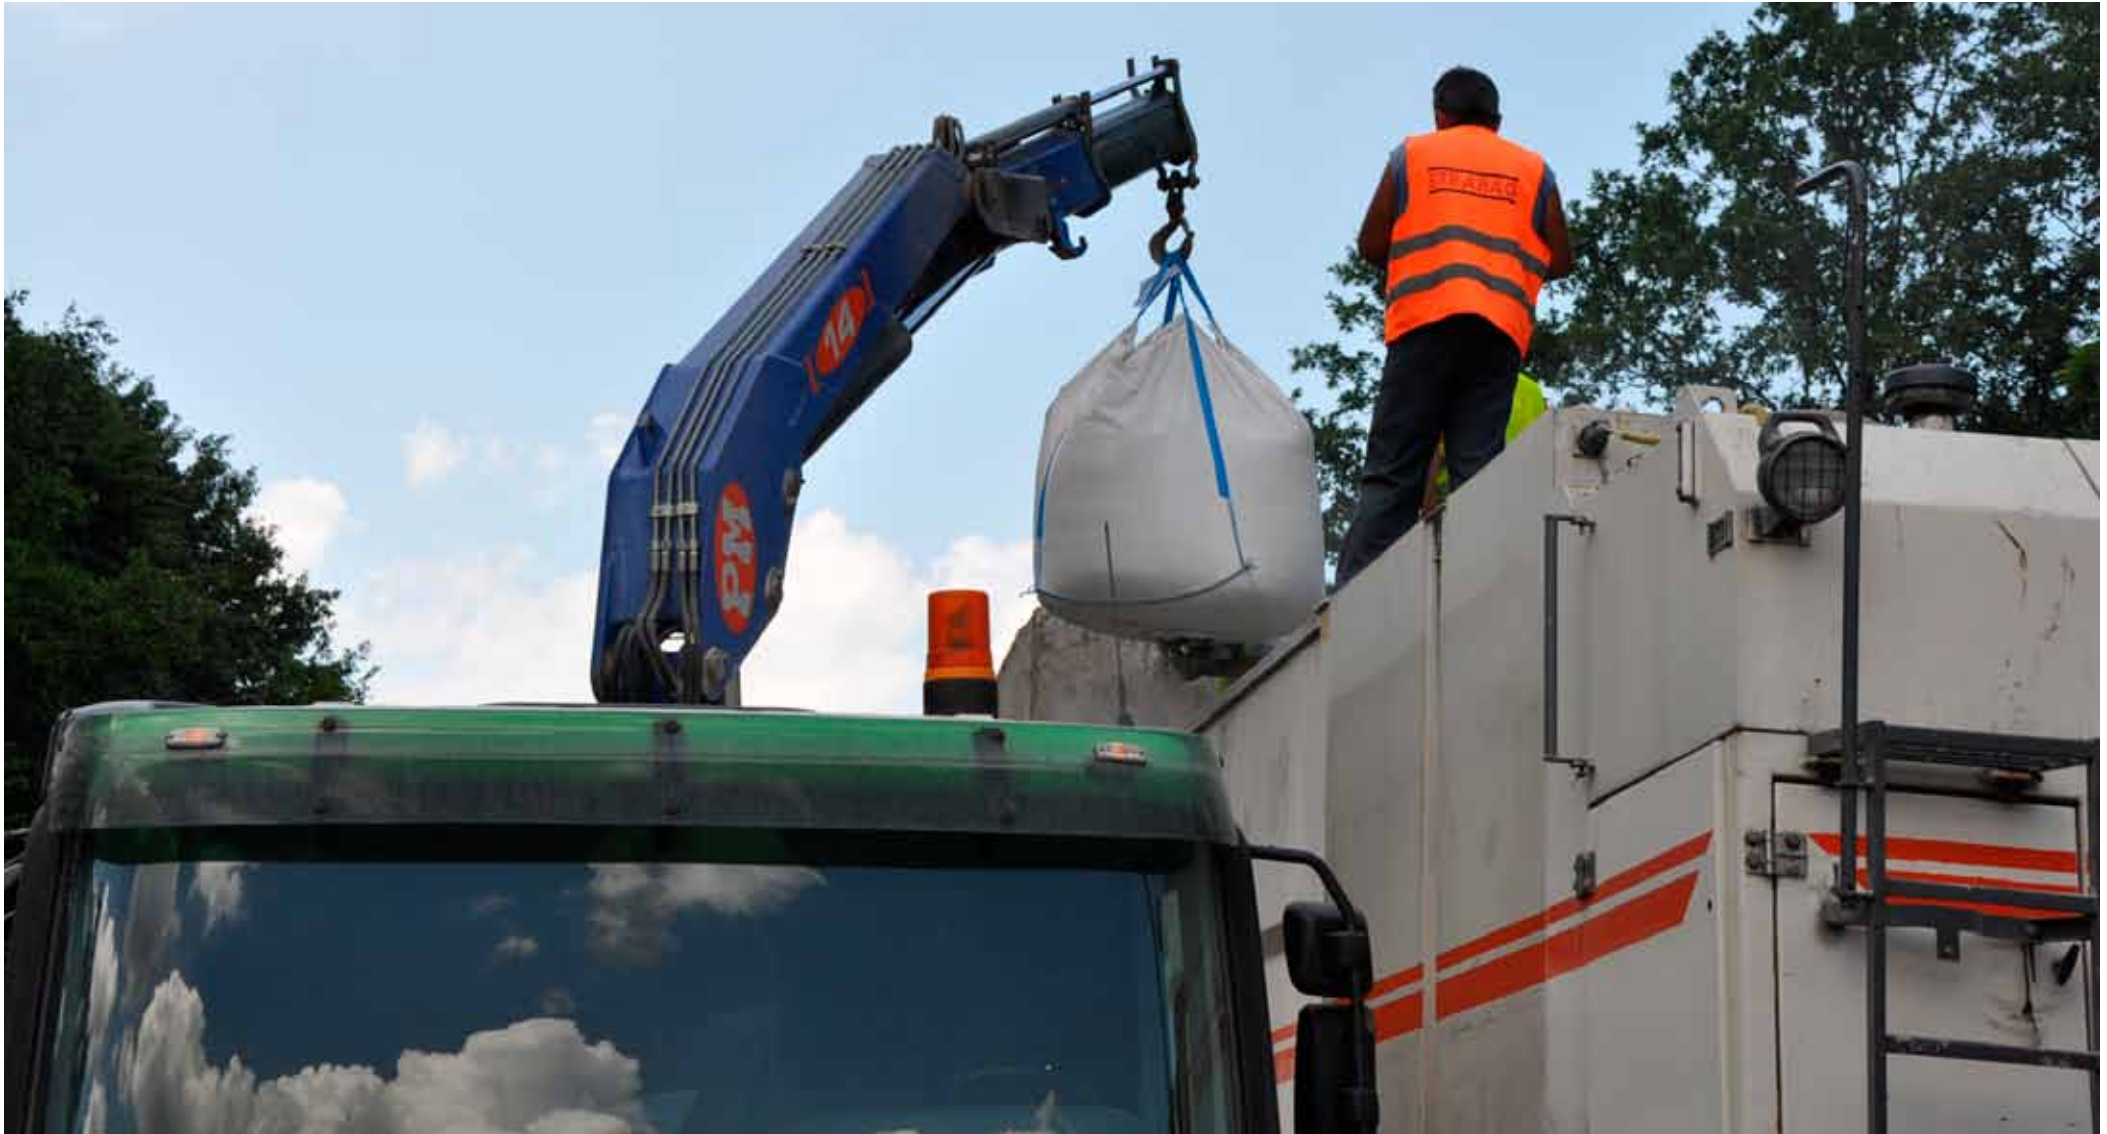
Delivery of NovoCrete for the slurry machine

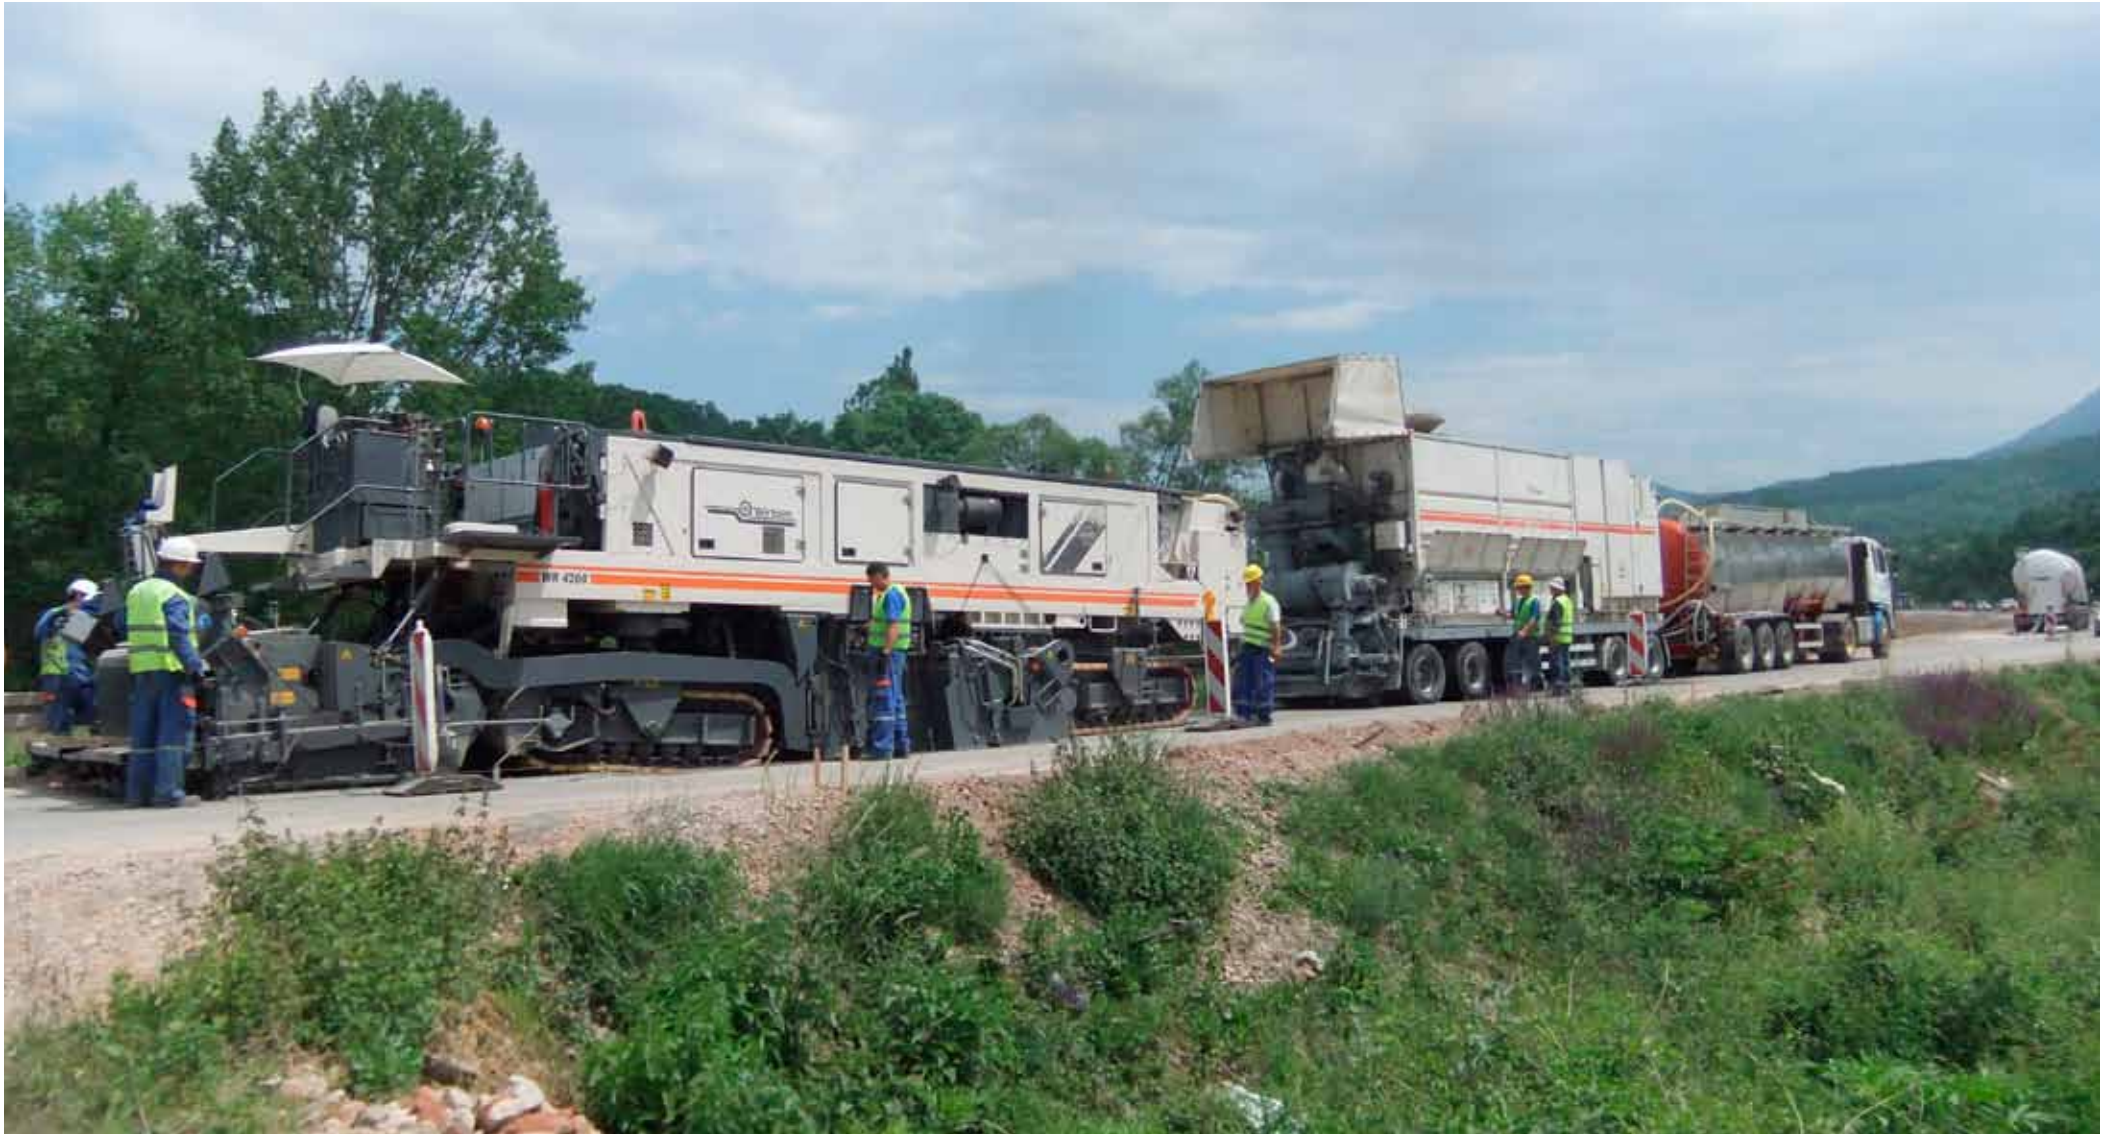
Use of the Mix Paver

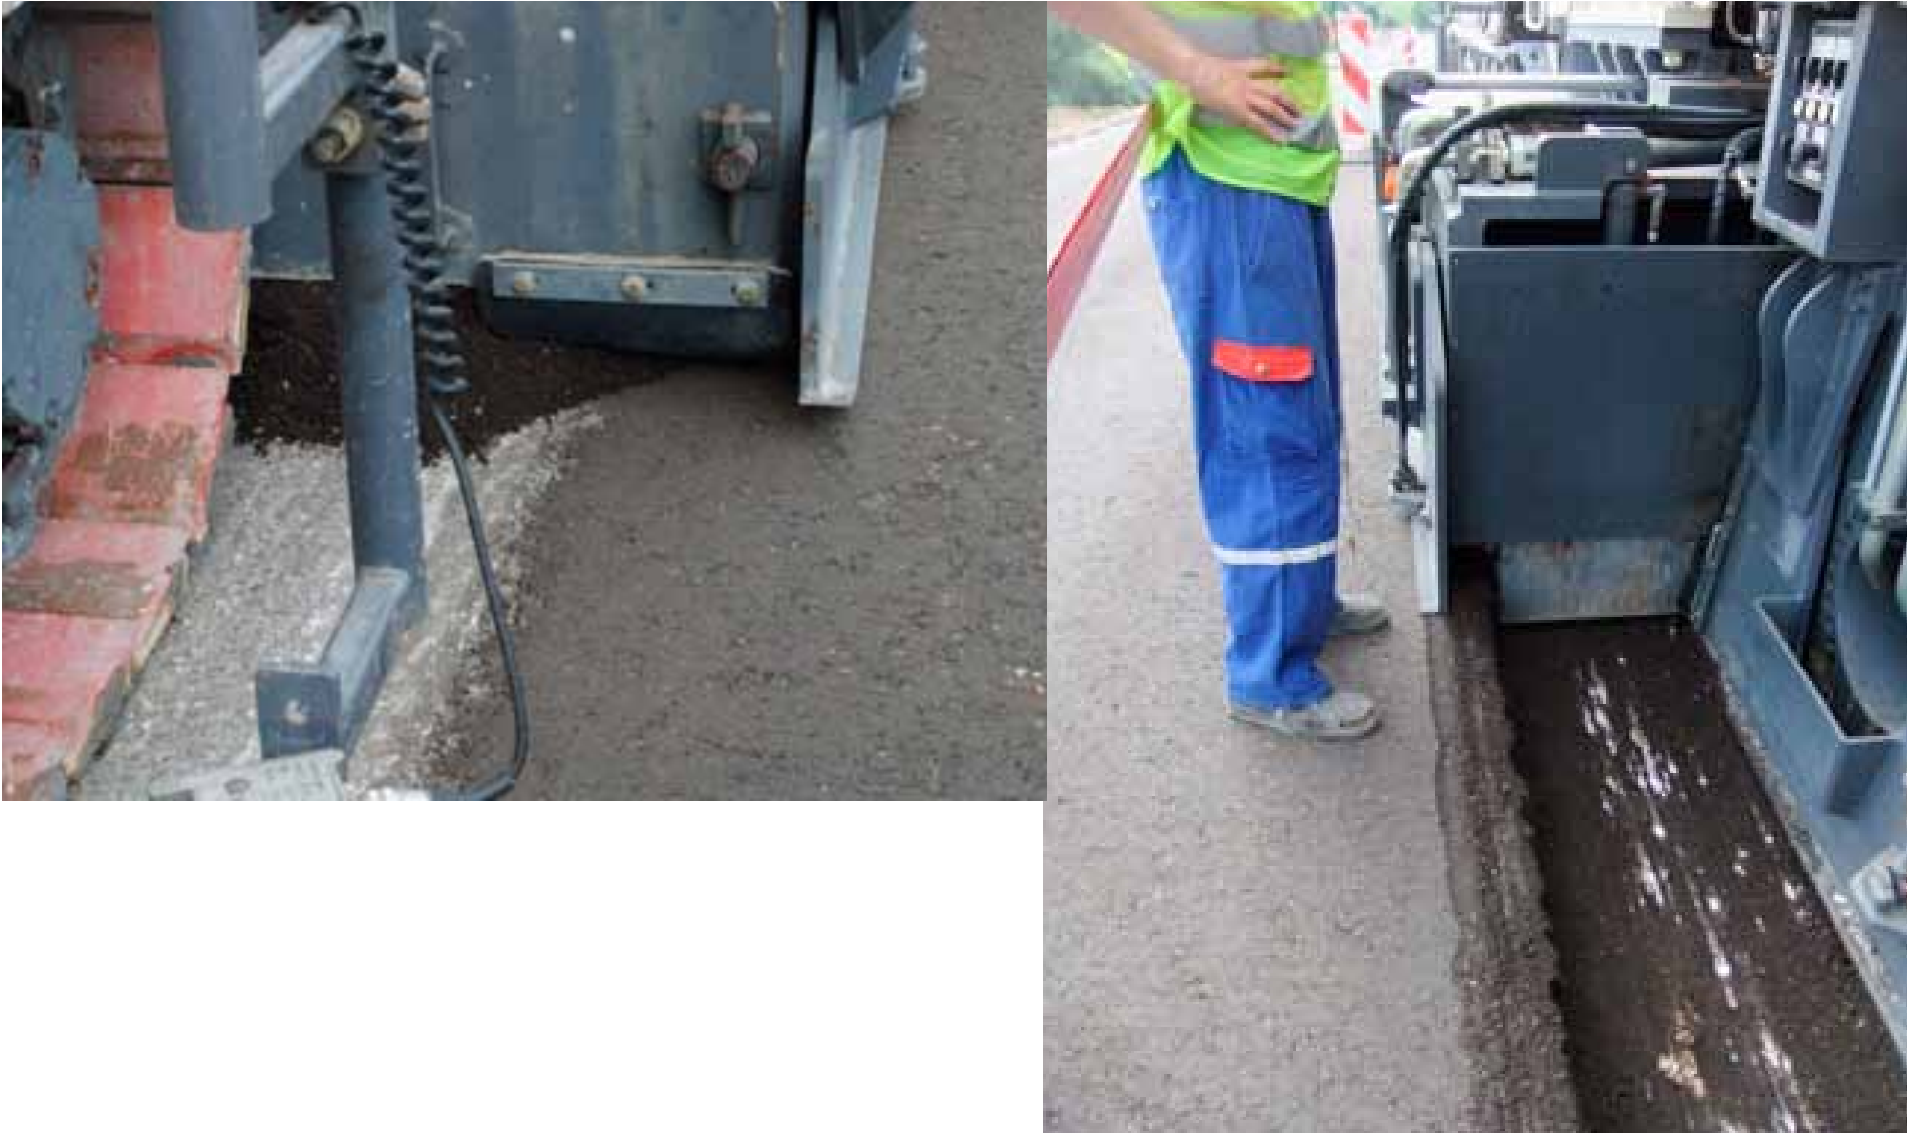
Use of the Mix Paver

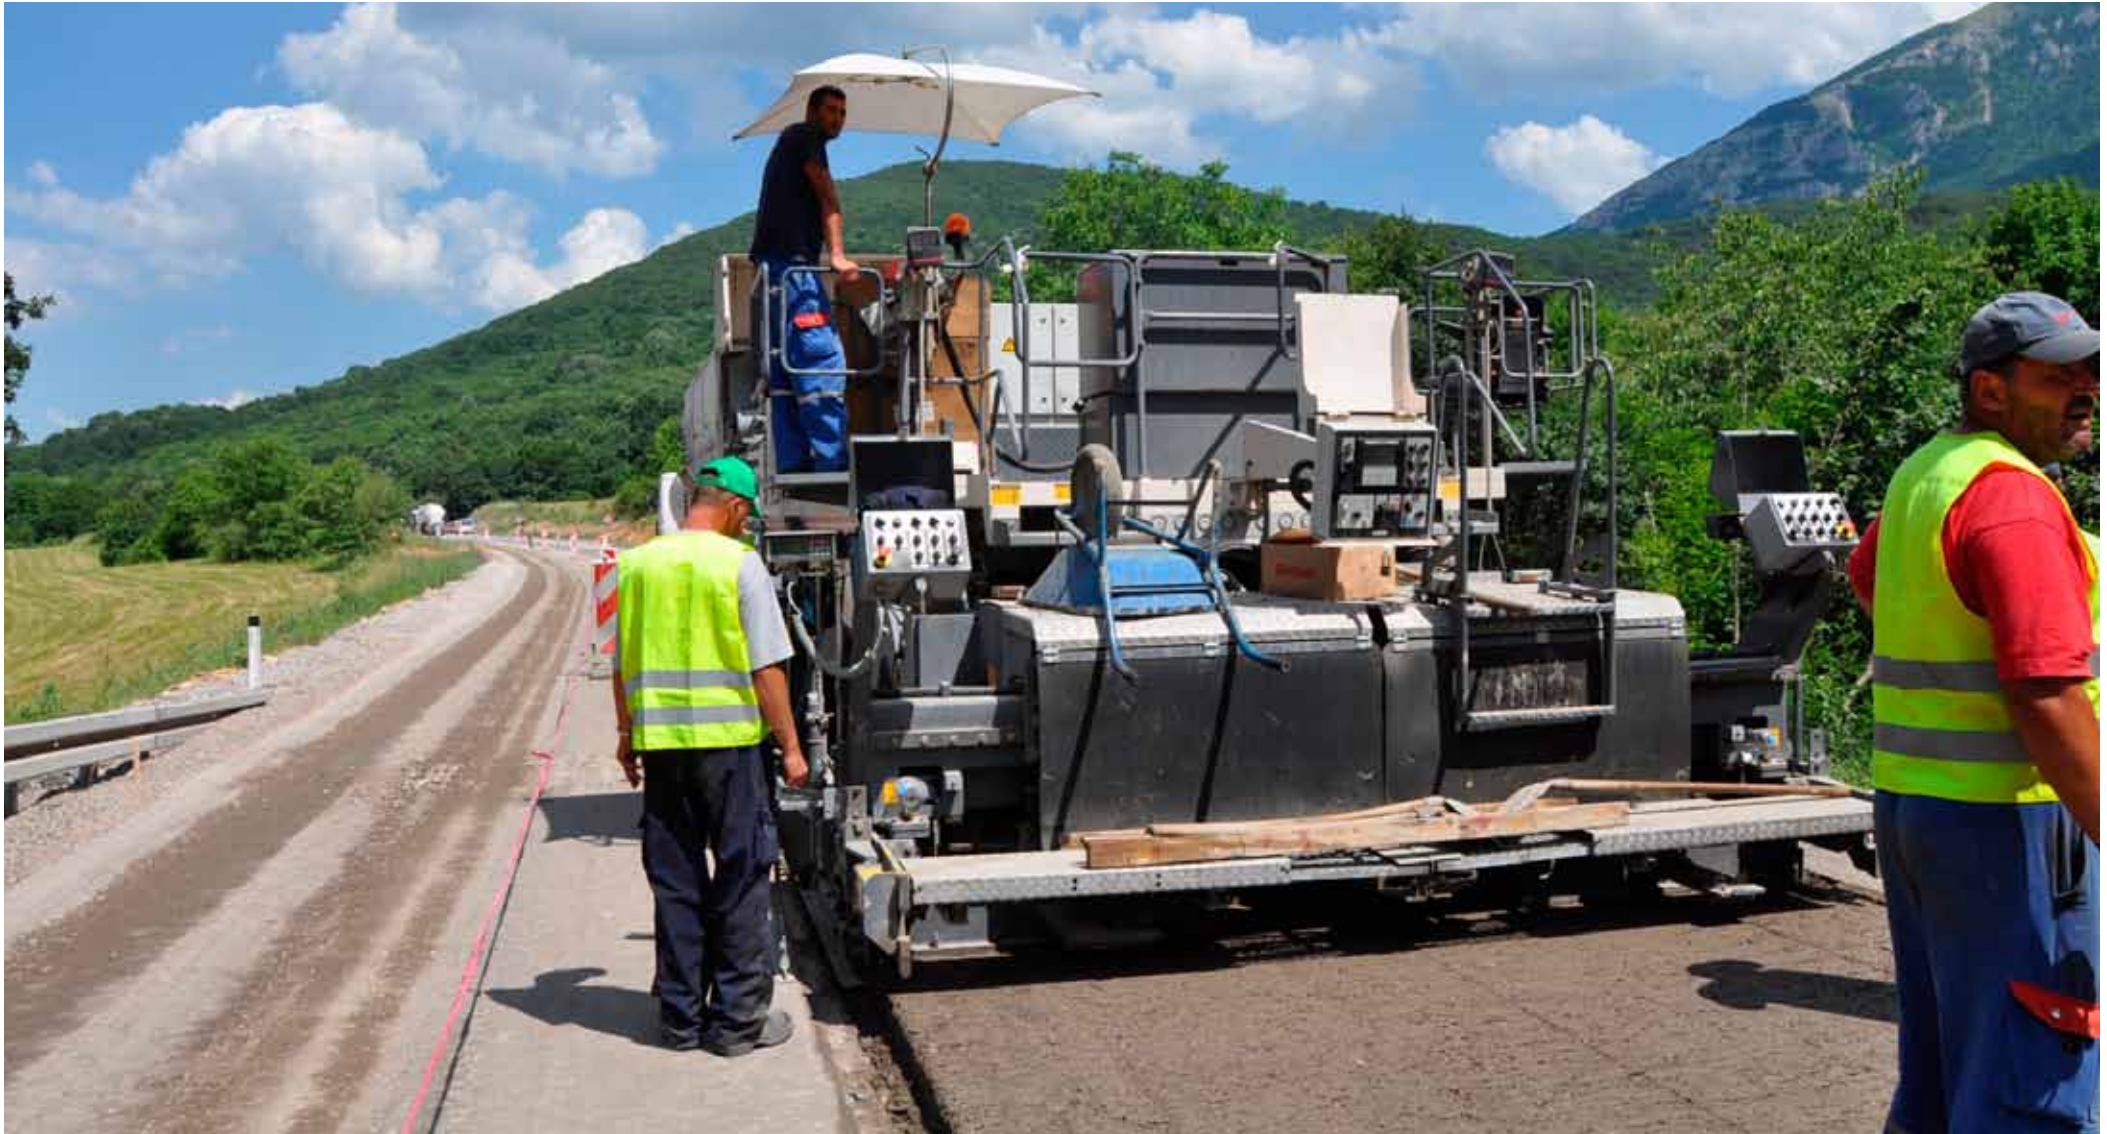
Use of the Mix Paver

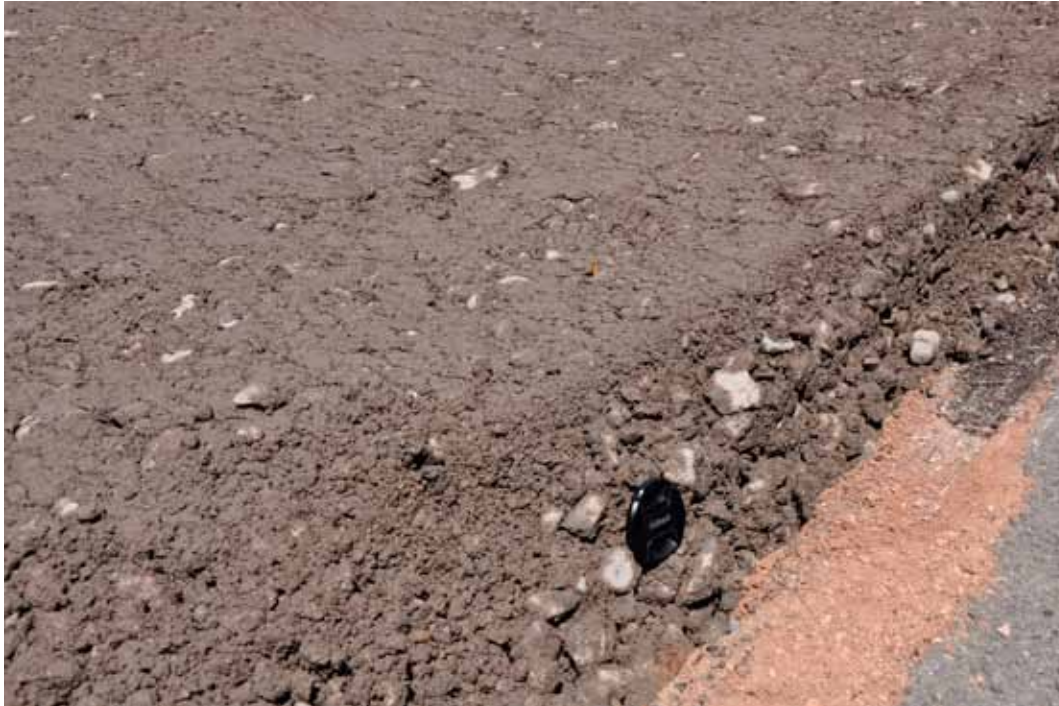
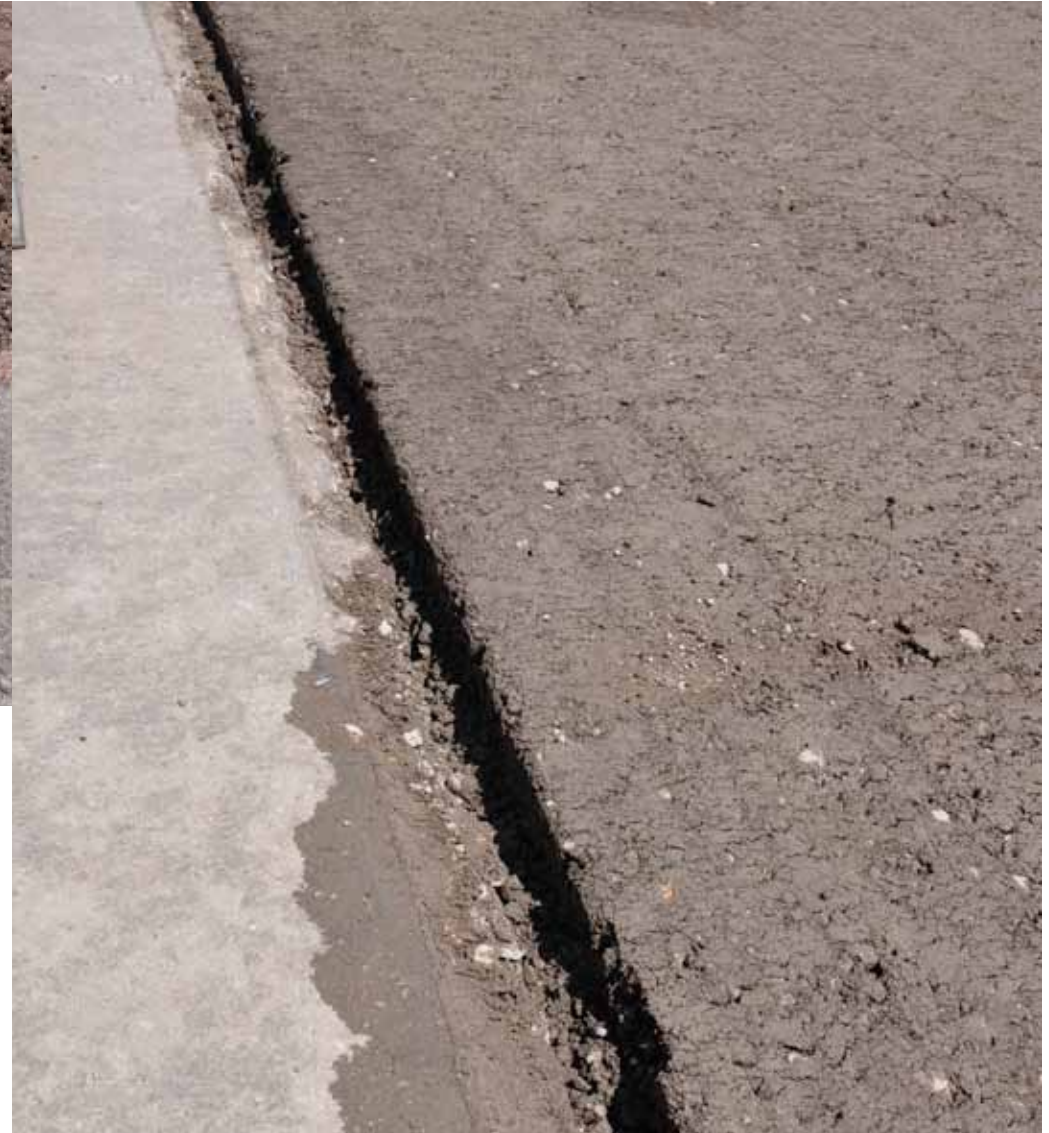
Close-up of the surface after the use of the Mix Paver

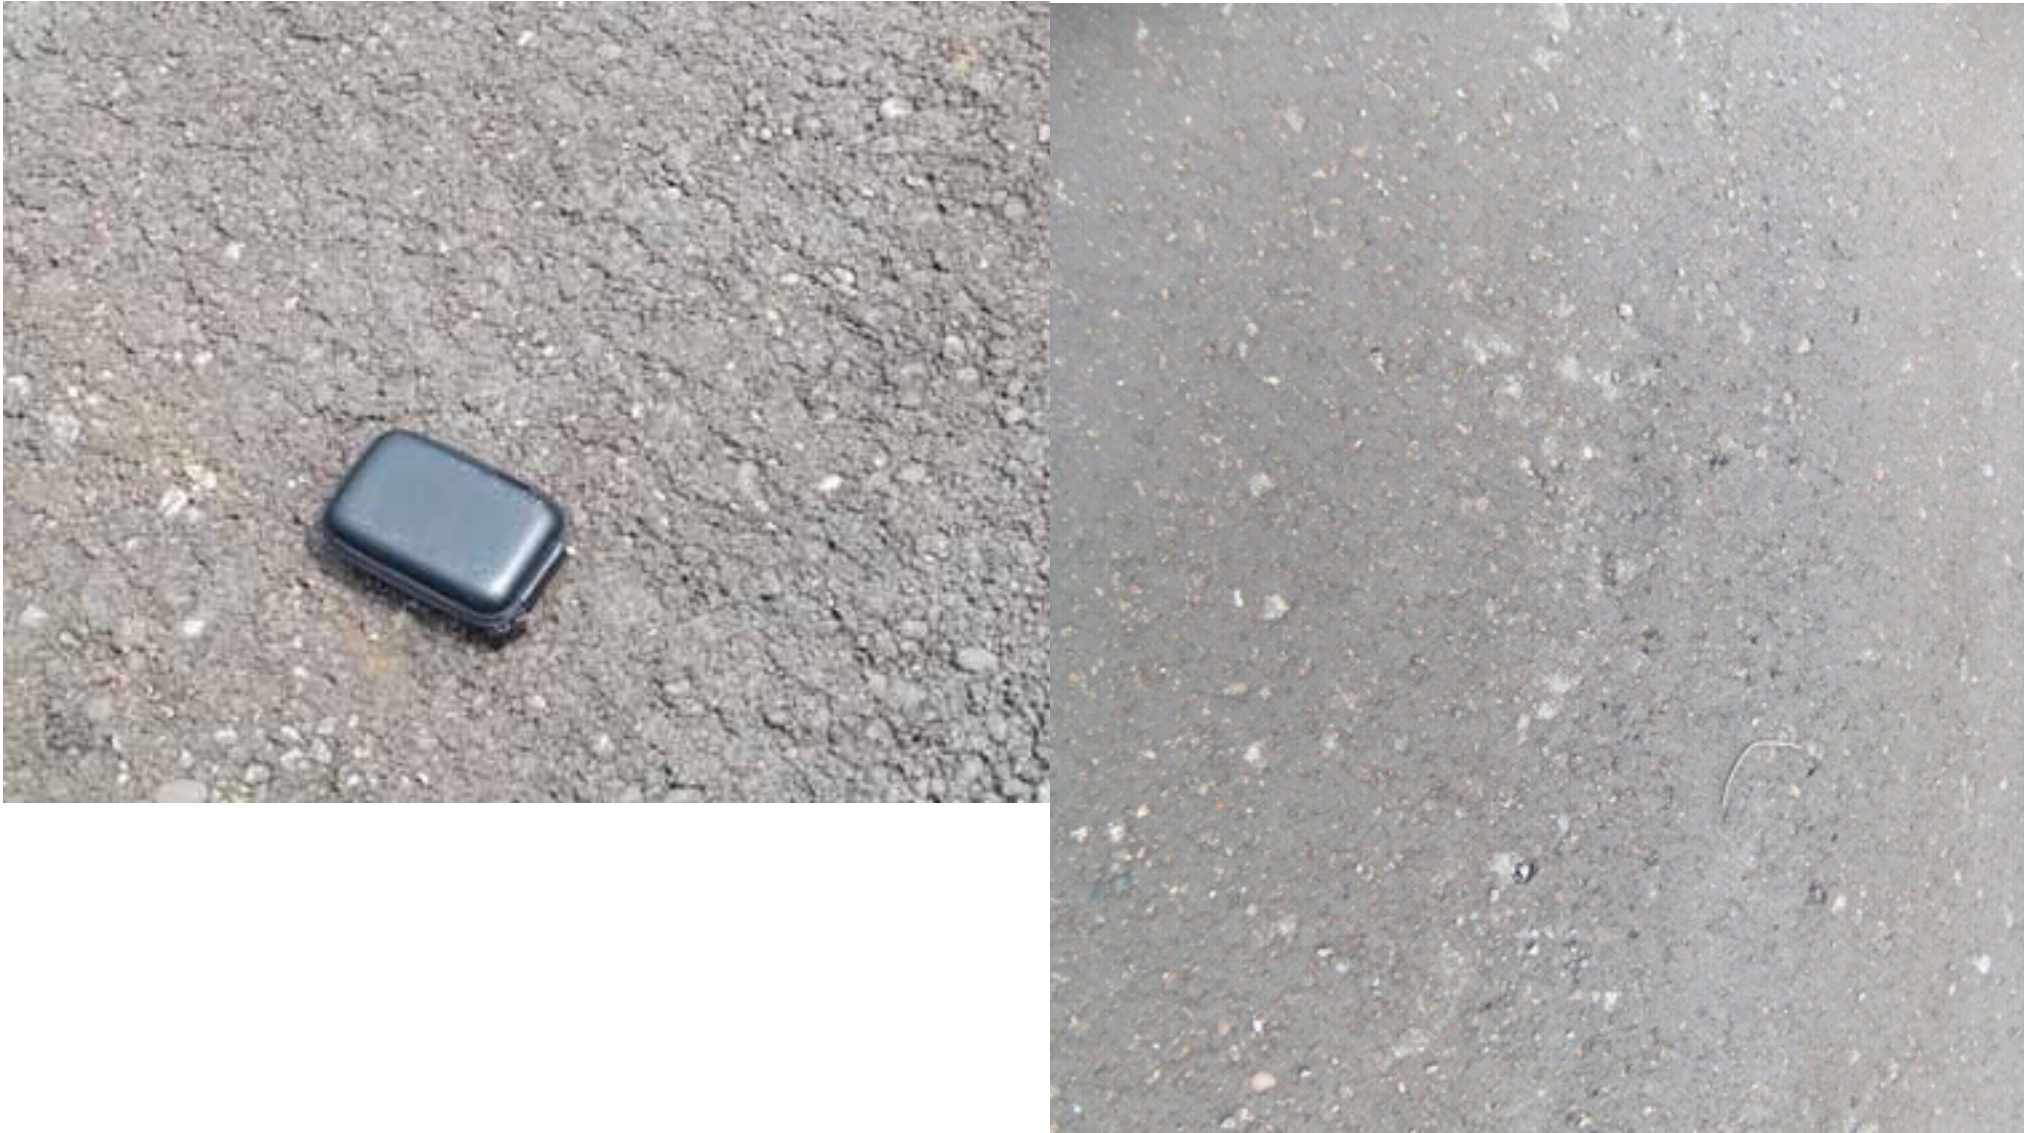
Close-up of the surface after the use of the Mix Paver

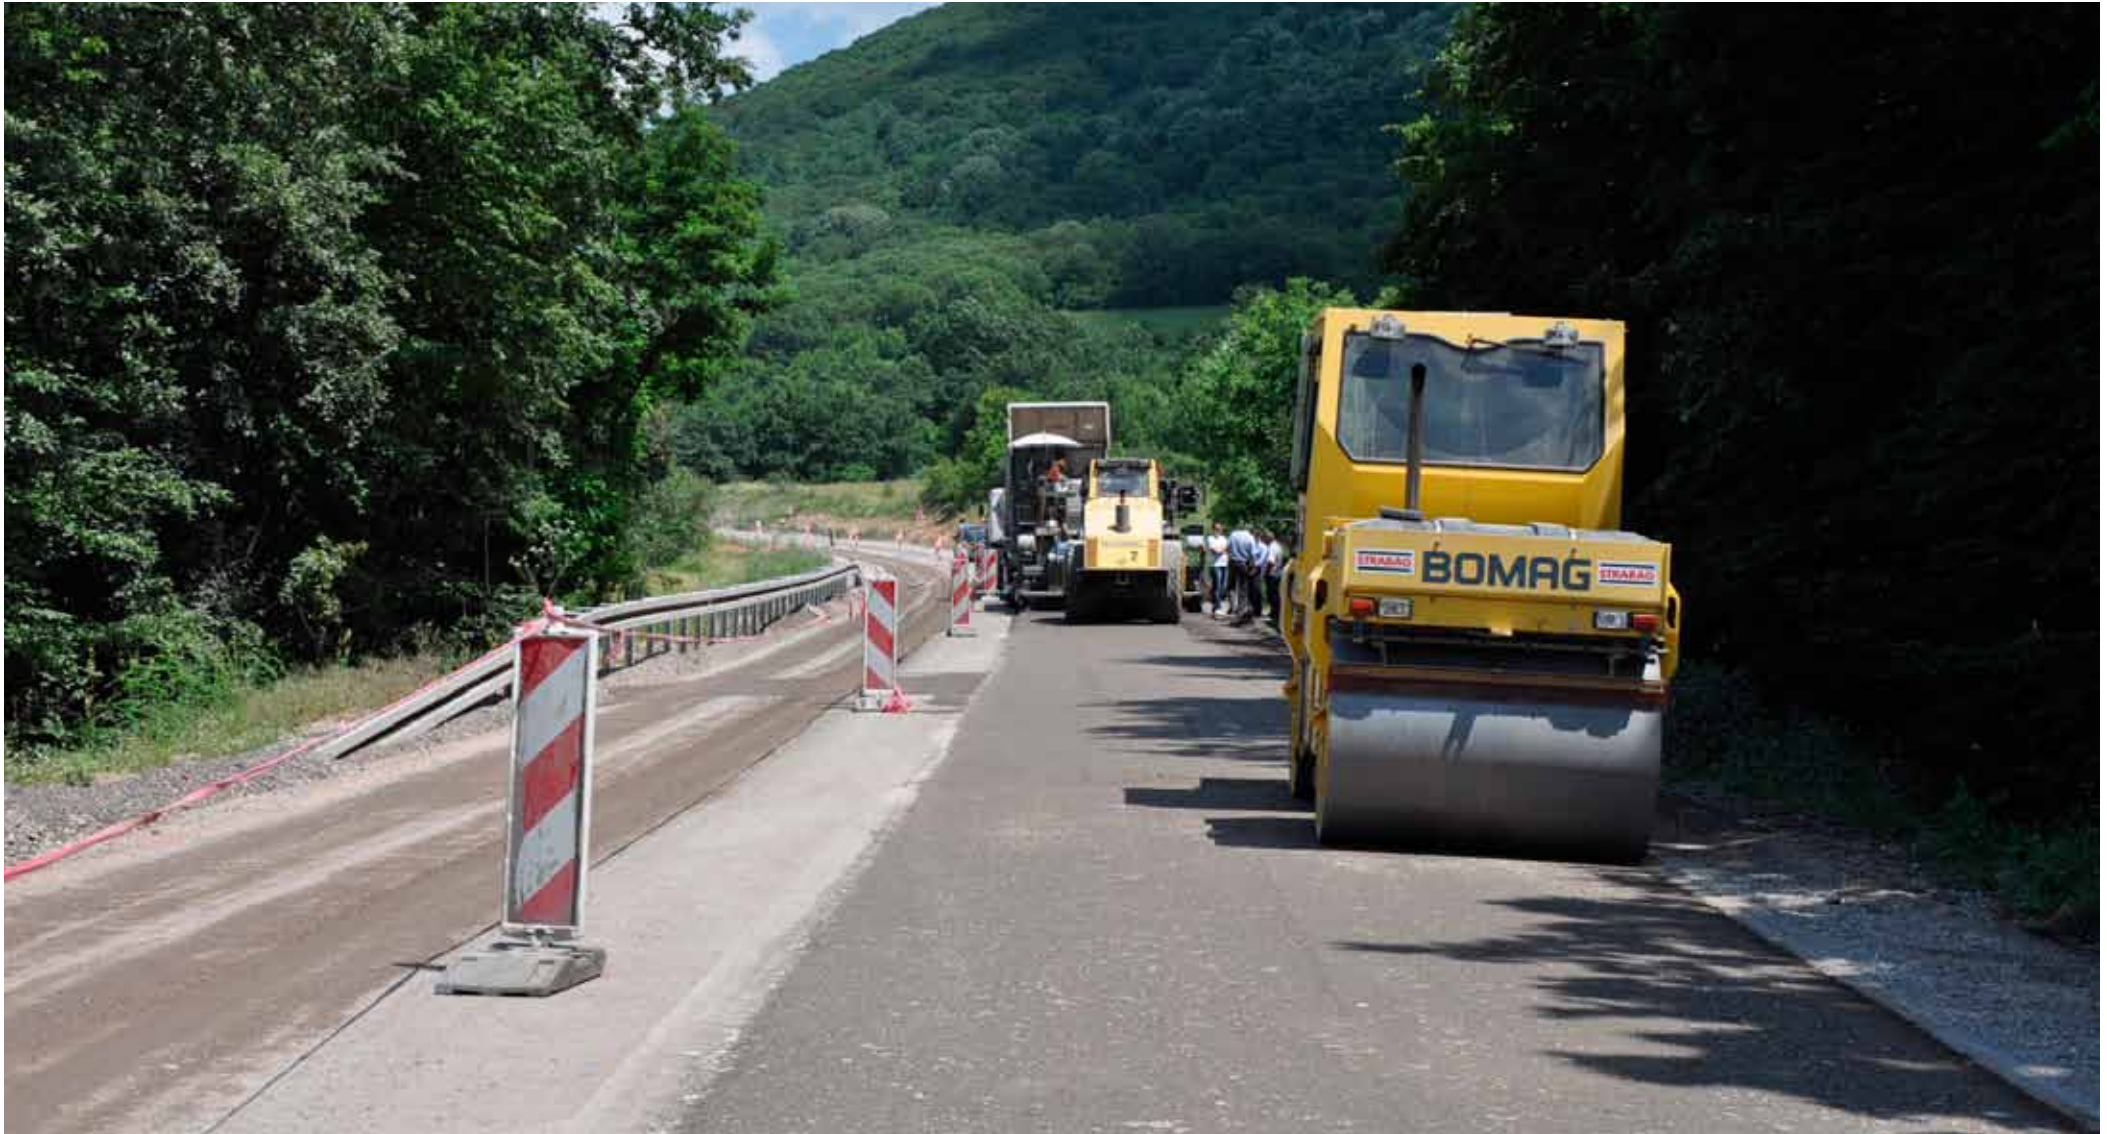
Compaction of the area

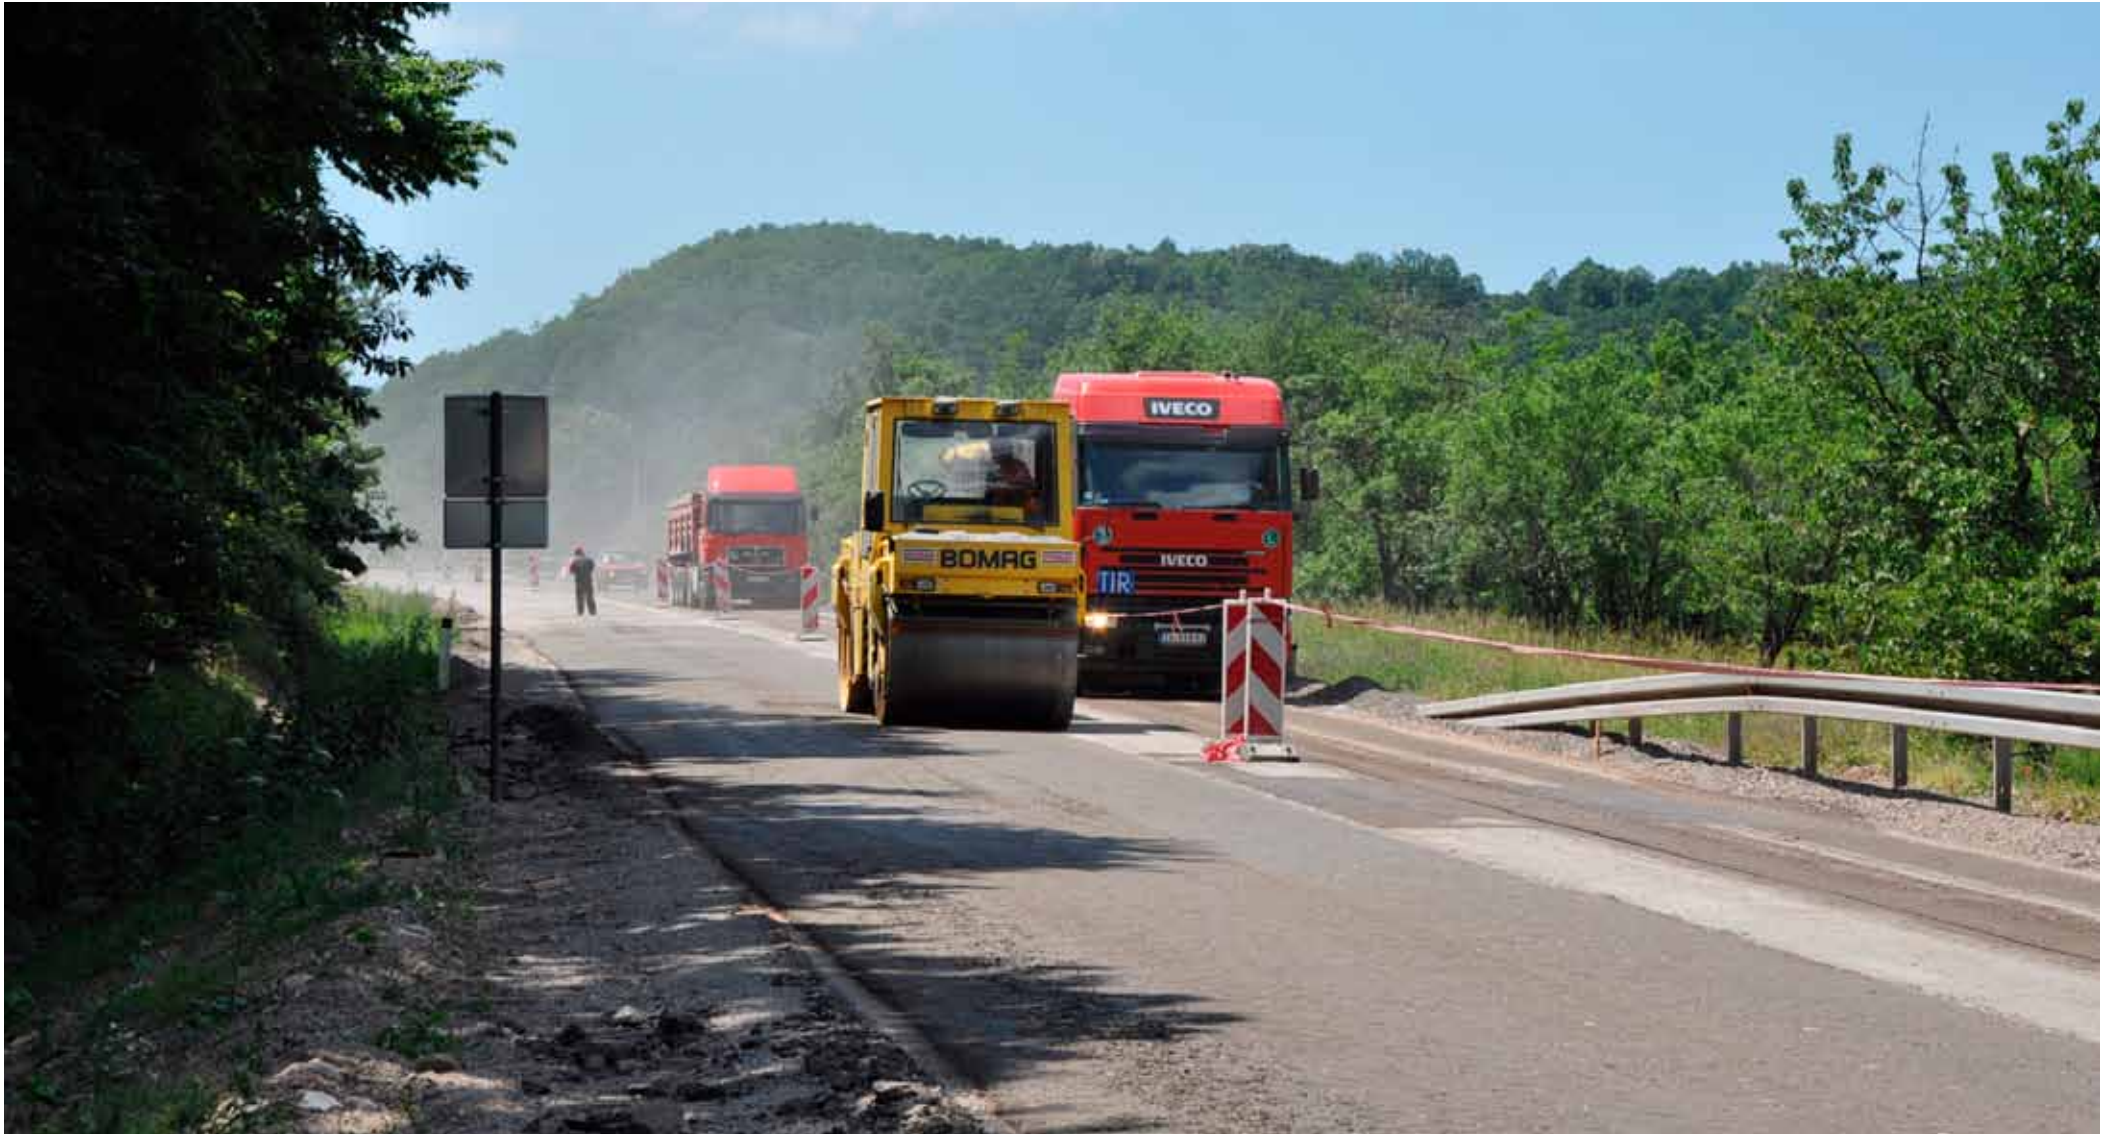
Compaction of the area
