Jobsite report

Rehabilitation of the magistral (M5) between Boljevac and Straza in Serbia with the Mix-Paver technology and the cement additive NovoCrete®

- Location: Boljevac/Serbia
- Period of execution: May/June 2012
- Time needed: 15 days
- Cement: 110 kg/m³ Zement 32,5 with 2% NovoCrete
- Strength of layer: 18 cm

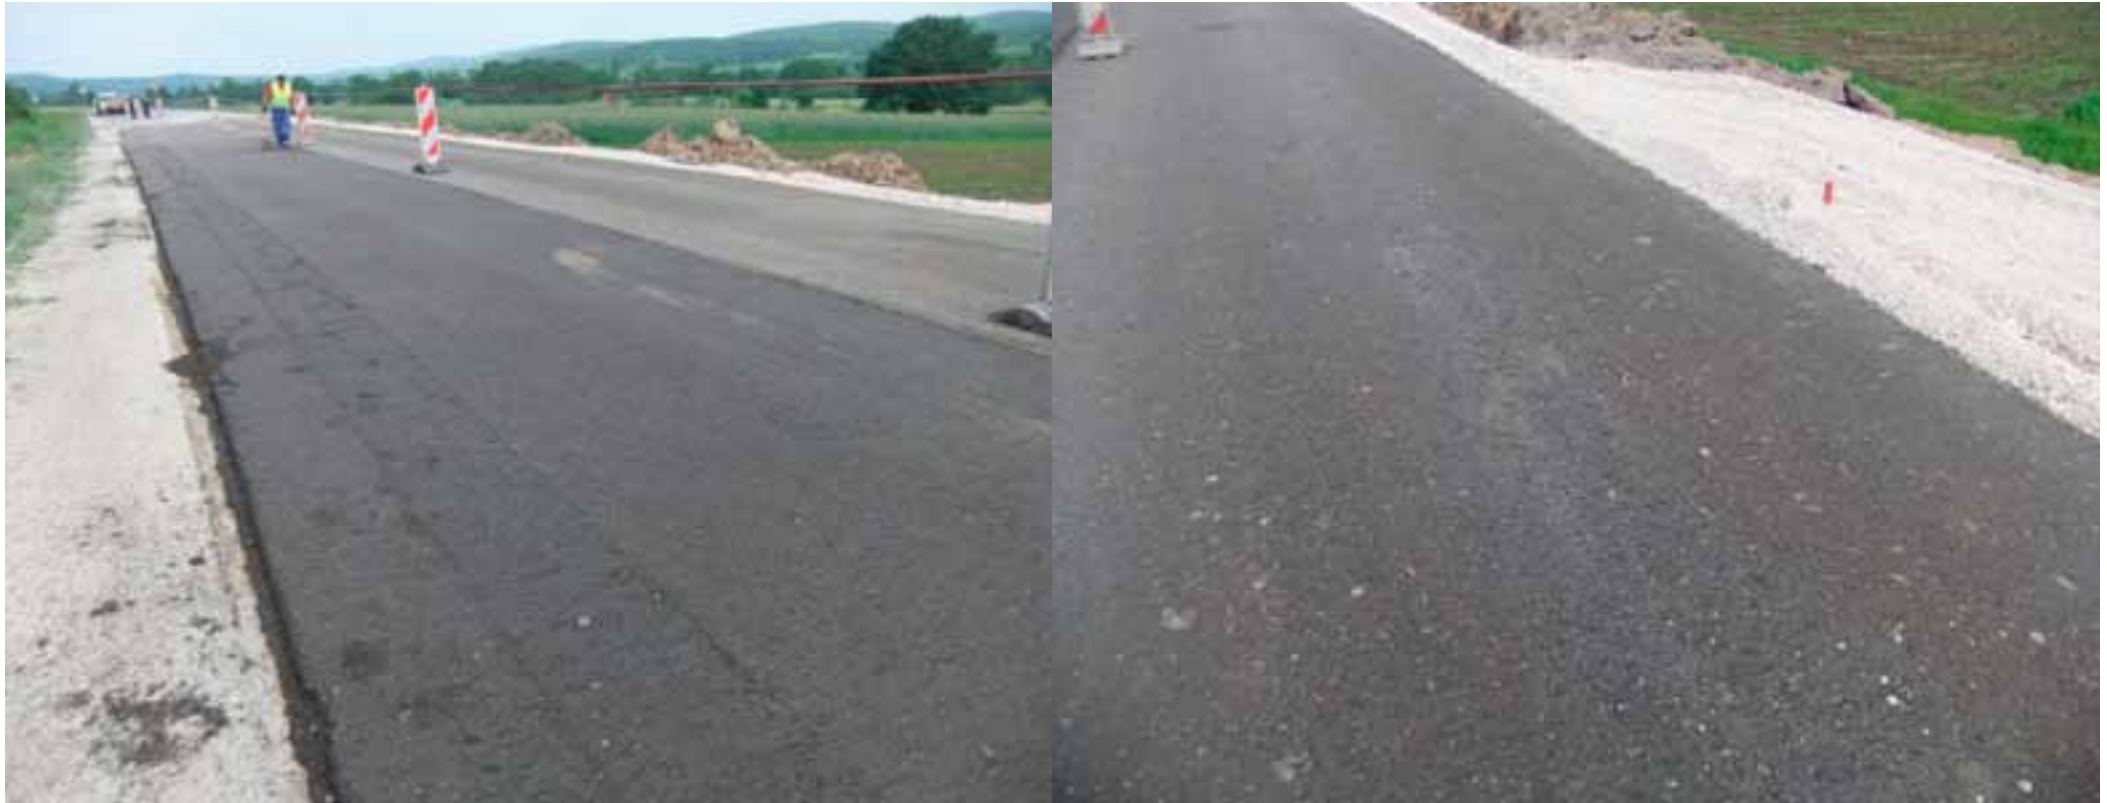
Area after compaction

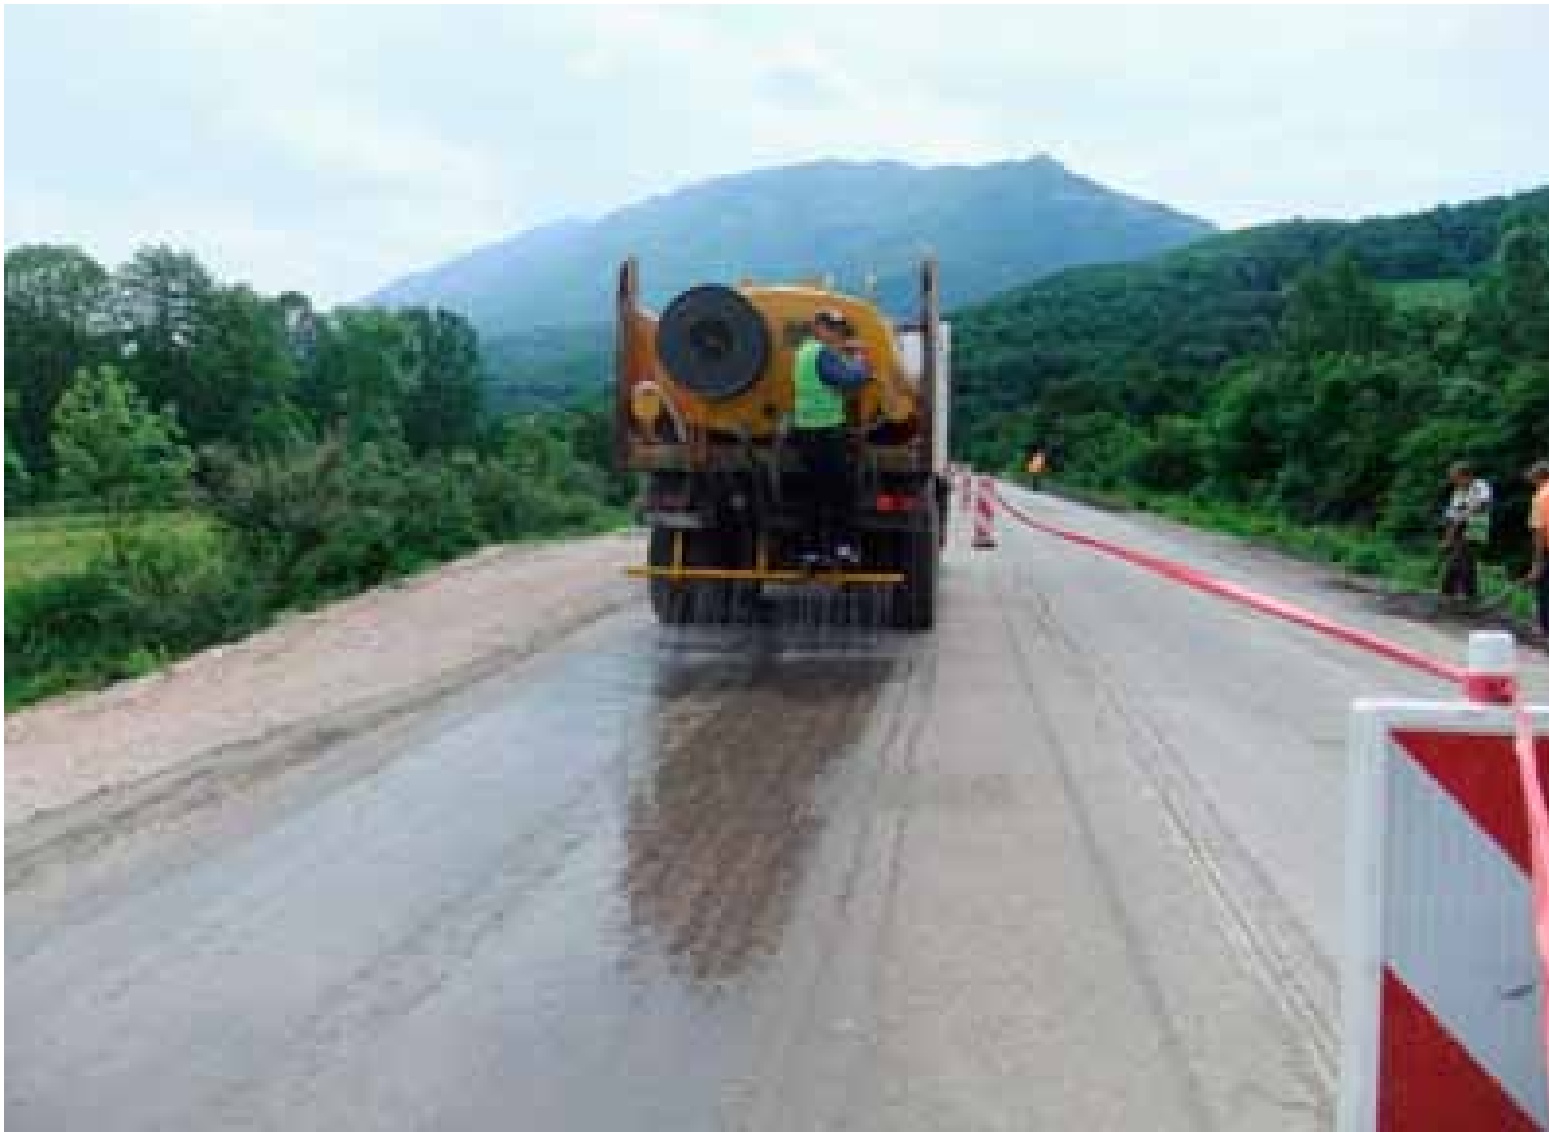
Irrigation of the area

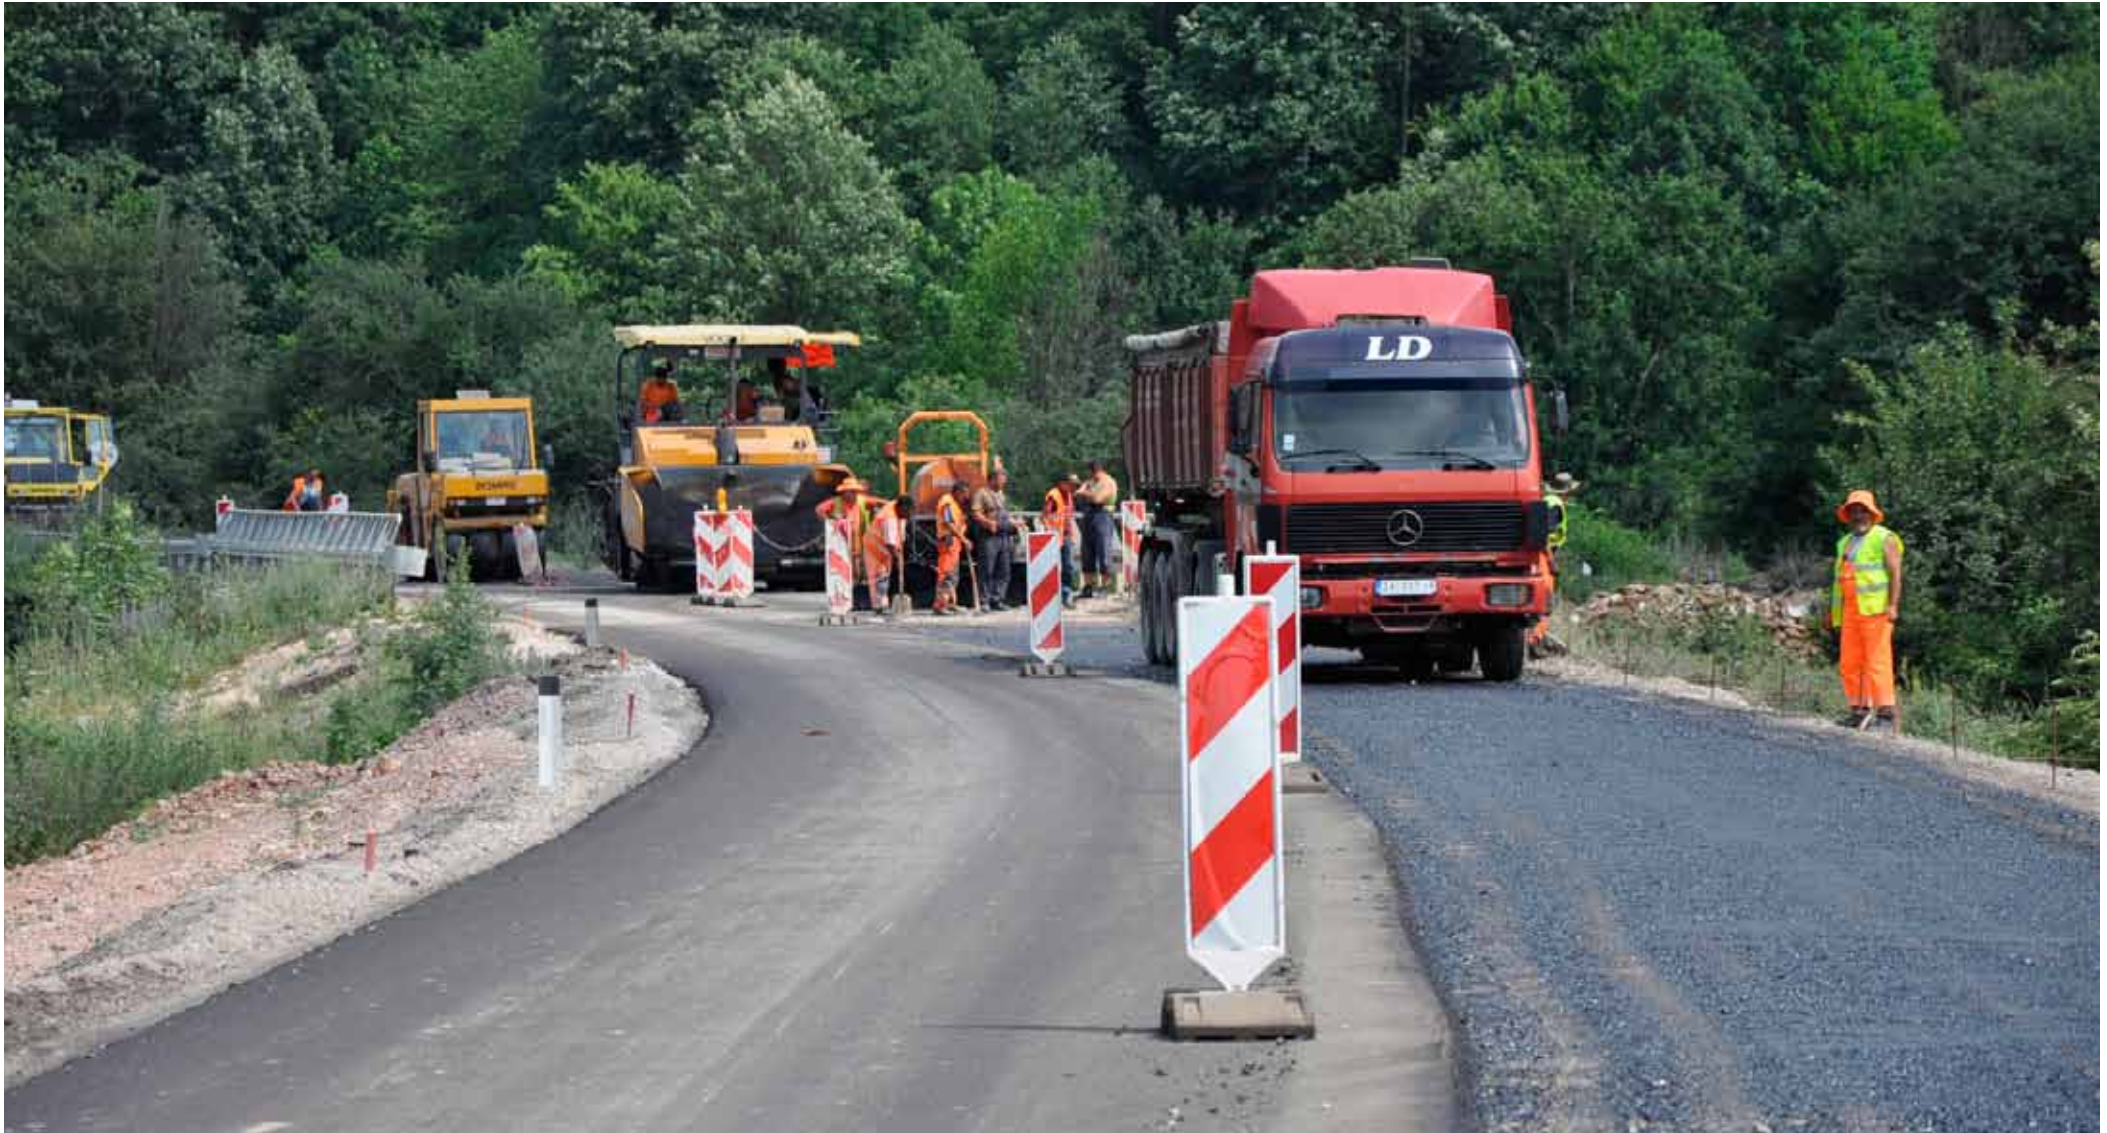
Fitting in of the new asphalt layer

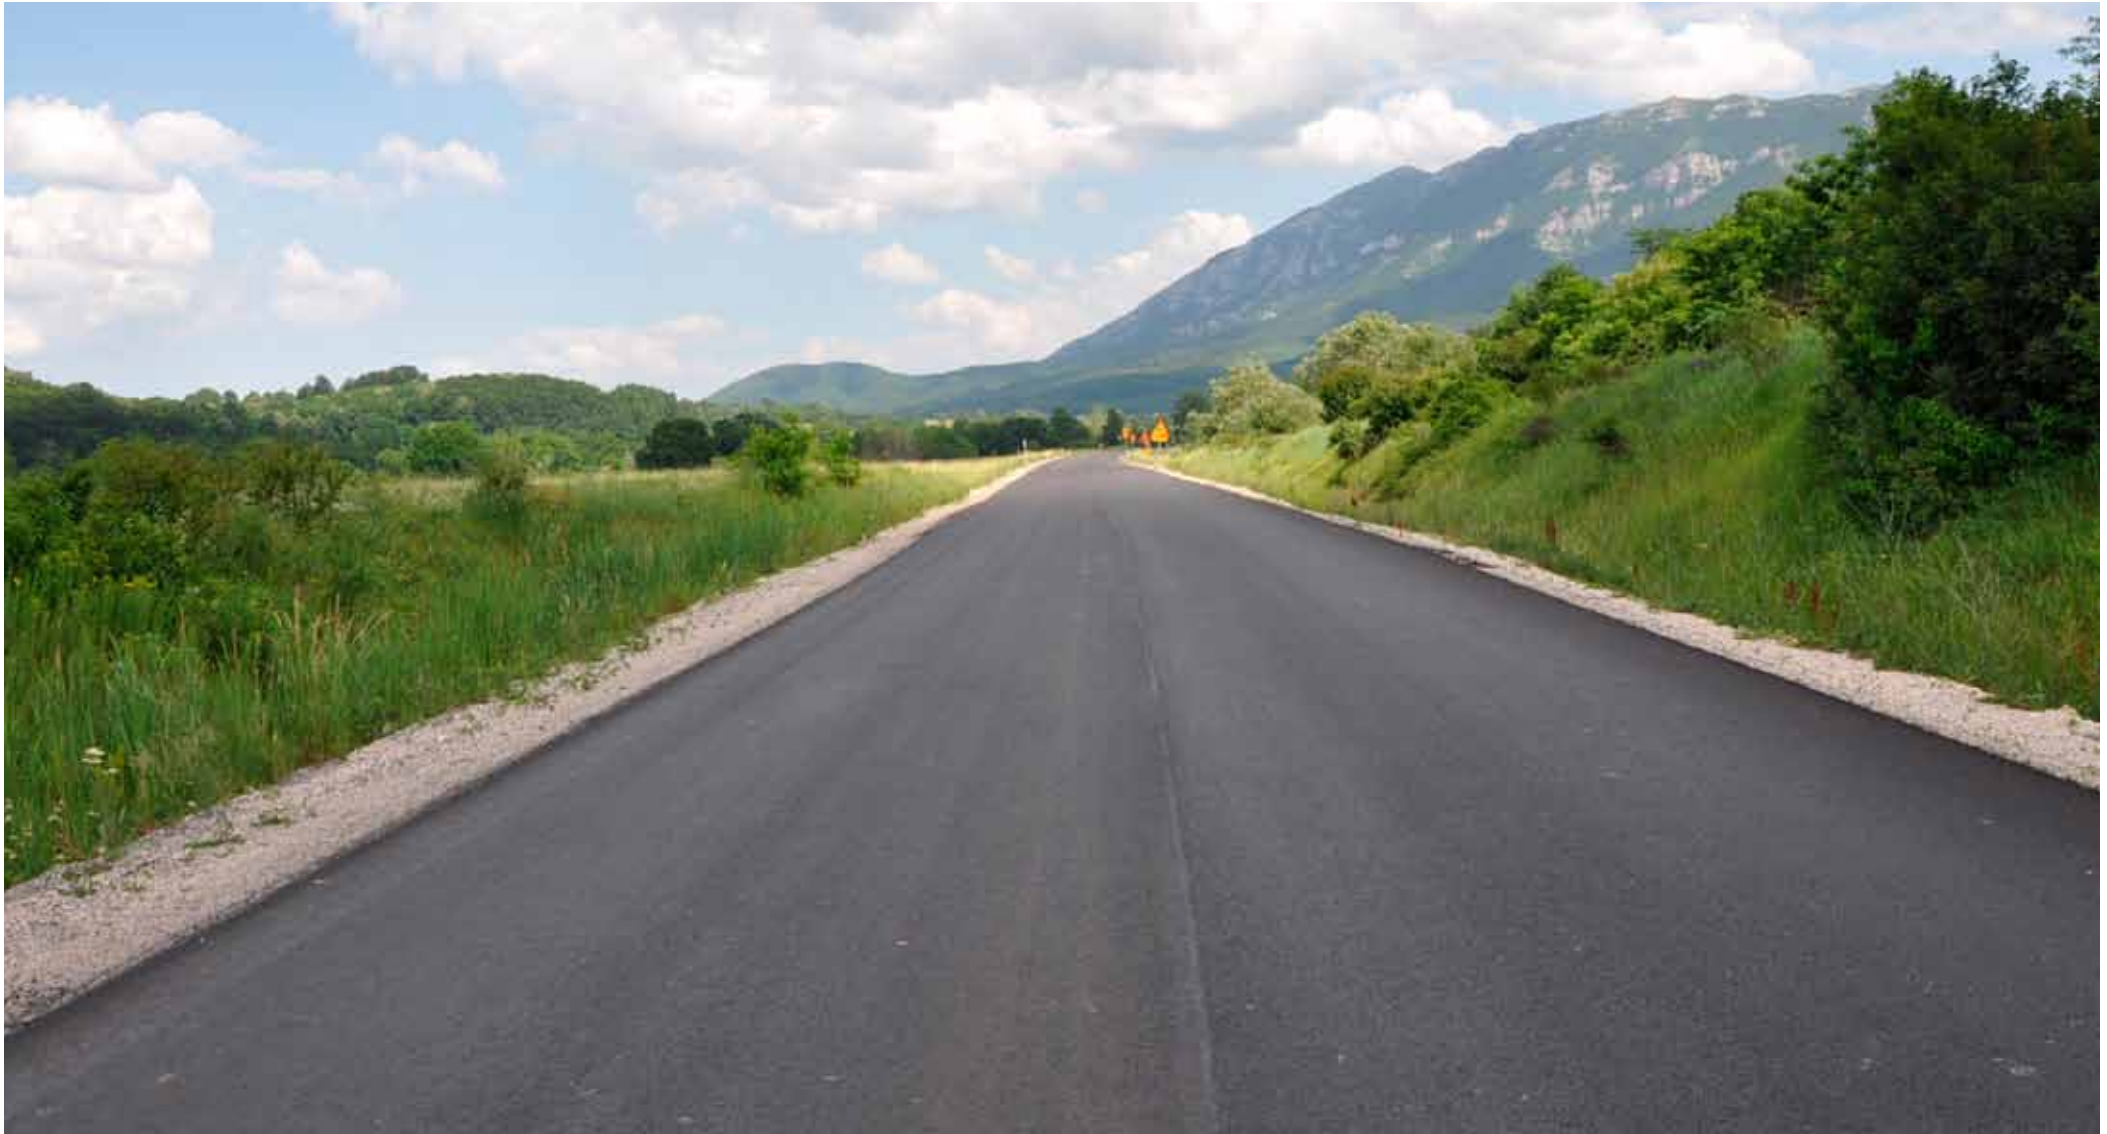
Road with new asphalt layer
